THE 2007 WEST SUMATRA EARTHQUAKE: SEISMIC HAZARD MITIGATION IN DEVELOPING COUNTRIES

H. Kit Miyamoto and Amir S. Gilani
Miyamoto International Structural and Earthquake Engineers
West Sacramento, CA, U.S.

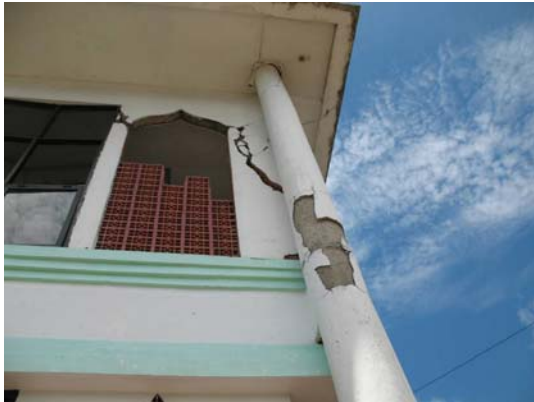
Religious Facilities Indonesia is the world's most populated Muslim country. Mosques are common in Indonesia. Typical mosque structures use concrete framing consisting of tall, slender columns. URM infills are placed on one (back) side of the building. As such, these buildings experience torsional-translational coupled response. More than 950 mosques were damaged in the earthquake. Approximately

Figure 2a shows typical mosque construction. Note the slender exterior concrete columns. This building was constructed in the mid-1990s. Figure 2b shows spalling of concrete from tall, slender column at the first-story level and shear failure of the interior URM wall. Note that URM walls are placed on the backside only, and thus the building is torsionally irregular.

a. Concrete spalling of slender columns

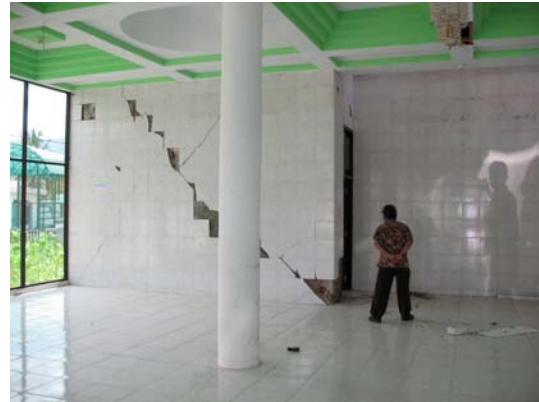
b. URM failure

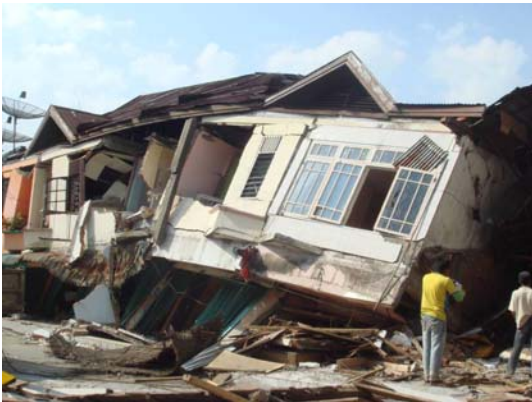
Figure 3 presents the types of damage observed to commercial and residential buildings. The commercial/residential structure of Figure 3a used URM framing. The lateral-story stiffness and strength were significantly less for the upper floors and resulted in a soft-story collapse of the first story. Figure 3b shows out-of-plane failure of URM walls. The URM buildings do not have adequate floor diaphragms, and URM walls are not positively connected to the perimeter bond beams and columns. As such, they are not restrained against out-of-plane failure. As seen in Figure 3c, the presence of URM infill dramatically alters the seismic response of concrete frames. The infills reduce the clear height of the columns from story height to the height between solid infills. This short-column effect prevents development of full flexural capacity and induces brittle shear failure. The beam-to-column joints for the concrete moment frames do not use ductile detailing; see Figure 3d. The reinforcement steel does not extend sufficiently

a. Soft story collapse

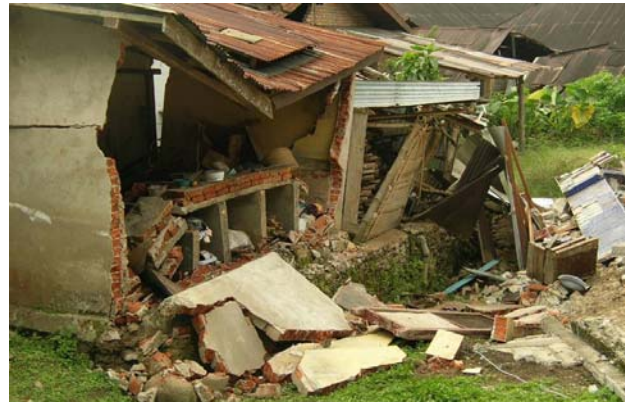
b. Out-of-plane failure of URM wall

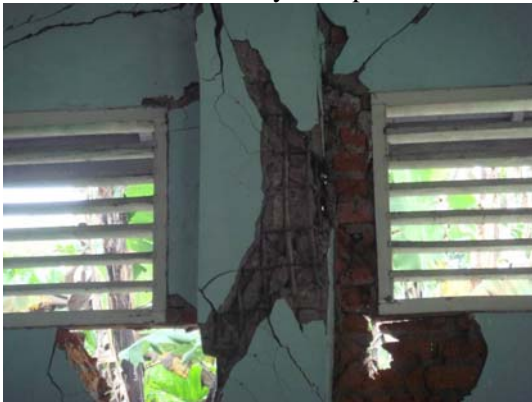
c. Short column effect

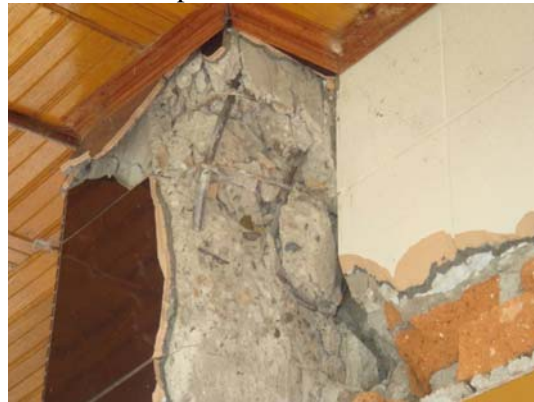
into the joint, nor does it have adequate development length. Furthermore, the joints are not confined and hence are susceptible to shear failure.

d. Beam-to-column joint failure

For URM infills and concrete bond beams, it is recommended to strengthen the beam-to-column joints; see Figures 7a and 7b. This will avert the brittle shear failure at the joints and will allow the concrete elements to provide some confinement to infills. Most importantly, they will carry the gravity loading and mitigate the building collapse. To alleviate soft-story and torsional response of mosques and other commercial buildings, either braces or dampers can be added to the first floor of the building; See Figure 7c. For bridges that are supported at the abutments on inadequate bearing pads, seismic isolation pads provide an attractive replacement alternative; Figure 7d. This isolation system will serve to reduce the inertial forces transferred to the substructure. Additionally, a well-designed system with adequate transverse shear keys would prevent the type of failures observed during this earthquake.

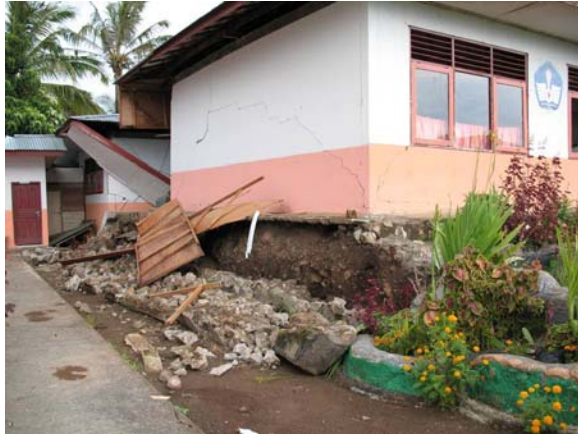
Figure 4a shows unreinforced retaining wall failure of a school building. Note the diagonal shear cracks on the URM walls at the side of the building. The out-of-plane collapse of URM walls is shown in Figure 4b. The walls were not adequately anchored to the foundation or roof diaphragm to restrain the URM walls. The Sumatra Fault is shown in the near distance. The roof diaphragm, perimeter concrete beam, and columns were weak. Figures 4c and 4d show nonstructural damage to a school building. This building did not sustain any structural damage. However, the ceiling and soffit collapsed. Unless these elements are properly designed and anchored, they are life-safety hazards. For this school building, ceiling panels collapsed in the classrooms, and roof soffit panels dislodged.

a. Soft story collapse

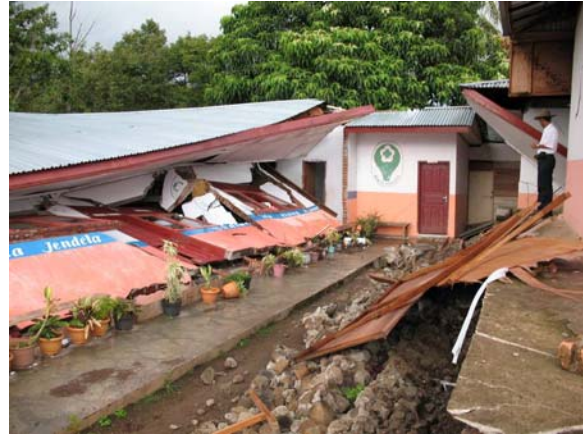
b. Out-of-plane failure of URM wall

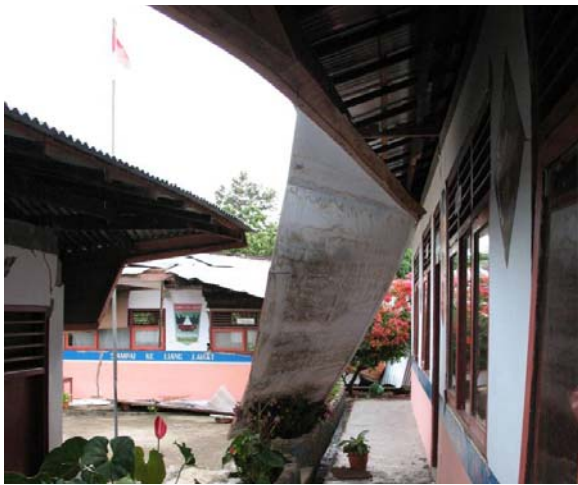
c. Soffit failure

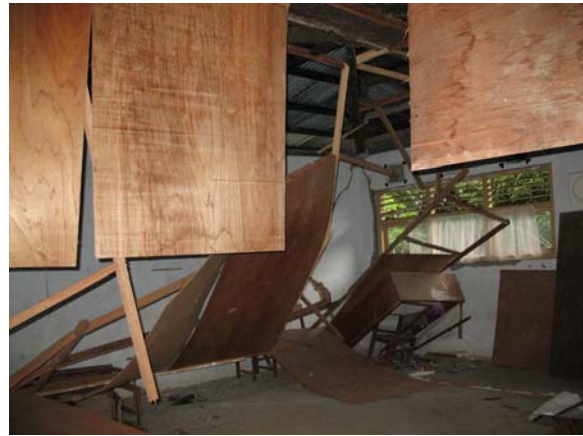
d. Ceiling damage

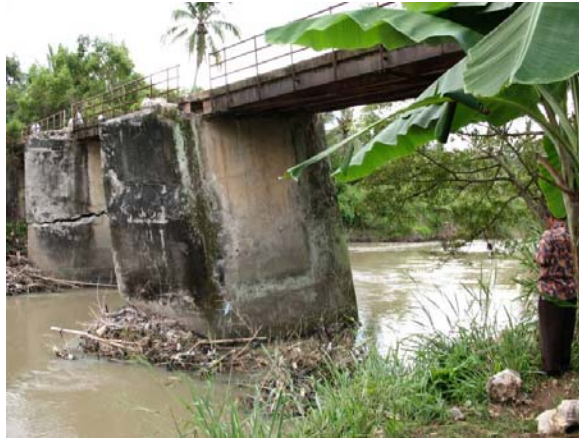
Figure 5 shows failure of piers for the concrete bridge. A heavy deck and bents contribute to high seismically induced force experienced by the bridge, which caused the rocking failure in one bent; Figure 5a, and brittle shear failure at another; Figure 5b. This bridge is near collapse, and traffic has been redirected. Figure 5c shows a steel truss bridge located in the earthquake-impacted area. The superstructure did not sustain any damage. However, the bridge had an inadequate abutment bearings (Figure 5c) and transverse shear key (Figure 5d), and its had insufficient movement capacity. The steel members in this bridge appeared to be undamaged. During the earthquake, the bridge slid off its bearings. The bearing pads did not have adequate width and/or restraint to allow or resist the seismic movement.

a. Rocking failure

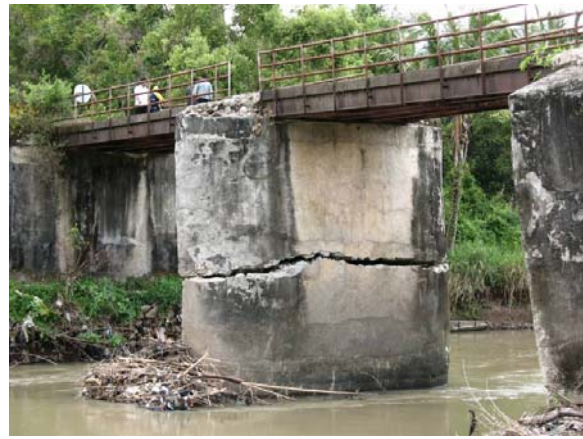
b. Shear failure

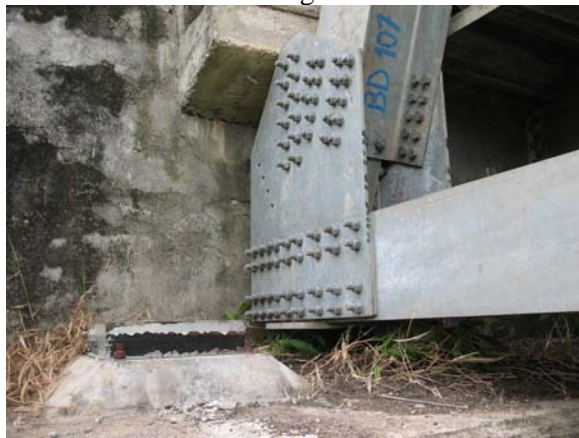
c. Transverse movement off bearing pad

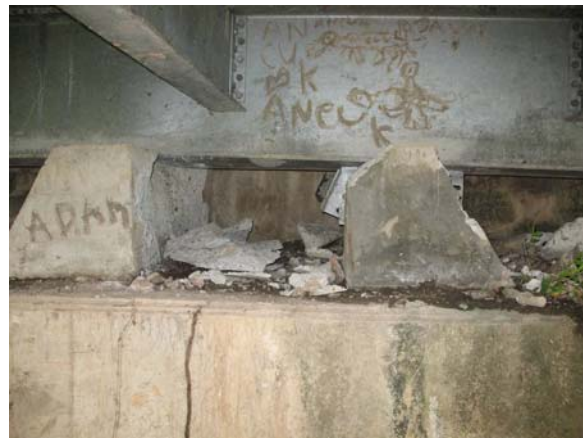
d. Shear key failure

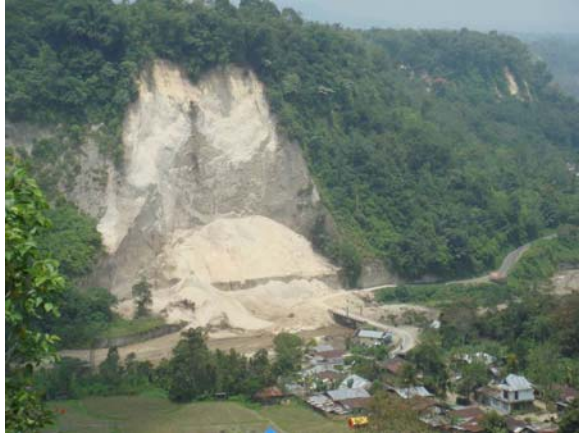
The Sumatra Fault is an inland slip fault and is 120 kilometers long with a subduction zone offshore. The earthquake caused a rupture along a 200-meter section, and there were three segments that slipped. A large landslide caused by the earthquake is shown in Figure 6a. Note the roadway at the bottom of the landslide. This slide buried four houses. As shown in Figure 6b, the earthquake also caused noticeable ground rupture both horizontally and vertically.

a. large landslide

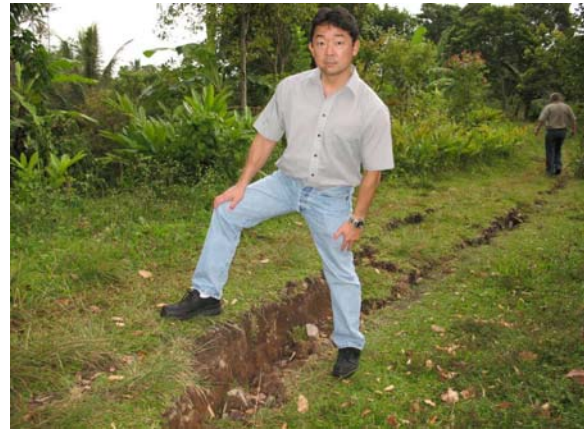
b. Ground failure
