# Damage Assessment and Seismic Retrofit of Buildings Following the 2015 Nepal and 2016 Ecuador Earthquakes

*H. Kit Miyamoto, PhD, SE and Amir SJ Gilani, PhD, SE  
Miyamoto International  
Los Angeles, CA*

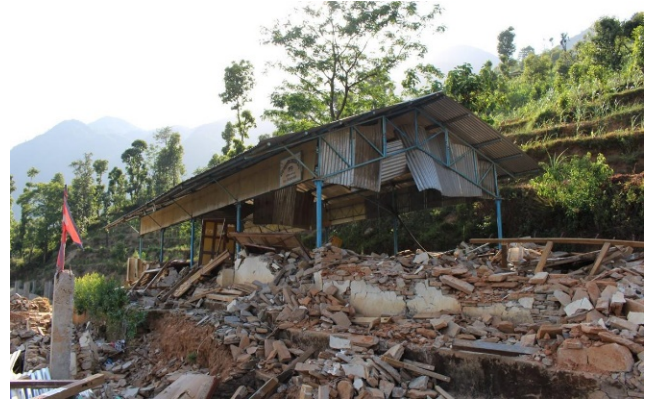
In past earthquakes in developing countries, school buildings have been especially vulnerable to damage from earthquakes (Miyamoto et al., 2011). The same was the case in Nepal; see Figure 3 and Figure 4. In the aftermath of the 2015 main event, data from the Department of Education (DOE 2015) was analyzed by the authors. Initial findings are shown in Table 2. It is noted that damage to school buildings was extensive and widespread. Fortunately the number of school casualties was limited because the earthquake occurred on Saturday when schools were not in session.

**Figure 3. Collapsed school building**

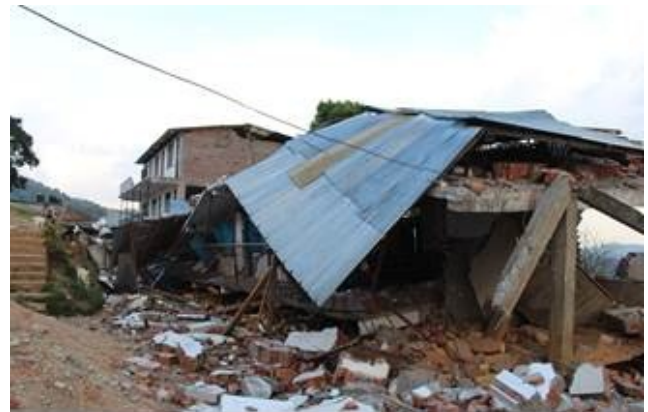
**Figure 4. Collapsed school building**

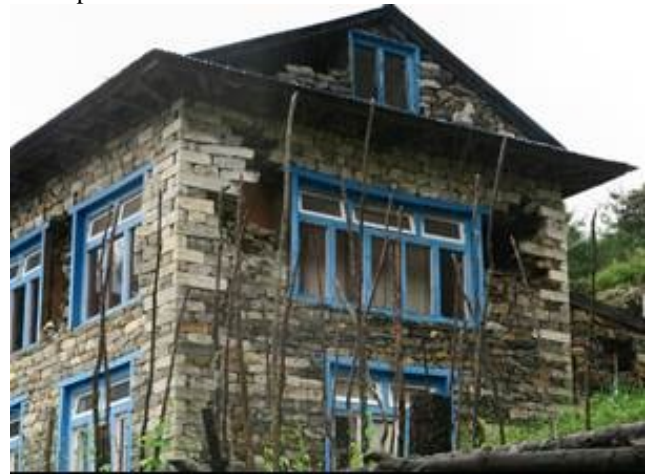
The level of damage in traditional construction depended on the construction practice. The buildings with stone and mortar generally performed well. By contrast, in older buildings where either no mortar was used or when mud was used as mortar there was significant damage. For these buildings, see Figure 5, the out-of-plane failure of walls was the most common mode of failure, where stone walls fell over or stones fell out, generally at the top of the walls. Since these bearing walls carry both seismic and gravity loading, their out-of-plane failure can compromise the gravity load path and can result in collapse of roofs and floors. For the surveyed buildings, a secondary wood beam supporting the roof was observed in many of the buildings. This member supported the roof after the failure of walls and prevented collapse of the roof. For an example of an accommodation structure built with cut rock, cement and ring beams that performed well; see Figure 6. Wood structures were mostly undamaged. The structural assessment of the buildings was conducted in accordance with the internationally recognized ATC-20 (ATC 2005) and the national guidelines for post-earthquake damage assessment specified by the Department of Urban Development and Building Construction (DUDBC) of the Government of Nepal. Out of approximately 710 surveyed buildings, earthquake damage of structural concern was observed in 120 buildings (17 percent); 83 percent of buildings were given a green tag per ATC-20 and DUDBC

**Figure 5. Out-of-plane failure of wall building**

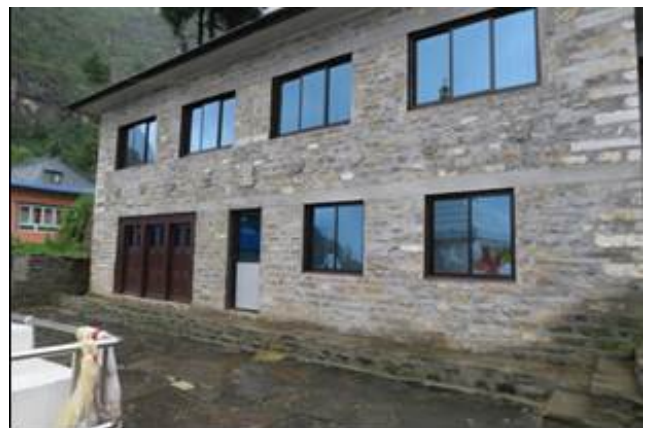
**Figure 6. Undamaged accommodation building**

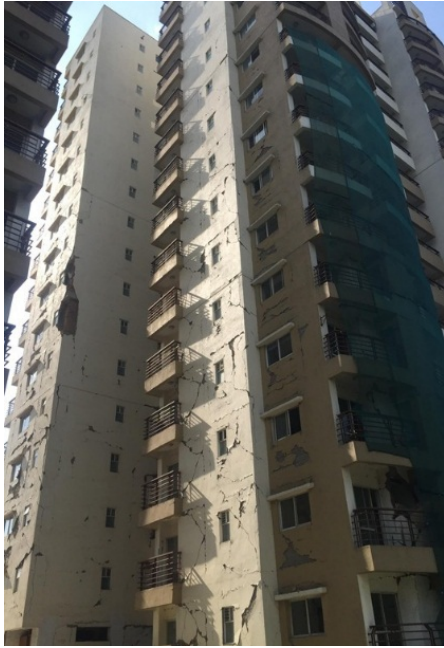
As mentioned previously, the soft soil underlying the Katmandu region produced large spectral accelerations in the 1-4 sec period range and excited mid-rise buildings. Many of these buildings are of newer construction vintage and had ductile detailing, and as such did not experience collapse. However, damage to these tower buildings was widespread; see Figure 7. Most of the mid-rise buildings used reinforced concrete moment framing as the lateral force resisting system. In addition, unreinforced infill walls were used for these buildings. The damage to the infill walls was extensive; see Figure 8, which caused the tenants to relocate temporarily from these units. It is noted that these are high-end condominium units.

**Figure 7. Exterior cracking, tower**

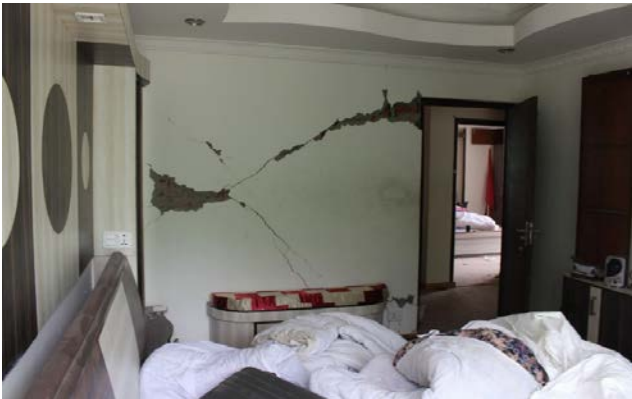
**Figure 8. Interior diagonal cracking of infill walls**

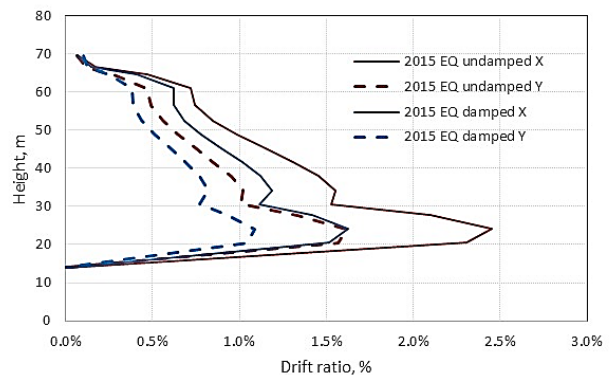
**Figure 10. 2015-earthquake analysis**

The new 70m tall hotel building has 15 stories and 3 basement levels, see Figure 9, reinforced concrete moment frame exterior shear walls comprises the lateral load resisting system. The structure was designed per IS 2002. Following the 2015 earthquake, it was decided to add the additional requirement of limiting the drift ratios to approximately 1.5 percent for a seismic event comparable to that earthquake. As shown in Figure 10, the building nearly met this criterion in the transverse direction. However, in the longitudinal direction, at the lower three levels, drift ratios exceeded this limit. To reduce the drift ratios, viscous dampers were added at these levels along the longitudinal direction. As shown in

the figure, in the new configuration, drift ratios were limited to approximately 1.5 percent.

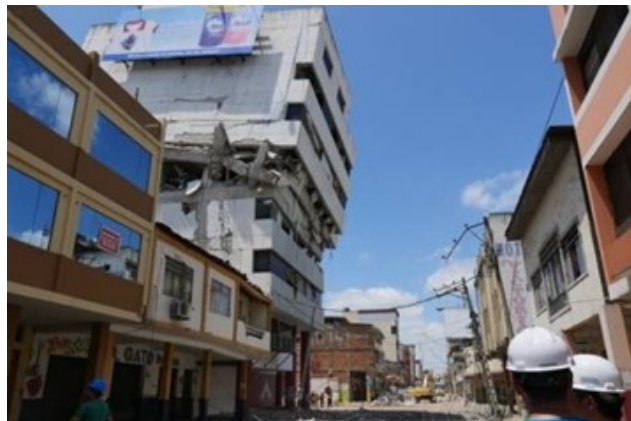
The team was divided into two teams and conducted damage assessment. Overall, 50 to 60 percent of buildings appeared undamaged and 30 percent had slight to moderate damage. The remaining 10 to 20 percent of buildings were severely damaged or collapsed. A multi-story tower building, see Figure 12, was severely damaged and presented life safety hazard to nearby buildings and the adjacent street.

**Figure 12. Multi-story damaged building**

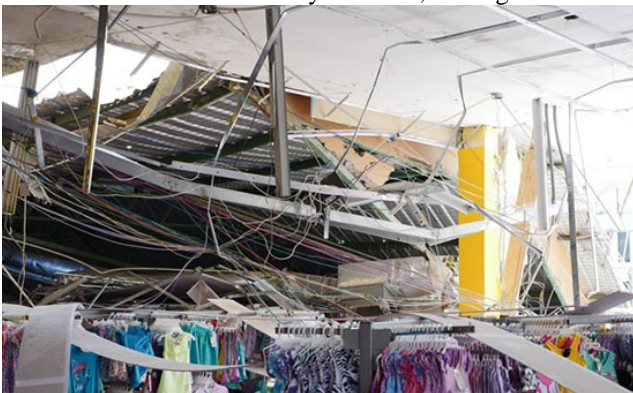
The Centro Municipal Commercial, taking up an entire city block, is a popular downtown market and includes a large department store on one floor, with small, subterranean independent vendor's stalls below it and an eight-floor office building. A large section of the market was severely damaged. The damage interrupted business for more than 180 vendors on this site and caused economic hardship. Damage assessment of the building was conducted. The older part of the building is the eight-story portion, and the department store is the new addition. The eight-story tower only sustained minor damage. However, sections of the market were deemed unsafe by the team, see Figure 15.

**Figure 15. Damaged market**

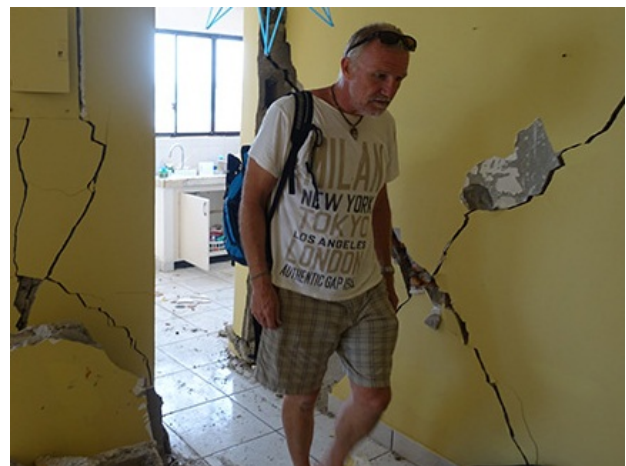
destruction. A row of tents was set up to house displaced people from damaged buildings and others who were frightened to return home. The exterior wall of a five-story building was on the verge of out-of-plane failure. In the downtown area, about one-third of the buildings were severely damaged or collapsed. Next, we visited two eight-story twin towers that had been recently constructed. One tower appeared undamaged, but the second building had suffered complete collapse and caused 12 fatalities. Such occurrences, noted in previous earthquakes, are attributable to variations in site condition, architectural detailing, material quality and means of construction. In a neighborhood of oceanfront high-rise condominiums, nearly all towers had exterior cracks. There were no fatalities, however, the extent of damage hampered recovery efforts. In one of the towers, there was major cracking of infill walls, see Figure 16. However, the concrete columns appear to have suffered only limited damage.

**Figure 16. Damaged plaster and infills**

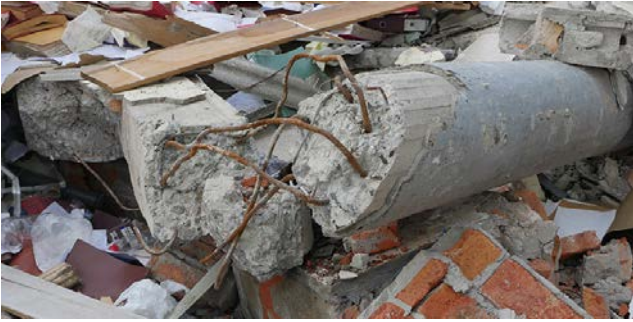
The coastal town of Pedernales, with 172 fatalities, was perhaps the worst hit by the earthquake. Many buildings collapsed here including a number of reinforced concrete structures with questionable material, inadequate strength and detailing, see Figure 17.

**Figure 17. Poor detailing of reinforced concrete**

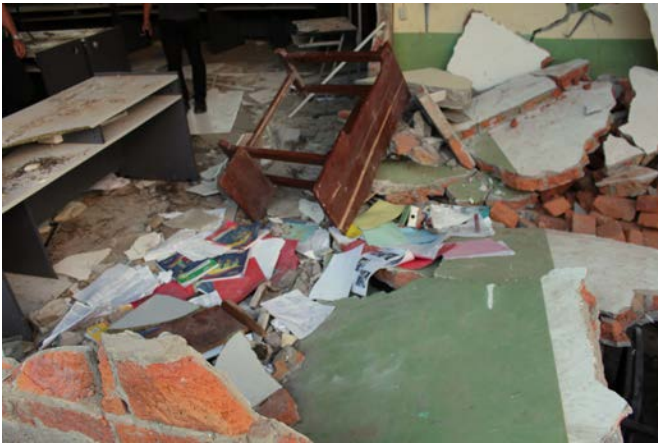
Chamanga is a humble fishing village tucked into a bay. Typical houses are rotted wood or concrete. The area regularly floods and sits in a tsunami zone without a warning system. More than 50 percent of the buildings collapsed, see Figure 18, and 6,000 people were living in temporary tents. One of four schools, constructed of bearing walls and a tin roof, had collapsed walls. Locals said the other schools had performed similarly.

**Figure 18. Partially collapsed school, Chamanga**

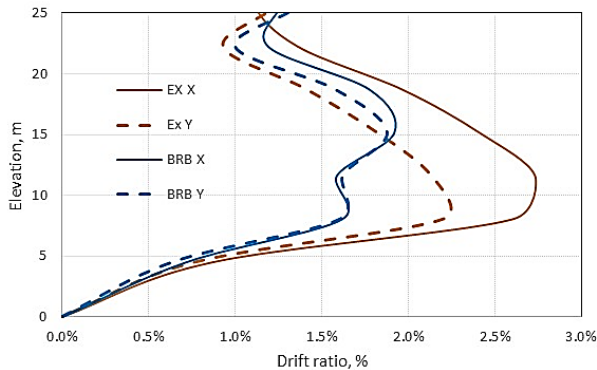
**Figure 20. MCE analysis**

The 41m tall building has 7 stories and 2 penthouse levels, see Figure 19. Reinforced concrete moment frame comprises the lateral load resisting system. Typical beams measure 350 x 450 mm and square columns vary in size from 450 to 700 mm. The structure was designed per Ecuador building code. Following the 2016 earthquake, it was decided to add the additional requirement of limiting the drift ratios to approximately 1.5 to 2 percent for the MCE event. BRBs were added to the building model, see Figure 20. As shown in Figure 21, the drift ratios for moment frame alone exceeded this limit and were 2.8 percent at the middle of the

building. To reduce drift ratios, BRBs were added to the building and this reduced the maximum drift ratio to approximately 1.8 percent.
