# Earthquake Reconnaissance of the 2008 Sichuan Earthquake and Retrofit Options

***H. Kit Miyamoto, President & CEO  
Amir S.J. Gilani, Structural Specialist***

***Miyamoto International, Inc.  
Sacramento, CA***

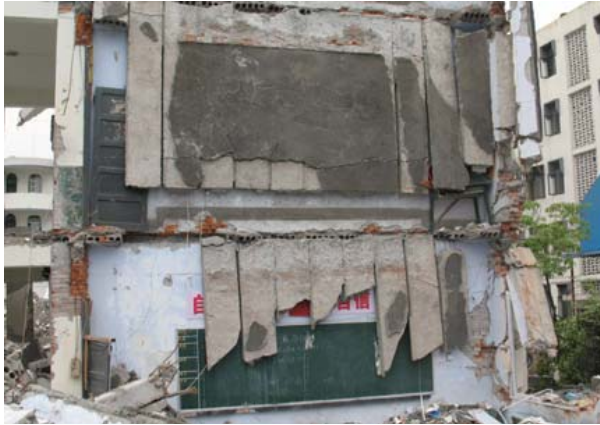
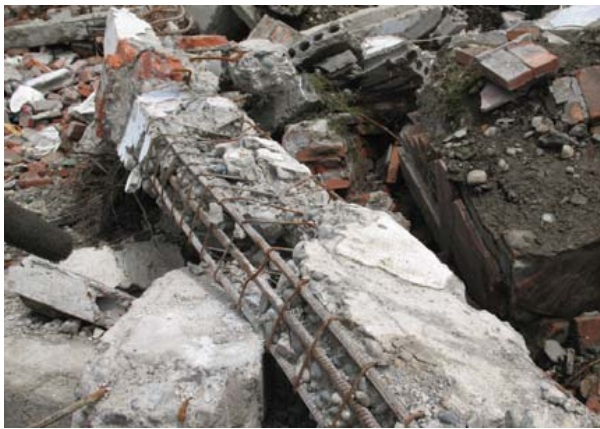
**Figure 10. Collapsed Juyuan Middle School**

This three-story school is in Juyuan, a town in the county-level city of Dujiangyan. Juyuan has a population greater than 50000 and is approximately 50 kilometers from Chengdu and 20 kilometers from the fault rupture. The school housed 1000 students. It is a relatively modern building, constructed in 1986, but used non-ductile detailing. More than 700 died when the building collapsed. Construction consisted of nonductile CIP-RC beams supported by URM walls, with precast concrete floor planks. There were no or minimal mechanical ties connecting the floor planks to the URM walls. Figure 10a shows the collapsed floor precast planks. Note that the planks pulled away from the walls and have rotated downward. They are attached to the remaining walls hanging by the wire steel reinforcement. The collapsed URM walls and nonductile concrete beam is shown in Figure 10b. A lab building adjacent to the collapsed school and with similar construction did not collapse. This better performance was likely due to the orientation of its URM walls or better construction quality. Figure 11 shows the cracked walls.

a. Collapsed Floor Planks

b. Collapse URM Wall and Concrete Beam

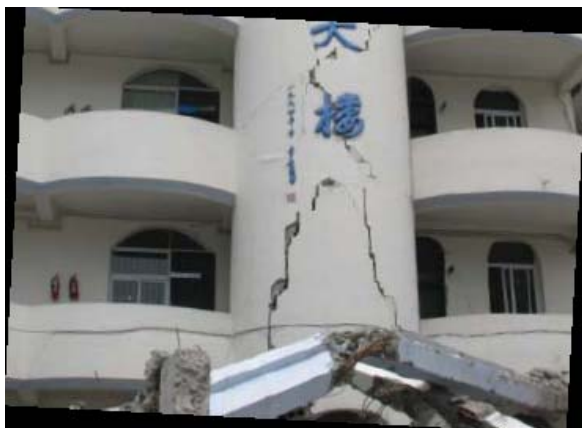
**Figure 11. Shear Cracks in Masonry Walls**

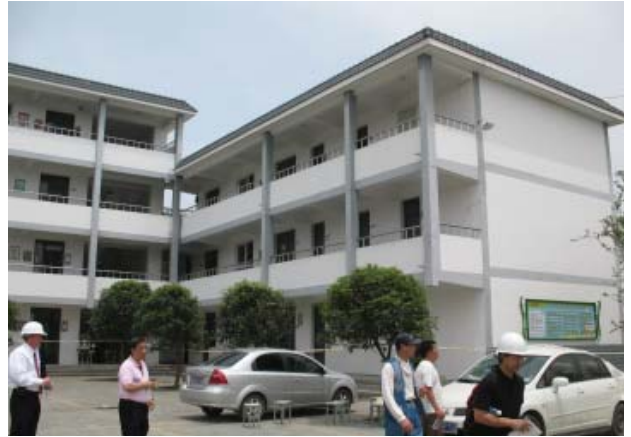
comprised of CIP-RC beams and columns, and URM walls. It only sustained minor shear (diagonal) cracks in the walls and minor pounding damage between buildings. Its good performance (Figure 12) could likely be attributed to its vintage and good construction practice.

**Figure 12. Undamaged School Building**

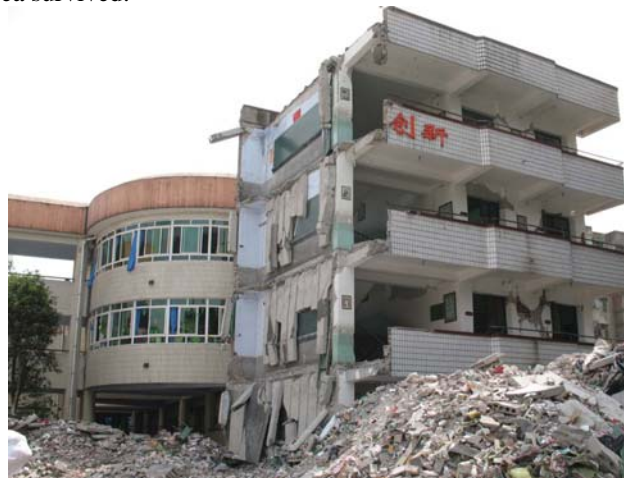
This four-story school is in the town of Xingfu, in the county-level city of Dujiangyan. It has a population of more than 300000 and is located 15 kilometers from the fault rupture. The building collapsed and killed more than 300 of the 600 occupants. Building framing consisted of nonductile CIP-RC columns and beams, URM walls, and precast concrete floor planks. The stairway (Figure 13) survived the event. This was a typical observation. The stairwells added stiffness and resistance to this portion of the buildings and survived even when the main building had collapsed. In many instances, the students and teachers who stayed in the classrooms perished, whereas those who had left the rooms and were in the stairway area survived.

**Figure 13. Collapsed Xingfu Primary School**

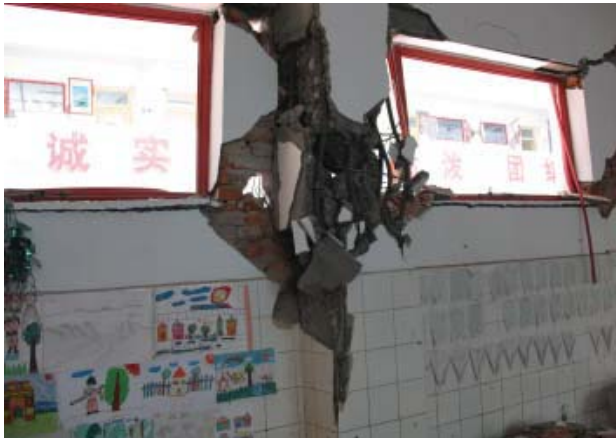
This four-story school is located in the Hanwang township of Mianzhu with a population of more than 60000. Hanwang is at the foot of the Dragon Gate Mountains, within 10 km of the fault. The building sustained significant damage but no collapse. Construction consisted of CIP-RC framing and URM walls. The walls had extensive damage and concrete columns failed. The column failed in shear (Figure 14) because the infill URM walls butted up against the concrete columns creating captive columns and preventing flexural yielding.

Figure 14. Captive Column Failure

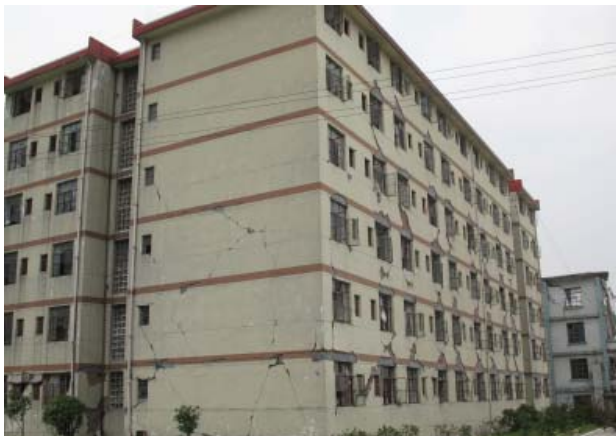
The main school building collapsed, but the adjacent dormitory building survived although its walls were cracked (Figure 15). Both structures were built in 1994 and were of similar construction using URM walls and precast concrete floor planks. The better performance of the dormitory is attributed to the redundancy provided by the many interior URM walls and shorter spans for precast floor planks.

Figure 15. Cracked URM Walls

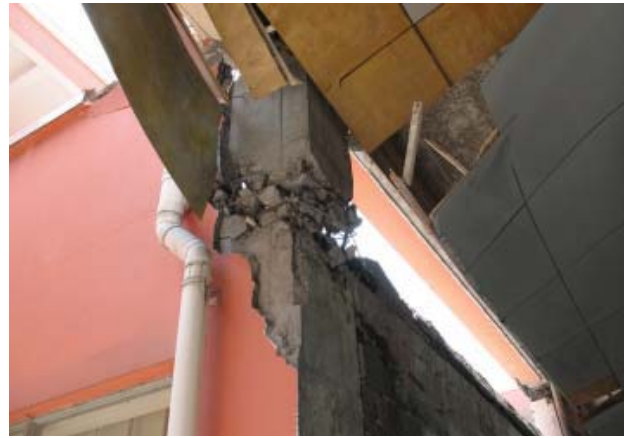
This school is located in the city of Mianzhu, with a population well over 500000, about 20 km from the fault rupture. Framing comprised of nonductile CIP-RC columns and beams, and URM bearing walls. There was significant structural damage. In particular, large flexural strains and lack of adequate confining transverse reinforcement resulted in severe column damage and loss of core concrete at the plastic hinge zones (Figure 16) comprising the lateral and vertical load capacities of these columns.

Figure 16. Column Flexural Failure

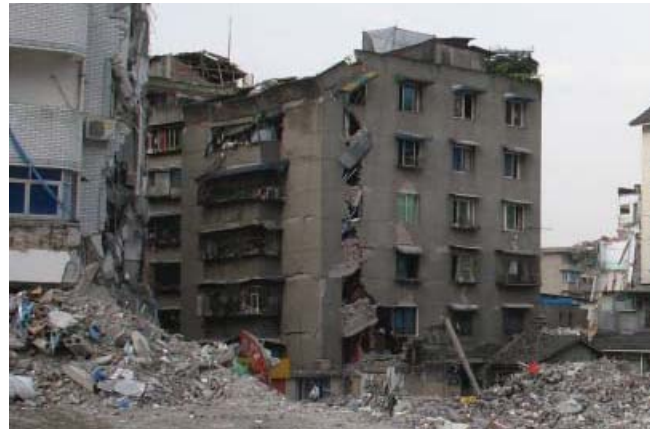
A wing at the Xingfu Hospital collapsed (Figure 17), resulting in 200 fatalities. This wing, constructed in 1996, had typical nonductile CIP-RC framing with URM walls and precast concrete floor planks. An adjacent wing, constructed in 2000, performed better and sustained moderate structural damage, shear-wall cracks, and nonstructural damage, dropped ceiling panels (Figure 18).

Figure 17. Collapsed Hospital Wing

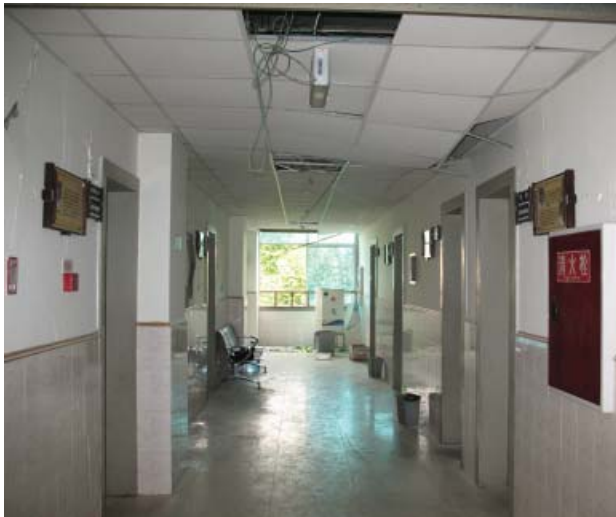
**Figure 18. Nonstructural Damage**

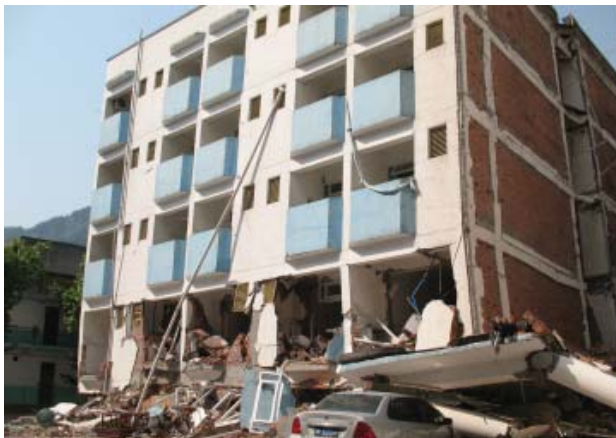
This five-story hospital was constructed in 1999. Construction consisted of nonductile CIP-RC framing and URM walls. The ground floor was designed as a parking garage. Hence, the URM bearing walls were terminated at the first floor, creating a bottom story with much smaller lateral stiffness. This soft story completely collapsed during the earthquake (Figure 19) and the upper floors dropped down one floor.

**Figure 19. Soft Story Collapse of Hospital Building**

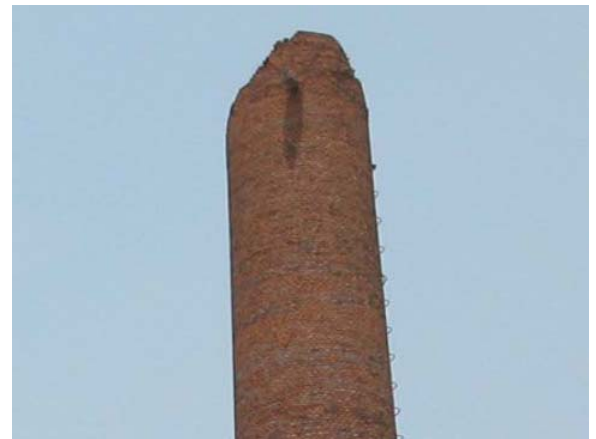
This 300-employee glass manufacturer, built in 1996, is located near the city of Mianzhu. The plant has several production and storage buildings, and many of the one-story buildings used lightweight steel construction. Two URM stacks measuring 50 m high and 5.8 m wide failed. The top 5 meters of the stacks collapsed (Figure 20) due to large accelerations. A mezzanine structure above the bottle production machine failed because it was not properly braced. Equipment at this plant was generally well anchored and performed well. Approximately 10% of the glass bottle inventory was destroyed when it fell from the 5 m tall product shelves (Figure 21).

**Figure 20. Damaged URM Stack**

The loss of the stacks is critical since the plant cannot operate without them. It is estimated that repairs could take up to six months. Such extended BI could lead to up to 50% revenue loss and could compromise the factories market share including its sole-source agreement with a Chinese wine label.

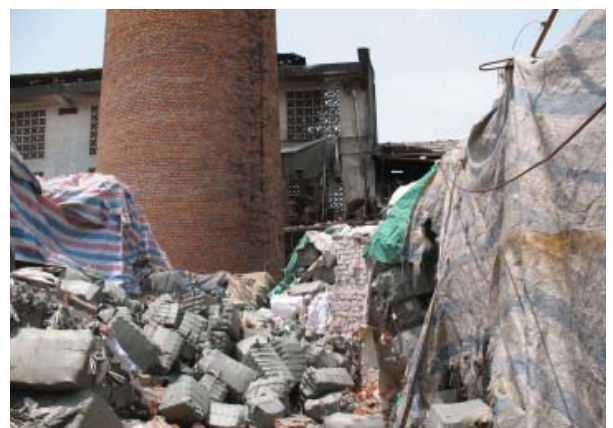
**Figure 21. Loss of Inventory**

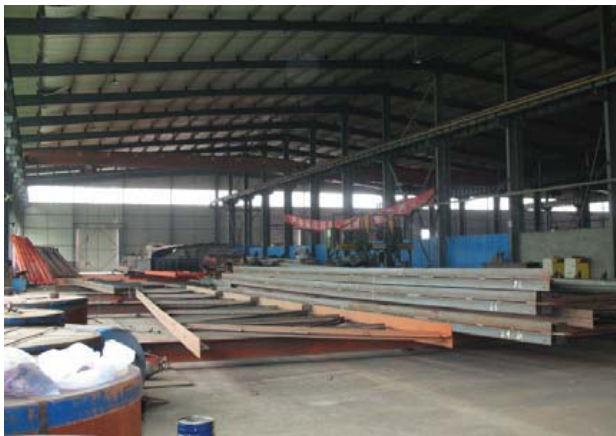
This lightweight steel fabricating plant, built in 2003, is southwest of the city of Mianyang, 40 kilometers from the fault rupture. No major damage was observed to either structural or nonstructural components (Figure 22), except for some broken window glass, which was caused by excessive building displacement. However, this facility sustained one week of BI because after the earthquake, workers were reluctant to return to work until structural inspection was completed. Such problems can be avoided by proper preparatory training.

**Figure 22. Undamaged Building**

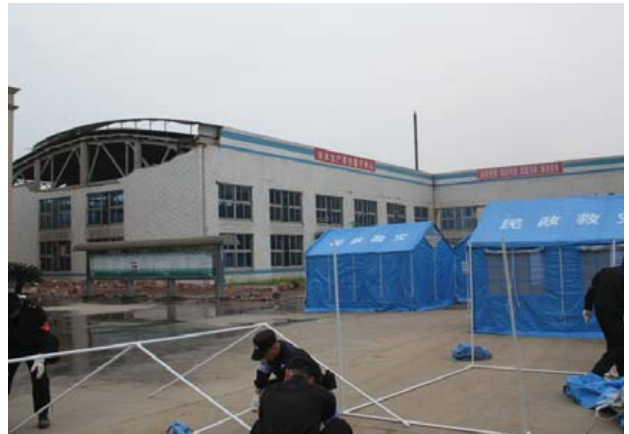
This packaging plant is located in the Hanwang township of Mianzhu. The plant was constructed of precast roof panels over steel trusses supported by steel columns, and URM infill walls. These walls did not have adequate out-of-plane anchorage and many sections, including part of the roof (Figure 23) collapsed because of out-of-plane seismic excitations. BI for this plant is expected to exceed six months. BI was exacerbated when the plant grounds were used by emergency medical units (Figure 23). This usage precluded accessing the site and beginning structural repairs.

**Figure 23. Damaged URM Wall and Emergency Tents**

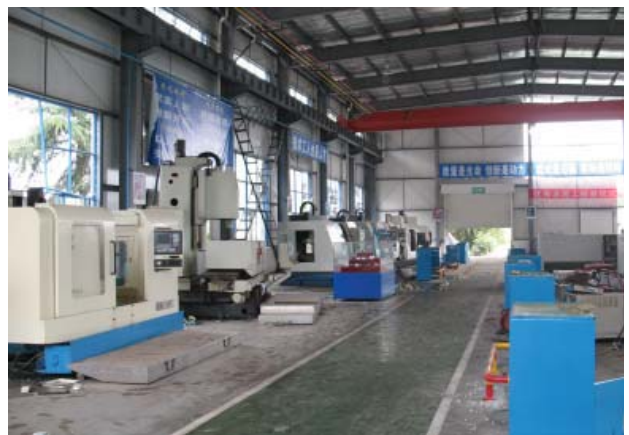
This light industrial plant is located in the Hanwang township. The plant was constructed of precast roof panels over steel trusses supported by concrete columns. This structure performed well, except for the collapsed entrance canopy. Unanchored heavy pieces of equipment slid at least 150 mm off their base (Figure 24). BI is expected to be several months because of direct damage to the building and unanchored equipment.

**Figure 24. Sliding of Non-Anchored Equipment**

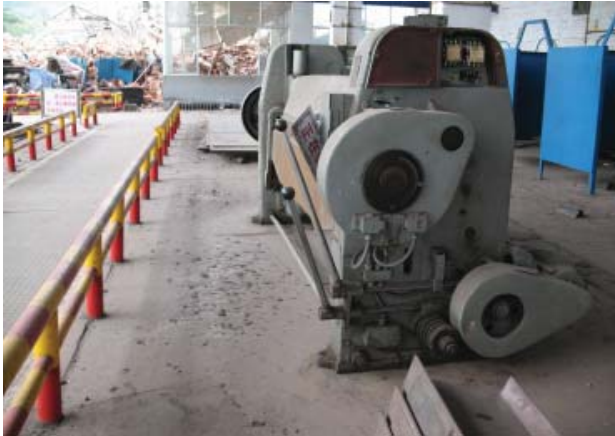
This steel fabricating plant is located in the Hanwang township. The plant was constructed with a lightweight steel roof, steel trusses, and steel braces. The structure performed well and had little damage. However, unanchored heavy pieces of equipment slid off their bases (Figure 25) causing BI of several months.

**Figure 25. Sliding of Non-Anchored Equipment**

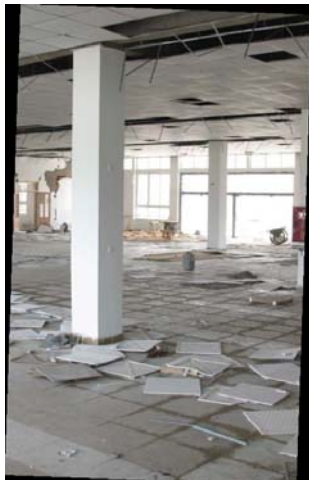
The two-story and four-story office complex, still under construction, is located in the town of Juyuan, Dujiangyan City, very near the collapsed middle school building. The structural damage was minor and consisted of cracking of URM walls. Nonstructural damage was mainly the panel loss and grid collapse of suspended ceilings (Figure 26). The ceilings did not have lateral bracing.

**Figure 26. Damaged Suspended Ceiling**

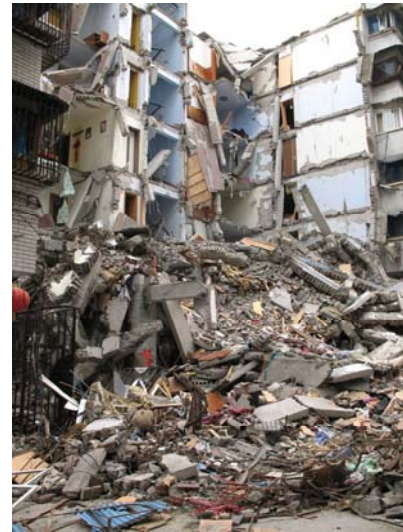
This five-story building is located in Xingfu. Construction consisted of nonductile CIP-RC columns and beams, URM walls, and precast concrete floor planks. The corner of the structure collapsed into the street. It appears that the termination of walls above the ground floor resulted in a soft story response at that floor, leading to collapse (Figure 27). Incidentally, an almost identical building next door, only sustained minor damage, leading to the conclusion that the construction quality and detailing are the likely differences.

**Figure 27. Collapsed Corner of the Building**

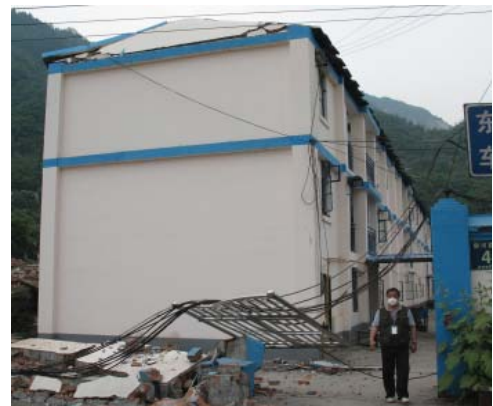
This three-story office building is located in the Hanwang township of Mianzhu. It sustained minor damage, although many close by buildings collapsed. The only visible damage was to the wood roof (Figure 28). This concrete structure has many walls, and appears to be well designed and constructed.

**Figure 28. Damaged Roof of the Building**

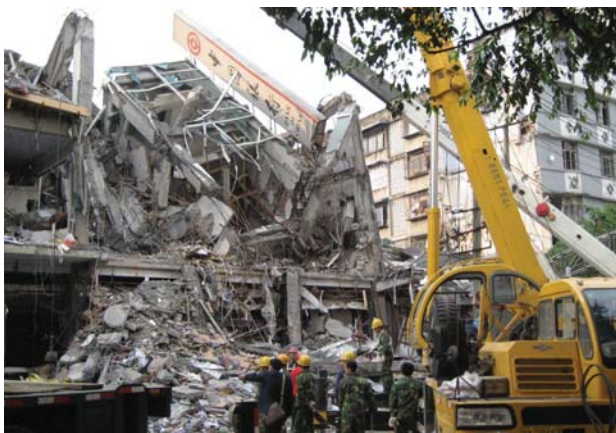
This five-story office building is located in the business district of Dujiangyan City, almost 25 km from the epicenter. Construction consisted of nonductile CIP-RC frames, URM walls, and precast floor planks. This structure collapsed (Figure 29). Bank branches experienced significant damage and collapse in hard hit areas, including those of China Construction Bank Corp. and Agricultural Bank of China. Within three weeks of the earthquake, financial institutions began providing financial services in tent banks and mobile banking stations, complete with security cameras, in much of the disaster zone.

Figure 29. Collapsed Bank of China Branch

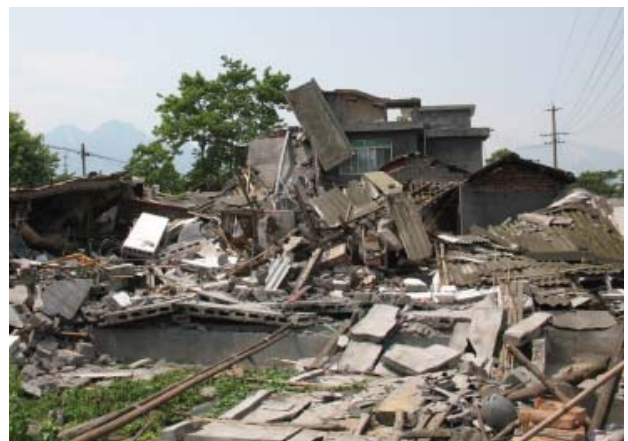
This small village of residential structures sustained severe damage and over 80% of the buildings collapsed (Figure 30). The structures were built of brick walls and wood-frame roofs with lightweight black roofing tiles.

Figure 30. Collapsed Residential Units

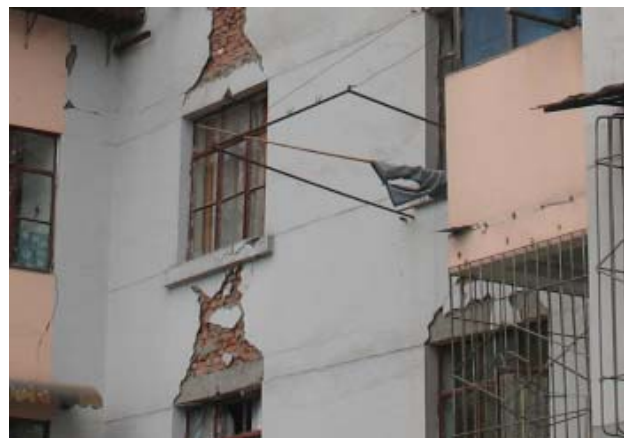
Several eight-story apartment buildings, constructed of URM bearing walls and concrete slabs, constitute a complex in the center of Hanwang. Many diagonal shear cracks occurred in the walls between windows (Figure 31), but the buildings did not collapse due to the redundancy and lateral capacity provided by the network of interior walls.

Figure 31. Cracked URM Walls

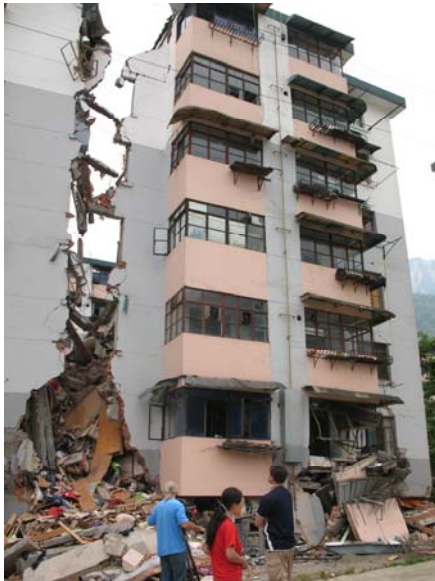
In this complex, a construction detail was used that called for connecting the adjacent residential units via a narrow corridor with a large number of windows. Hence, this portion of the complex, had little lateral stiffness or strength. The corridor URM walls for this complex failed, resulting in a portion of the building tilting and dropping by 3 m, and causing a vertical split in the corridor (Figure 32).

**Figure 32. Vertical Split and Displaced Apartment Complex**

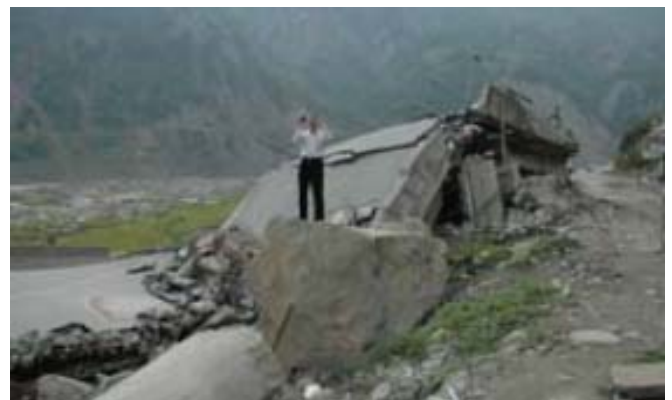
**Figure 33. Collapsed Bridge (NCREE)**

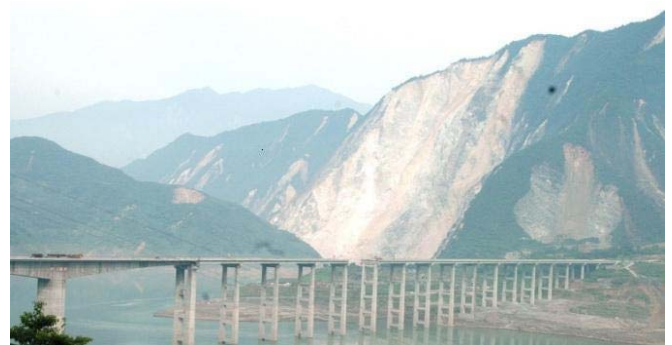
**Figure 34. Bridge with Un-Seated Span (NCREE)**

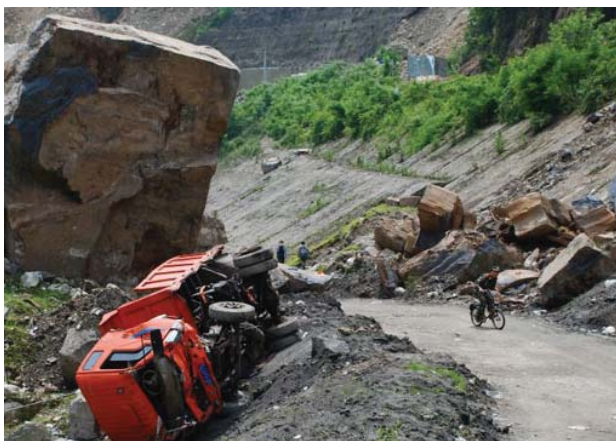
Over 16000 km of highway was damaged. Roadway damage (Figure 35) was the result of ground shaking (acceleration), surface rupture, and earthquake related geotechnical issues such as landslide, and slope instability. Furthermore, in the mountain regions, landslides or slipping road or rail foundations blocked many traffic arteries. Heavy rains and aftershocks in the weeks following the earthquake exacerbated sliding initiated by the first shock. Routes into most of the heavily damaged area were reported as open two weeks after the earthquake

**Figure 35. Damaged Roadway**

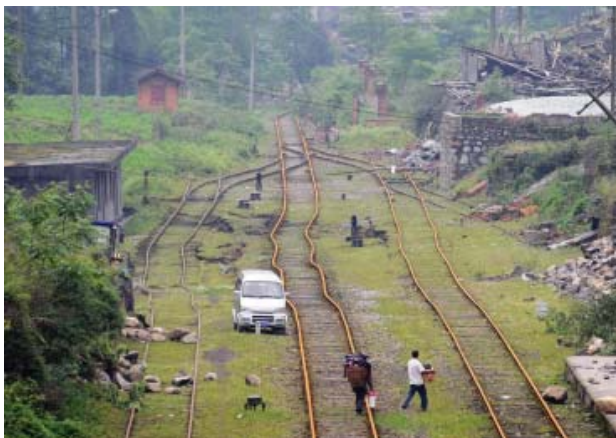
Railways were damaged because of shifting ground (Figure 36), slipping, or settlement. Rail lines are especially susceptible to earthquake damage because they must remain in alignment and therefore have less tolerance for ground shaking and movement. Rail-line restoration trailed behind roads. Many rail routes are electric powered and therefore require restoration of the power grid.

**Figure 36. Damaged Roadway**

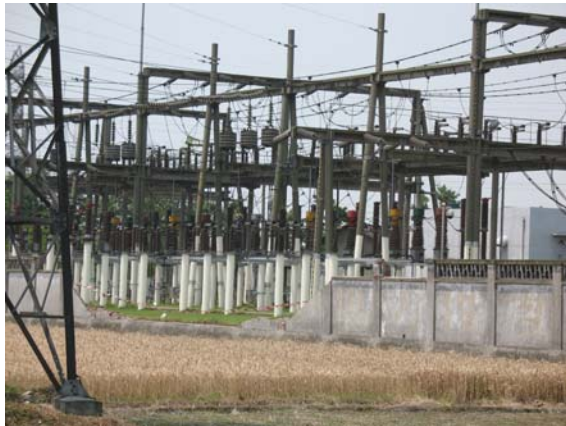
Figure 37 shows the damage to a substation located near Mianzhu, approximately 20 kilometers from the fault rupture.

This substation was shut down for five days because porcelain components of high voltage elements dislodged from their steel pole base. URM walls, subjected to out-of-plane seismic excitation and lacking bracing, also failed. In addition, water pipes into the substation's supply tank failed, elongating the downtime for this substation.

**Figure 37. Collapsed URM Wall at a Substation**

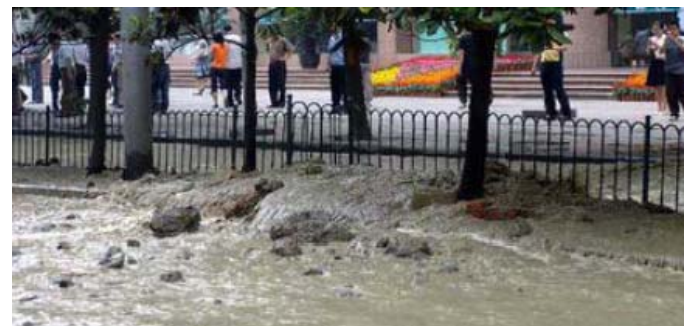
**Figure 38. Broken Water Mainline (MCEER)**

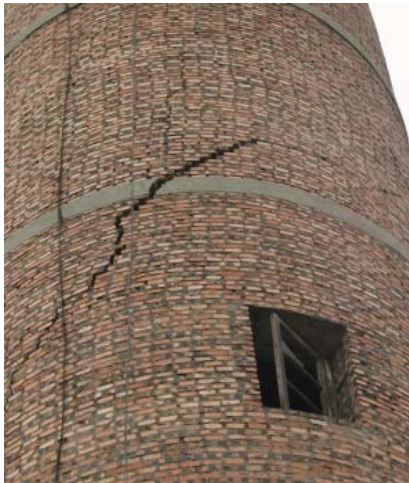
A water tower, constructed of URM, is located in the town of Juyuan, adjacent to the Juyuan Middle School collapse. The tower has leaned extensively and it threatens the adjacent, and undamaged, commercial building; thus making the building inaccessible. There is also a large shear crack in the tower wall (Figure 39). It is unlikely that this structure would be repaired.

**Figure 39. Large Shear Crack in URM Water Tower**

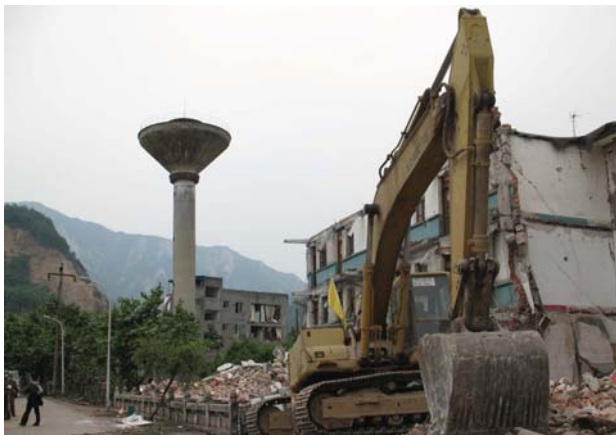
A concrete water tower located in the township of Hanwang constructed of CIP-RC, and was undamaged (Figure 40). Nearby buildings were damaged extensively and collapsed. The good performance of this tower is attributed to its structural system and dynamic properties.

**Figure 40. Undamaged Water Tower**

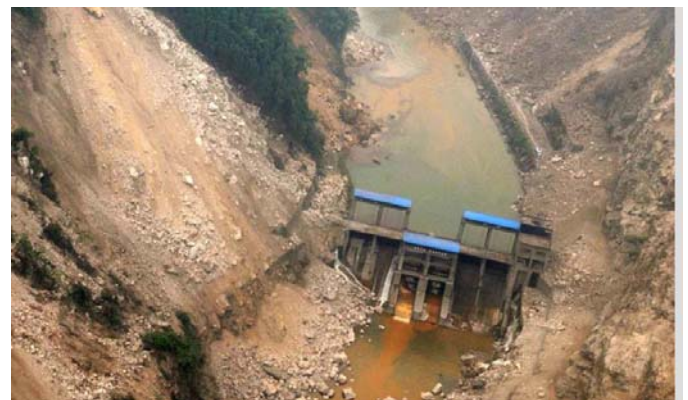
**Figure 42. Damaged Dam (MCEER)**
