DAMAGE ASSESSMENT AND SEISMIC RETROFIT OF TRADITIONAL AND MODERN MIDRISE BUILDINGS IN THE AFTERMATH OF 2015 NEPAL EARTHQUAKE

H. Kit Miyamoto (1) and Amir SJ Gilani (2)

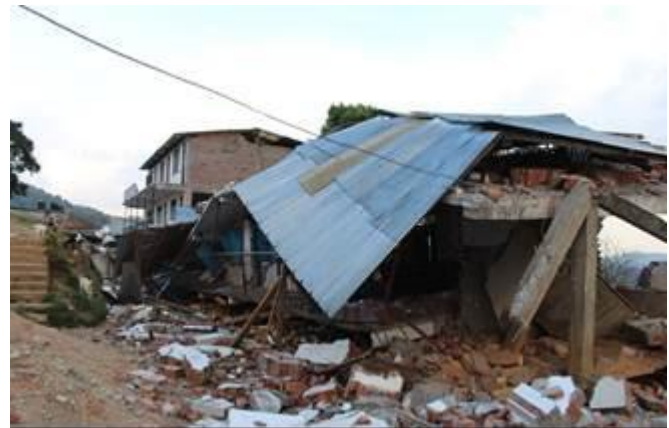
In the past earthquakes in developing countries, school buildings have been especially vulnerable to damage from earthquakes [2]. The same was the case in Nepal; see Fig. 5. In the aftermath of the 2015 main event, data from the Department of Education [3] was analyzed by the authors. Preliminary findings are shown in **Error! Reference source not found.** It is noted that damage to school buildings was extensive ad widespread. The number of school casualties was, fortunately, limited because the earthquake occurred on Saturday when schools were not in session.

Fig. 5 Collapsed school building

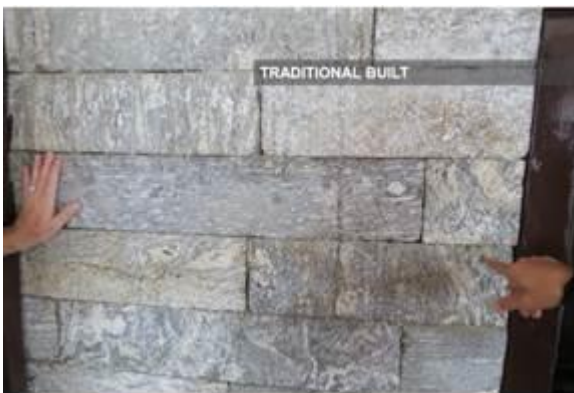
In the Everest area, 15 main villages with approximately 710 accommodations and houses were assessed. Typical hotel construction used either wood construction or bearing wall systems. Traditional buildings used bearing walls of uncut stone with mortar and bearing walls of cut rectangular block stone with or without mortar; see Fig. 7. The older construction used mud as mortar, whereas, newer buildings used cement. Some accommodation structures in Everest utilized horizontal concrete bands spaced intermittently in the stonewall construction; see Fig. 8. Typical roof construction used metal corrugated roof panels placed on top of wood framing. In a few, flagstone roof tiles, approximately 25 mm thick, were used on top of wood framing. Typical floor construction used mud placed over flat wood boards over wood beam framing. In some cases, there was no mud used and wood flooring was placed over wood framing. Typical foundations, according to local residents, were approximately one m deep below walls and were constructed using the same material as the wall itself, typically stone with mud, or cement mortar.

Fig. 7 Traditional bearing wall building

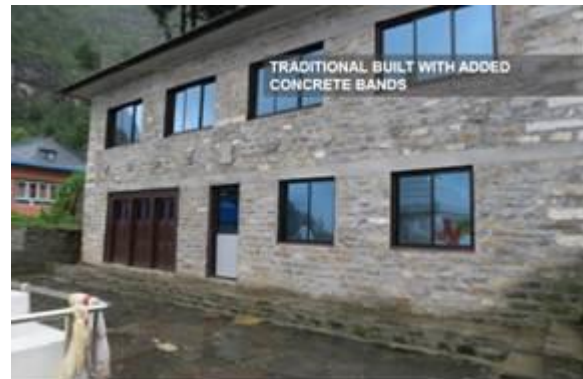
Fig. 8 Building with concrete band

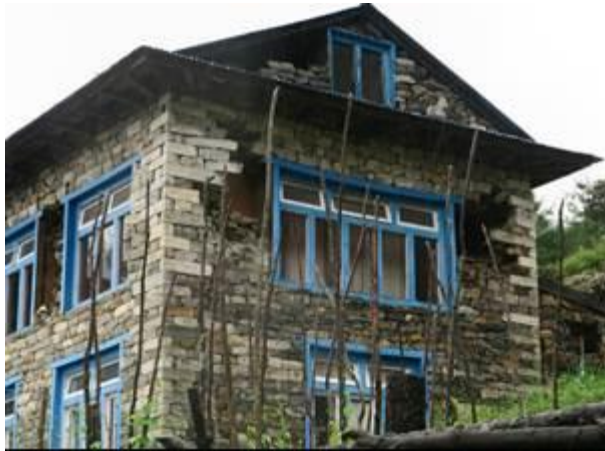
The level of damage in traditional construction was highly depended on the construction practice. The buildings with stone and mortar generally performed well. Although cracks were noticed in many of these buildings, these cracks did not pose a safety hazard. By contrast, in older buildings where either no mortar was used or when mud was used as mortar, there was significant damage. For these buildings, as shown in **Error! Reference source not found.**, the out-of-plane failure of walls was the most common mode of failure, where stonewalls fell over or stones fell out, generally at the top of the walls. Since these bearing walls carry both seismic and gravity loading, their out-of-plane failure can compromise the gravity load path and can result in collapse of roofs and floors. For the surveyed buildings, a secondary wood beam supporting the roof was observed in many of the buildings. This member supported the roof after the failure of walls and prevented

Fig. 9 Out-of-plane failure of bearing wall building

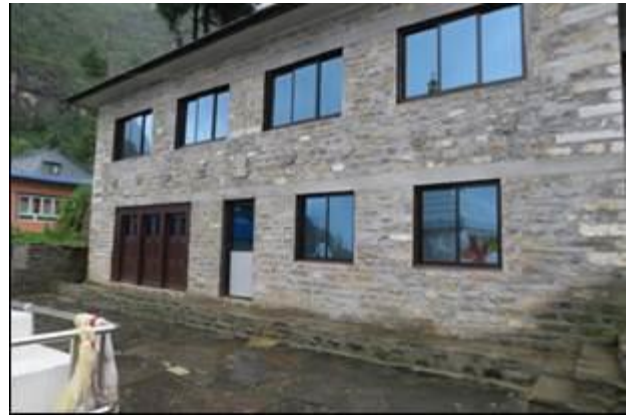
collapse of the roof. Visual observations also showed that, of the traditional buildings that experienced damage, the mud mortar appeared to be more brittle than the mud in other buildings. Accommodation structure built with cut rock, cement, and ring beams that performed well; see **Error! Reference source not found.**

Fig. 10 Undamaged accommodation building

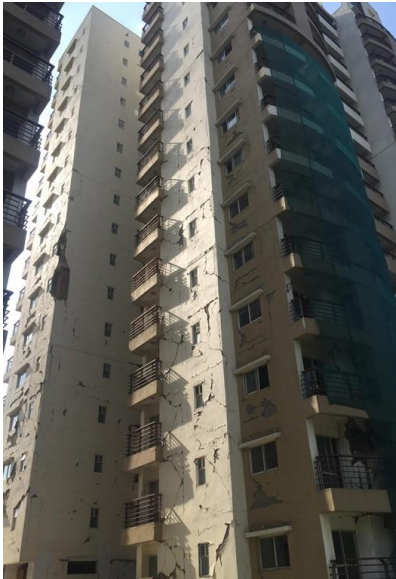
As mentioned previously, the soft soil underlying the Katmandu region produced large spectral accelerations in the 1-4 sec period range and excited mid-rise buildings. Many of these buildings are of newer construction vintage, had ductile detailing, and as such did not experience collapse. However, damage to these tower buildings was widespread; see **Error! Reference source not found.** Most of the mid-rise buildings used reinforced concrete moment framing as the lateral force resisting system. In addition, unreinforced infill walls were used for these buildings. The damage to the infill walls was extensive; see Fig. 12, which caused the tenants to move temporarily out of these units. It is noted that these are high-end condominium units.

Fig. 11 Exterior cracking, residential tower

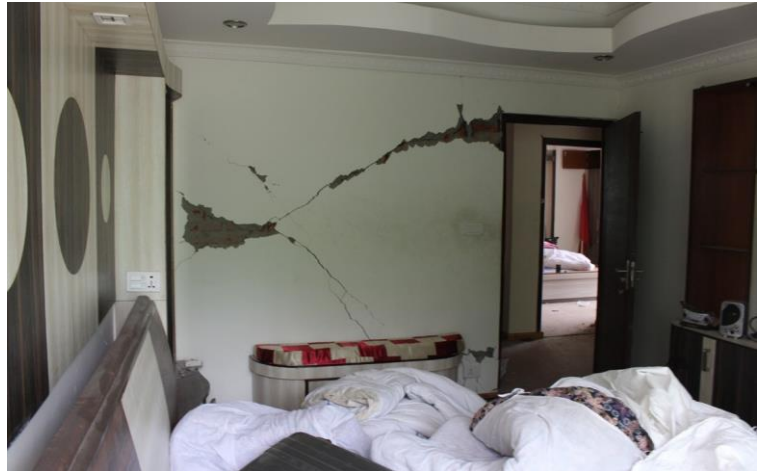
Fig. 12 Interior diagonal cracking of infill walls

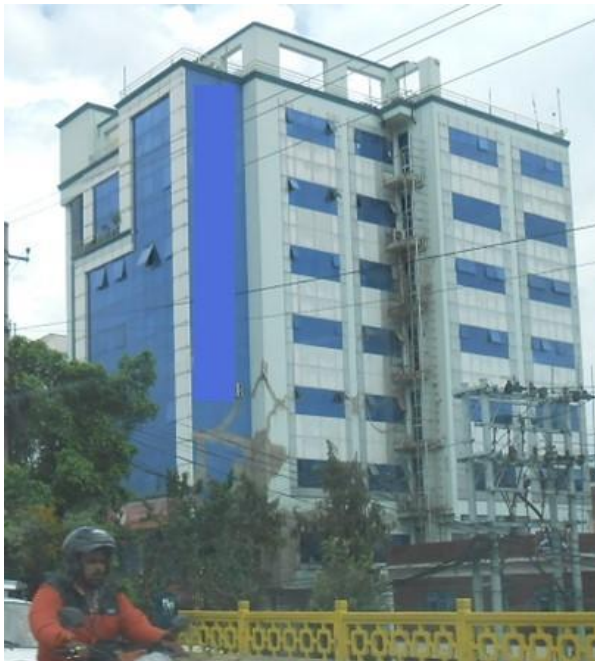
Fig. 13 Photograph of residential tower

The application of seismic dampers to an existing building was demonstrated after damage assessment of a residential tower was completed. The 10-story 32-m tall tower is approximately square in plan measuring 18 m on side; see Fig. 13. This tower was constructed using reinforced concrete moment frame system with masonry infill. Typical columns were 600x600 mm to 800x800 mm square and rectangular beams measured 300x600 mm. The mathematical model of the building is presented in Fig. 14. In this model, the diagonal viscous dampers are also shown. The building seismic weight is approximately 47 MN.
