SURVEY OF DAMAGED SCHOOL AND HOSPITAL BUILDINGS IN THE 2008 WENCHUAN EARTHQUAKES, RETROFIT OPTIONS, AND APPLICATION TO TURKEY

H.K. Miyamoto^{1,2}, and A.S. Gilani¹ and Akira Wada²

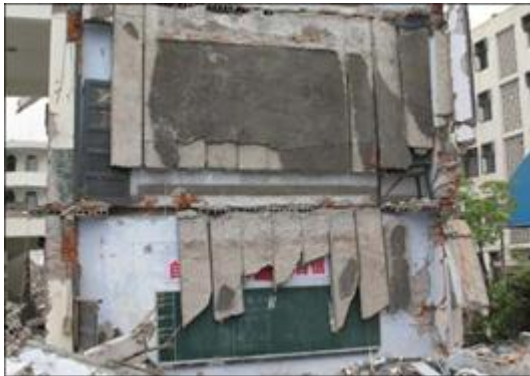
This three-story school is in Juyuan, a town in the county-level city of Dujiangyan. Juyuan has a population greater than 50,000 and is approximately 20 kilometers from the fault rupture. The school, constructed in 1986, housed 1000 students. More than 700 died when the building collapsed. Construction consisted of nonductile CIP-RC beams supported by URM walls, with precast concrete floor planks.

Figure 5a shows the collapsed floor precast planks. Note that the planks pulled away from the walls, were hanging, and attached to the opposite walls. The collapsed URM walls and nonductile concrete beam is shown in Figure 5b. Figure 5c shows the collapse of a nonductile bond (perimeter) beams. A lab building adjacent to the collapsed school with similar construction, constructed in 1996, did not collapse (see Figure 5d). This better performance was likely due to the orientation of its URM walls or better construction quality.

a. Collapsed floor planks

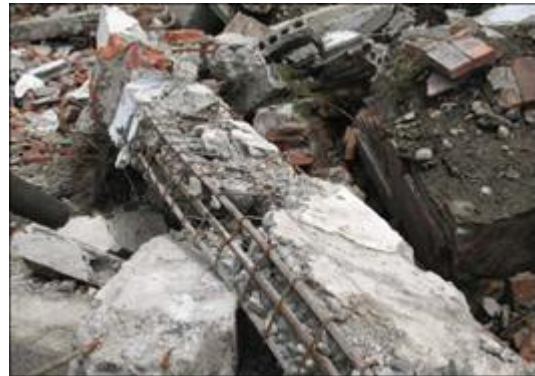
b. Collapse URM wall and concrete beam

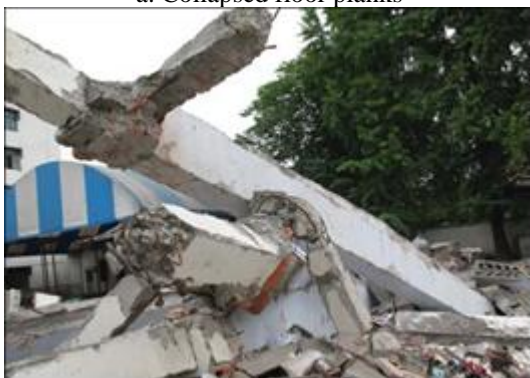
c. Non-ductile CIP-RC beam

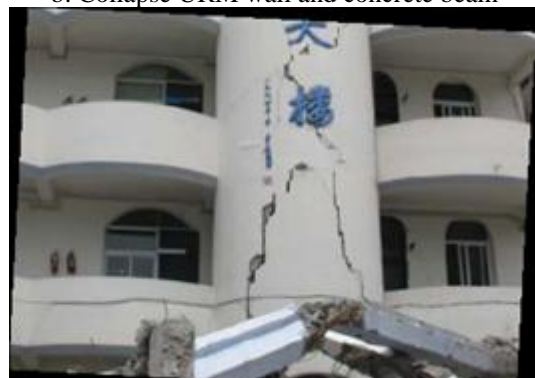
d. Cracked URM

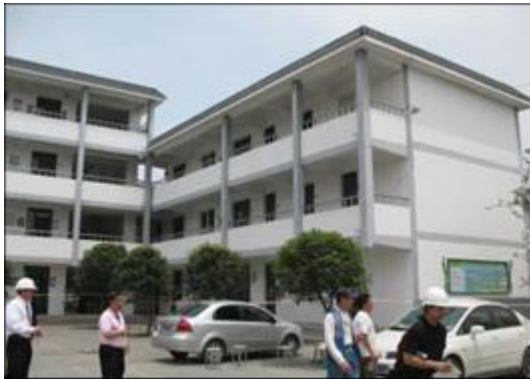
The school was built in 2007. This four-story building is a few miles away from the collapsed Juyuan Middle School. Construction consisted of CIP-RC frames (beams, columns) and infill URM walls. There were a few shear (diagonal) cracks in the shear walls and minor pounding

damage between buildings (Figure 6a). Overall the damage was minor (Figure 6b). This is likely an indication that the new construction practices could perform well in major earthquakes.

a. Minor pounding damage

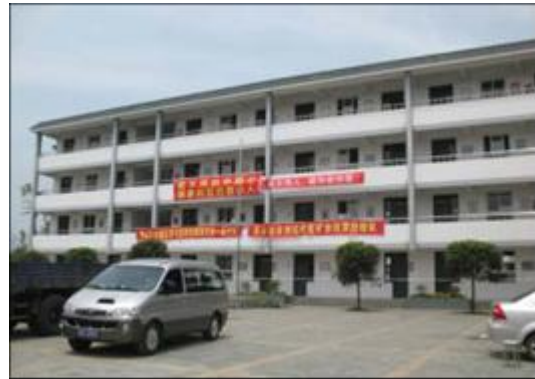
b. Frontal view of school

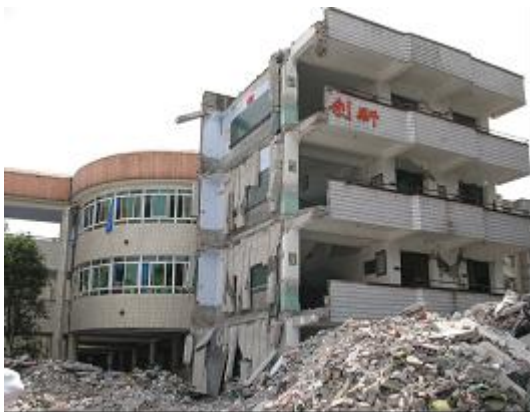
This four-story school is in the town of Xingfu, in the county-level city of Dujiangyan. It has a population of more than 300,000 and is located 15 kilometers from the fault rupture. The building collapsed and killed more than 300 of the 600 occupants. Building framing consisted of nonductile CIP-RC columns and beams, URM walls, and precast concrete floor planks. The stairway (Figure 6a) survived the event. The stairwells added stiffness and resistance to this portion of the buildings and survived even when the main building had collapsed. The collapsed first floor is shown in Figure 6b.

a. Collapsed building; note the standing stairway

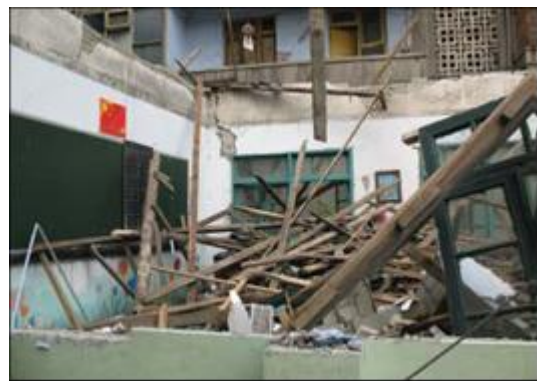
b. Collapsed first floor

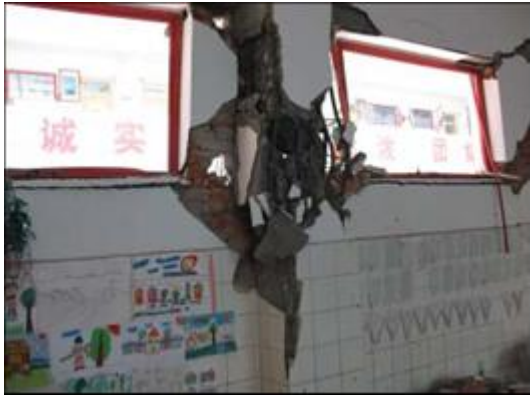
This four-story school is located in the Hanwang township of Mianzhu with a population of more than 60,000 within 10 km of the fault. The building sustained significant damage but no collapse. Construction consisted of CIP-RC framing and URM walls. The walls had extensive damage and concrete columns failed (Figure 7a) because the URM walls created captive columns and prevented flexural yielding. As shown in Figure 7b, the URM walls sustained out-of-plane failure because they were not adequately anchored.

a. Captive column

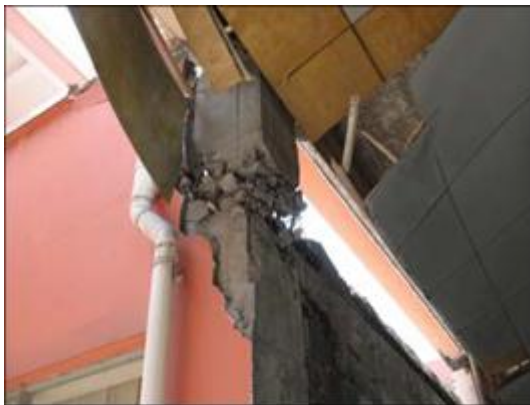
This school is located in the city of Mianzhu, with a population well over 500,000, about 20 km from the fault rupture. Framing comprised of nonductile CIP-RC columns and beams, and URM bearing walls. There was significant structural damage. In particular, large flexural demand and lack of adequate confining transverse reinforcement resulted in severe column damage (Figure 8a). The URM walls sustained shear cracking (see Figure 8b)

a. Column flexural failure

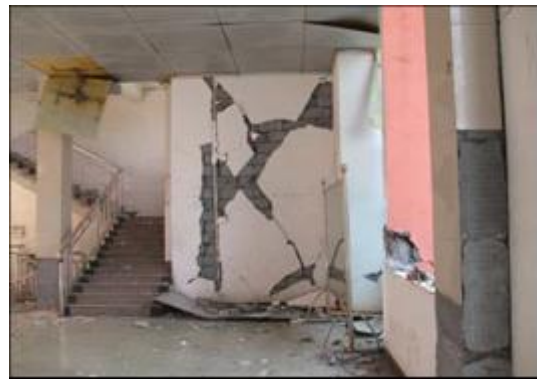
b. Cracked wall

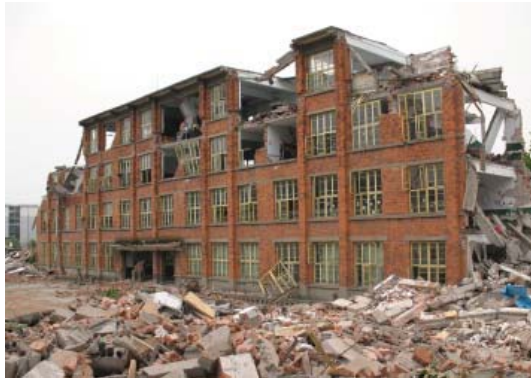
The main school building collapsed (see Figure 9a), but the adjacent dormitory building survived although its walls were cracked (Figure 9b). Both structures were built in 1994 and were of similar construction using URM walls and precast concrete floor planks. The better performance of the dormitory is attributed to the redundancy provided by the many interior URM walls and shorter spans for precast floor planks.

a. Column flexural failure

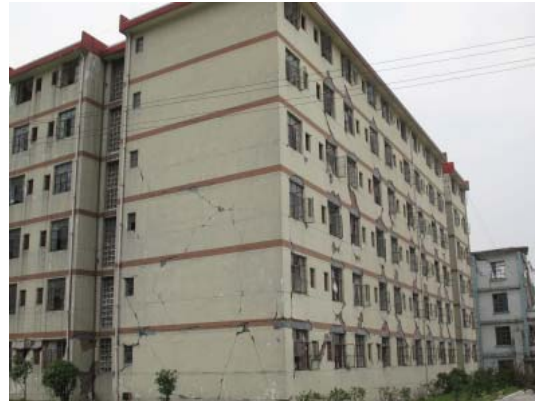
b. Cracked wall

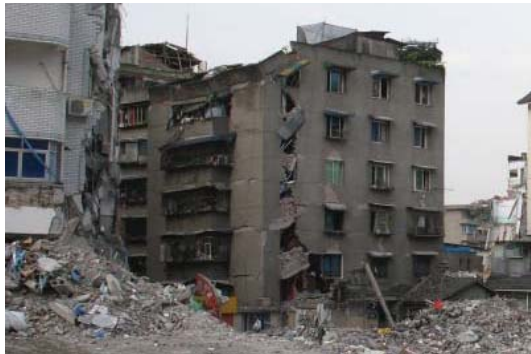
A wing at the Xingfu Hospital collapsed (Figure 11a), resulting in 200 fatalities. This wing, constructed in 1996, had typical nonductile CIP-RC framing with URM walls and precast concrete floor planks. An adjacent wing, constructed in 2,000, performed better and sustained moderate structural damage, shear-wall cracks, and nonstructural damage; dropped ceiling panels (Figure 11b). Such nonstructural damage, although minor, could be potentially problematic as it can be a falling hazard, block exit, and interfere with the operation of the hospital.

a. Collapsed wing

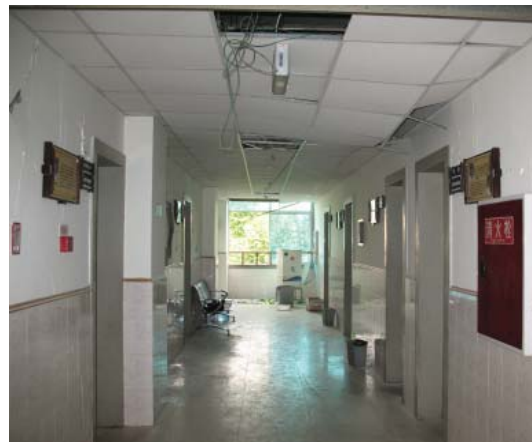
b. Nonstructural damage

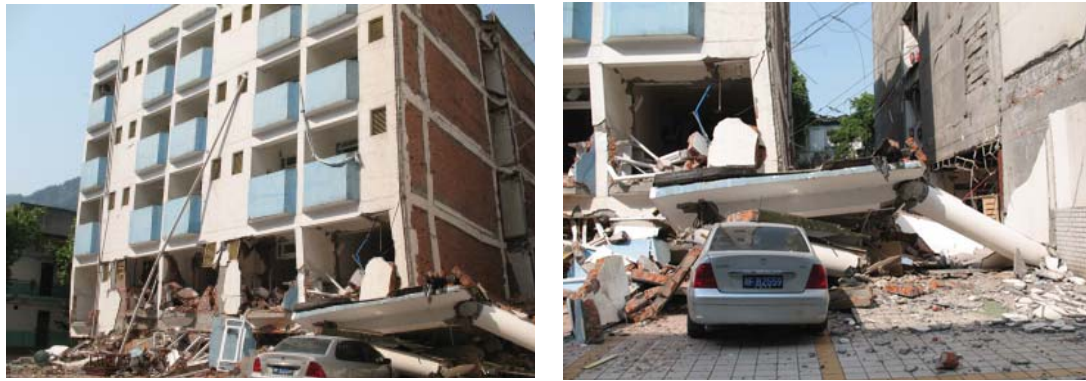
This five-story hospital was constructed in 1999. Construction consisted of nonductile CIP-RC framing and URM walls. The ground floor was designed as a parking garage. Hence, the URM bearing walls were terminated at the first floor, creating a bottom story with much smaller lateral stiffness. This soft story completely collapsed during the earthquake (Figure 12a) and the upper floors dropped down one floor (see Figure 12b).

a. Soft story collapse

b. Close-up of the first floor

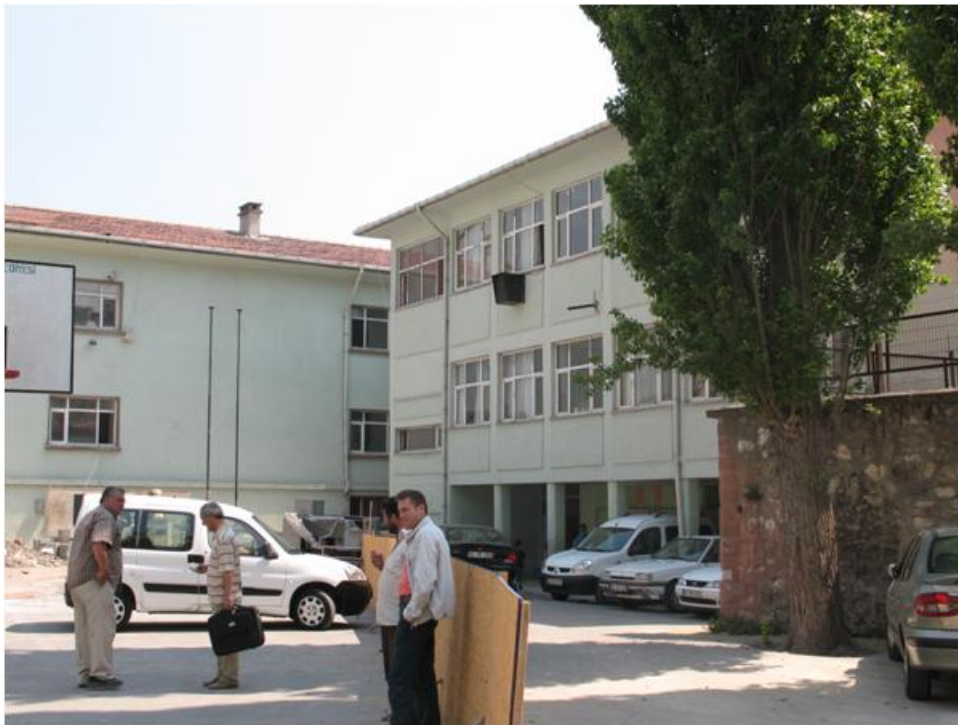
Figure 14 shows a photograph of a vulnerable building taken by the main author (Miyamoto) during a site visit and condition assessment survey. For this building, the walls terminate above first floor to allow for parking. However, this introduces soft-story mechanism at this level and can lead to collapse in a future earthquake. This structure configuration is not much different from many observed in China. Once such dangerous buildings are identified, retrofit measures are proposed and implemented.

Figure 14. A vulnerable structure
