# Massive Damage Assessment Program and Repair and Reconstruction Strategy in the Aftermath of the 2010 Haiti Earthquake

H. Kit Miyamoto,<sup>a)</sup> M. EERI, Amir S. J. Gilani,<sup>b)</sup> and Ken Wong<sup>c)</sup>

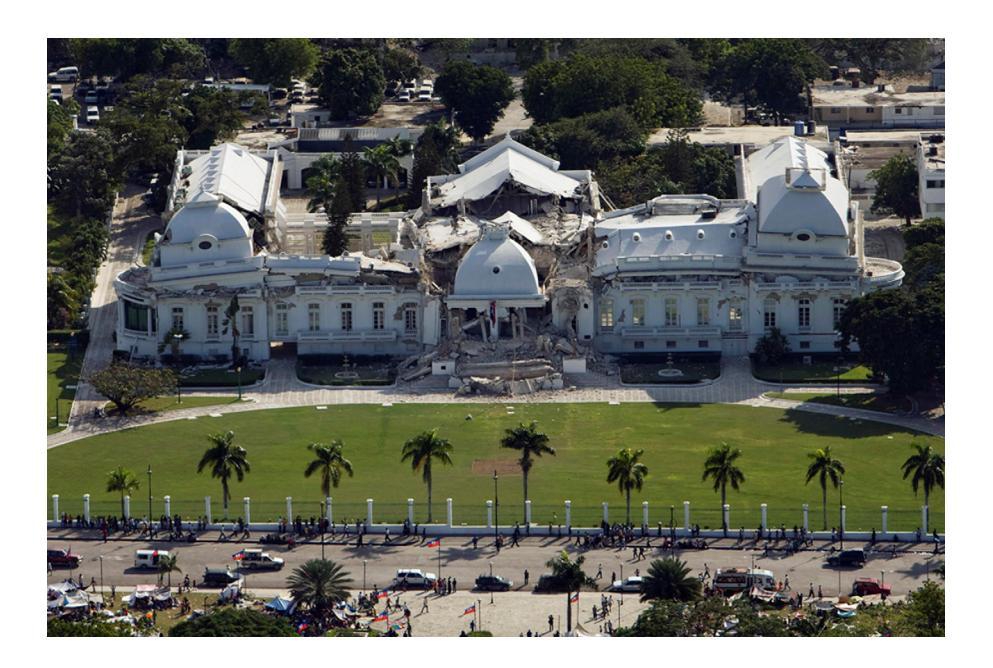
Figure 2. Damaged Presidential Palace in Port-au-Prince (UNDP Global 2010).

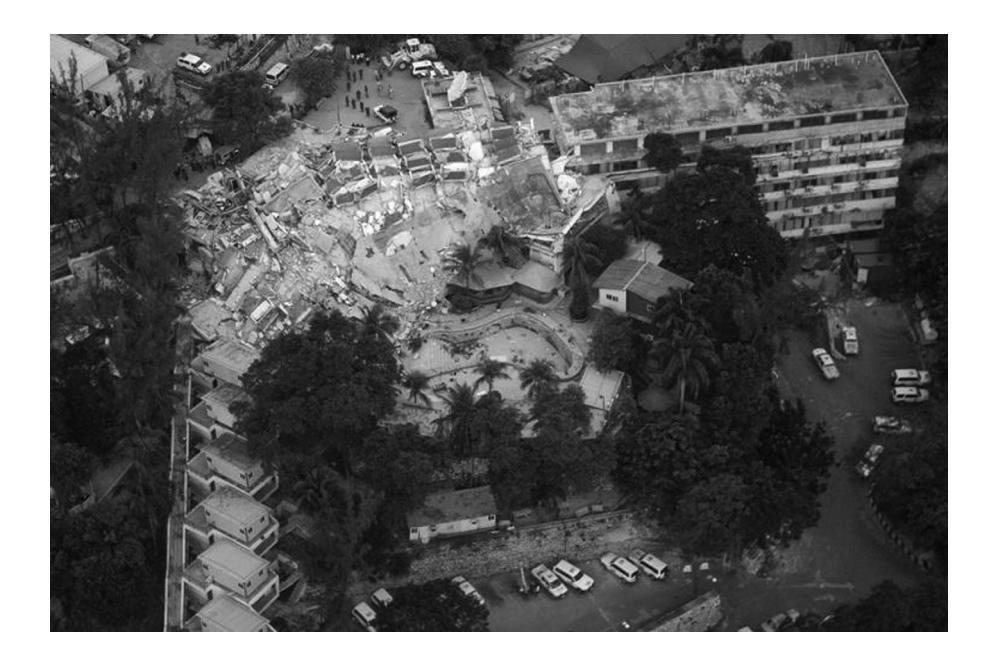
Figure 3. Collapsed United Nations building in Port-au-Prince (UNDP Global 2010).

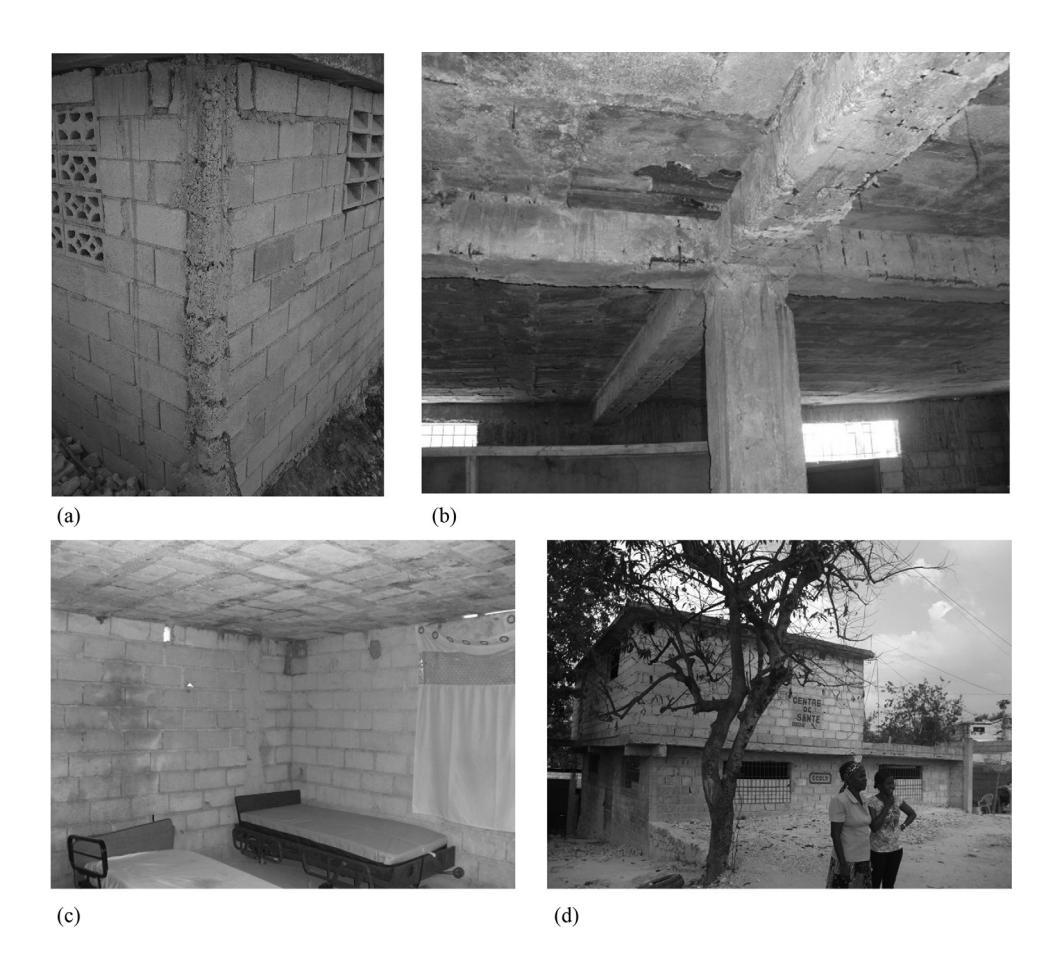
Concrete gravity frames display numerous design and construction practices that would be considered defective by international standards, particularly in seismic zones. Figure 5 shows some of the common seismic deficiencies.

- Inadequate column size (cross section dimensions)
- Insufficient amount of longitudinal reinforcement
- Use of smooth reinforcing bars
- Lack of column confinement reinforcing
- Inadequate lap splices and rebar development length
- Presence of captive columns

Typical masonry construction also had numerous defects, including irregular coursing, missing or inadequate vertical mortar joints, inadequate horizontal joints, poor material

**Figure 5.** Typical Haitian construction practices showing common inadequacies: (a) Column with poor concrete consolidation, (b) beam with embedded formwork and exposed reinforcing, (c) poor workmanship in unreinforced hollow concrete block wall, (d) building with overhanging upper floor.

quality, and extensive use of broken block. These conditions were found in nearly all the buildings surveyed, regardless of age, size, or number of stories. These design and construction practices led to a combination of heavy buildings with little lateral strength and essentially no post-yielding capacity, and were key factors in the vast majority of failures observed.

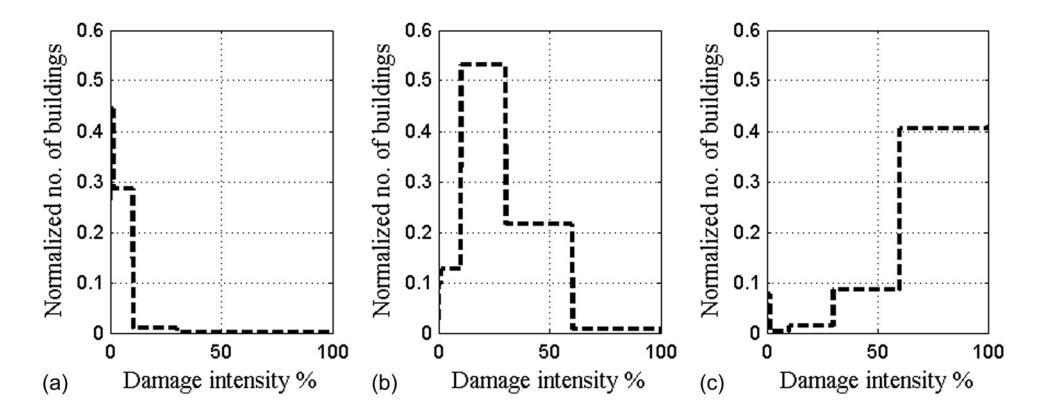
The median damage estimate was computed from the histograms of Figure 6. During the assessment process, the damage for each structure (regardless of the assigned tag) was classified in the following subsets: none (0%), 0.1% to 1%, 1% to 10%, 10% to 30%, 30% to 60%, 60% to 99%, and complete (100%). The data was then normalized for each color-tagged building, and the median damage estimate was computed.

Figure 6. Histograms of damage intensity for all assessed buildings: (a) Green-tagged, (b) yellow-tagged, and (c) red-tagged.

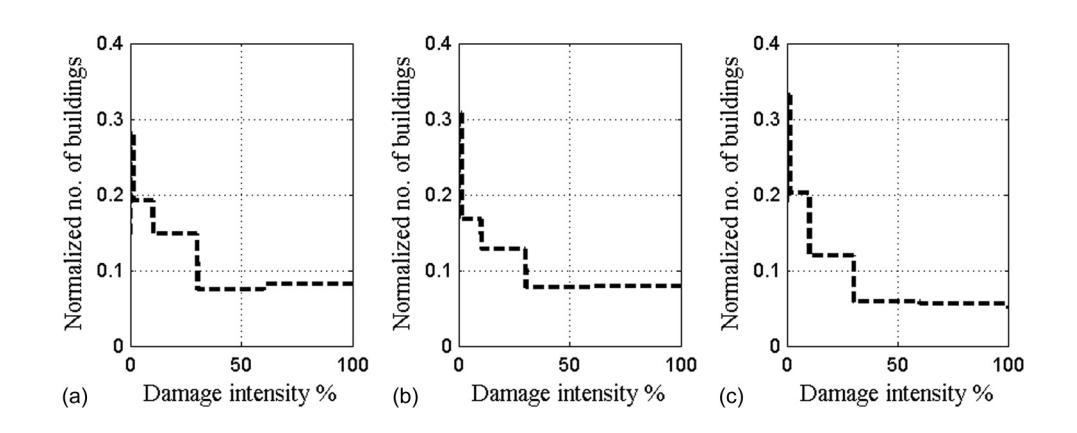
**Figure 8.** Histograms of damage intensity for various building occupancies: (a) Residential, (b) school, and (c) commercial.

listed the level of damage (from 0% for none to 100% for collapse) and the number of buildings in each occupancy category that experienced a given level of damage. The horizontal axis is the number of surveyed buildings in each category normalized with respect to the total number of buildings surveyed. The median damage for these occupancies is in the 1% to 10% range.

- For residential and school buildings, greater damage was observed, which led to a higher level of damage for the median surveyed building.
- For single-family homes, the main cause of the higher damage median is the large number of nonengineered buildings.
- School buildings are vulnerable for two reasons, as listed below. These vulnerabilities are common in many other countries as well. For example, the authors witnessed more than 7,000 classrooms that were destroyed in the 2008 Sichuan, China, earthquake (Miyamoto et al. 2008). The primary causes of damage are the following:
  - <sup>°</sup> The presence of many windows introduced captive columns in the structure.
  - <sup>°</sup> Fewer wall elements were used per square meter of the structure. Although this data was not measured during the assessment, such construction is typical.

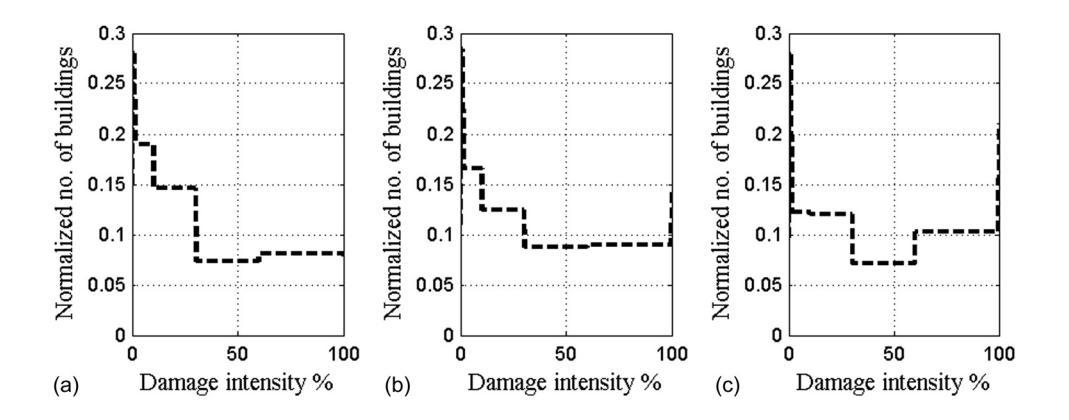
In general, the evaluation showed that building performance (as measured by the percentage of red-tagged structures in each group) was progressively worse as building height increased, and tall buildings were much more susceptible to severe damage. Of the buildings that were four stories or more in height, 40% were red-tagged; versus 20% for onestory buildings (see Table 4). In other words, the potential for catastrophic failure or collapse is almost twice as high for buildings of four-stories or more as for one-story buildings. This trend is shown clearly in Figure 9, where at the median number of surveyed buildings the damage level increases significantly as the number of floors increase in a building.

**Figure 9.** Histograms of damage intensity for various numbers of stories in buildings: (a) One and two stories, (b) three stories, and (c) four or more stories.

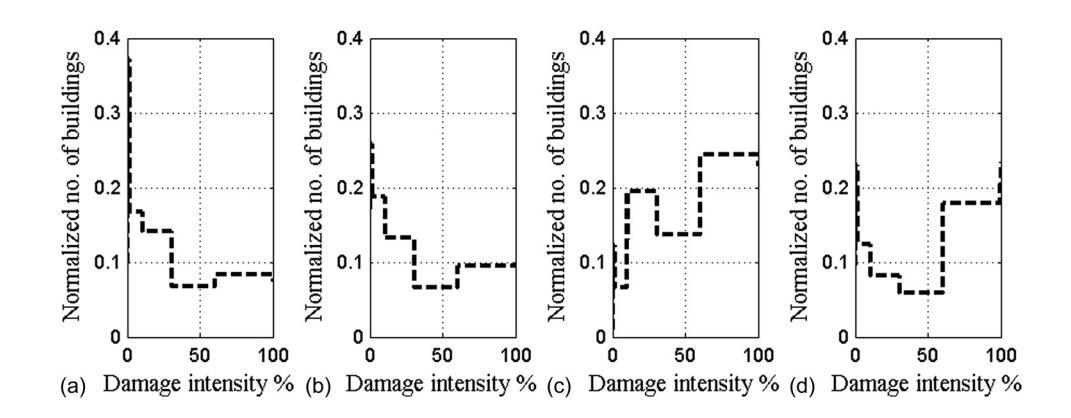
Figure 10 presents histograms for the buildings with vertical irregularities. It is noted that the buildings with captive columns have a much larger median of damage intensity compared with the other types of vertical irregularities.

The actual performance of buildings with these irregularities, particularly soft stories and captive columns, was likely worse than shown by the data in Table 5. In many

**Figure 10.** Histograms of damage intensity for buildings with vertical irregularities: (a) Soft story, (b) setback, (c) captive column, and (d) pounding.

instances, soft stories and captive columns led to total collapse, making the underlying irregularity difficult to detect. Therefore, the actual number of red-tagged buildings with a soft story or captive column is larger than the 21% and 49% values, respectively, shown in the table.
