COST-EFFECTIVE SEISMIC ISOLATION RETROFIT OF HERITAGE CATHEDRALS IN HAITI

HK Miyamoto(1), ASJ Gilani(2), A Wada(3)

Abstract

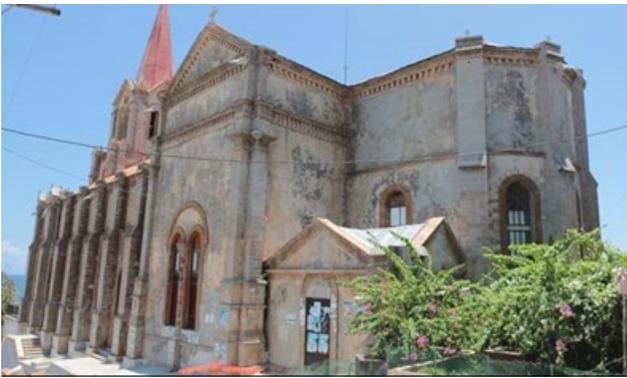
Fig. 1 Miragoane Cathedral

Saint John Baptist Cathedral of was originally constructed in 1880 and is one of the oldest Cathedrals in Miragoane— a coastal town approximately 80 km west of Port-au-Prince, the capital of Haiti. Figure 1 shows a photograph of the building looking east. Saint Jacques et Saint Philippe Cathedral of Jacmel; see Figure 2 was originally constructed in 1859 and is one of the oldest Cathedrals in Jacmel— a coastal town approximately 80 km southwest of Port-au-Prince, the capital of Haiti.

Both Cathedrals suffered minor damage, primarily minor cracking during the 2010 Haiti Earthquake. The damage to the building was minor because they were not located near the epicenter of the 2010 earthquake

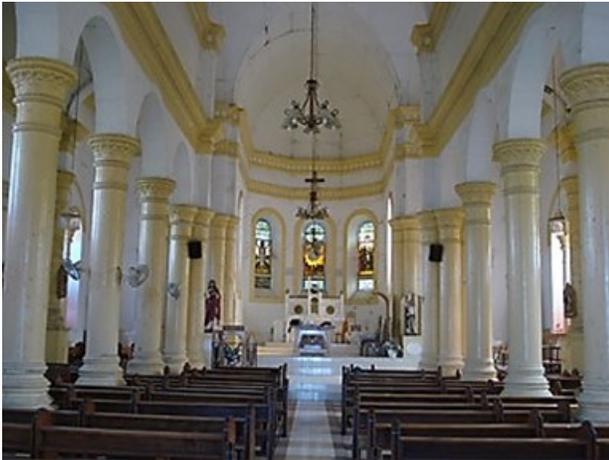
Fig. 3 Miragoane Cathedral

Fig. 3 and Fig. 4 present the interior of the cathedrals. As seen in these figure, these structures comprise a large number of architectural and heritage features. The retrofit solution for the buildings was selected to preserve the architectural features of the buildings. In addition. It was critical to maintain low accelerations for the buildings to reduce potential damage to such features. Seismic isolation retrofit was selected to achieve both of these goals.

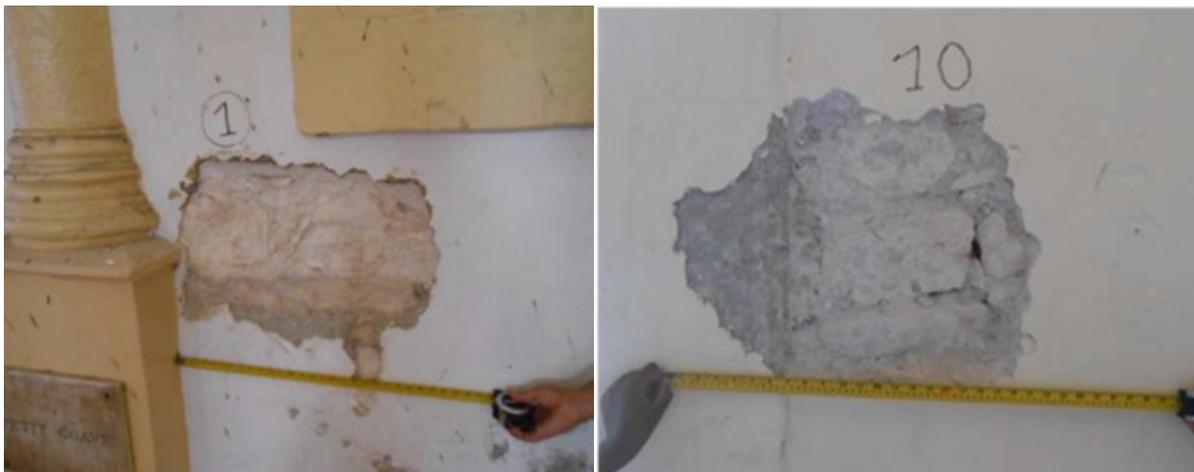
Irregular-shaped stones placed in the mortar Rectangular-shaped stone and debris in mortar
Fig. 7 Typical composition of exposed unreinforced masonry stone walls

The Cathedrals' unreinforced stone masonry (URSM) walls are the load bearing elements resisting the applied vertical and lateral load applied to the building. Fig. 7 depicts exposed sections of the walls with the wall plaster removed for investigation for the two structures. The composition of the wall is that of unreinforced masonry with irregular-shaped stones or with rectangular-shaped stones and debris placed in the mortar
