# Best Design Practices for Seismic Evaluation and Preservation of Historic Buildings

***H. Kit Miyamoto, President & CEO  
Lon M. Determan, Principal  
Kimberly D. Scott-Hallet, Senior Associate  
Amir S.J. Gilani, Structural Specialist***

***Miyamoto International, Inc.  
Sacramento, CA***

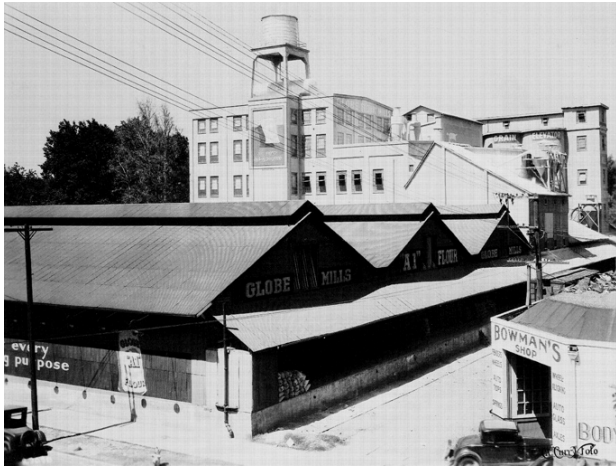
This building complex is a city designated historic landmark. The construction on the complex began in the late 1880's and continued into the 1920's. A historic photograph of the site from the 1930's ([California State Library collection, 2007](#)) is shown in Figure 1. In this figure the Mill building and its water tower are facing the west.

**Figure 1. Globe Mills Complex, 1933**

The existing water tower on the Mill building is one of the historically significant features of this building (see Figure 1 and Figure 3) and hence required preservation. However, its framing was structurally deficient and required retrofit. The structural upgrade consisted of providing lateral stability to the supporting concrete framing by adding 1-in diameter rod bracing and copious concrete patching. Figure 18 shows the water tower during retrofit.

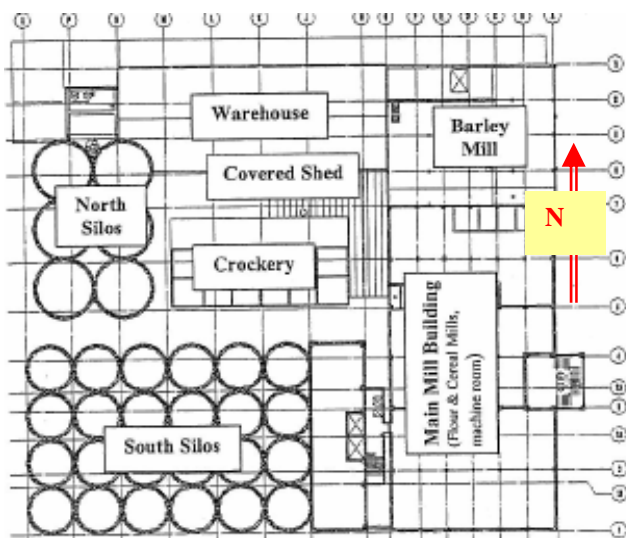
It is a former grain and cereal mill complex and operated until the 1970's. The complex footprint approximately measures 170 x 150 ft. The original site plan for the complex is shown in Figure 2 and consisted of seven adjacent structures. Cast-in-place concrete wall structures were used for the silos, Main Mill, and Crockery structures.

**Figure 2. Original Site Plan**

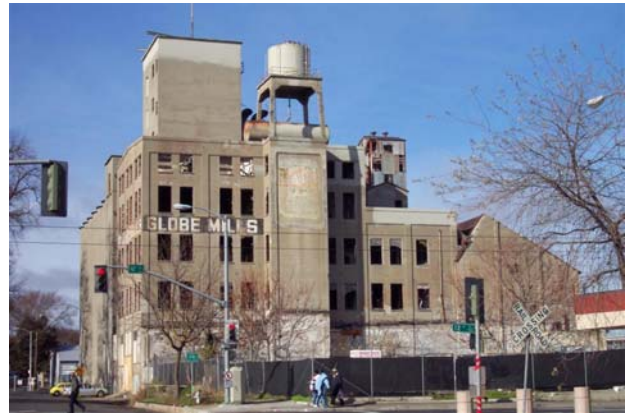
The mill's ceased operation in the 1960's. The sporadic use of the site since 1970 had left the complex in a severely dilapidated condition; see Figure 3. This picture was taken looking west and shows the Mills building on the left side.

**Figure 3. West Elevation of Globe Mills Complex, 2006**

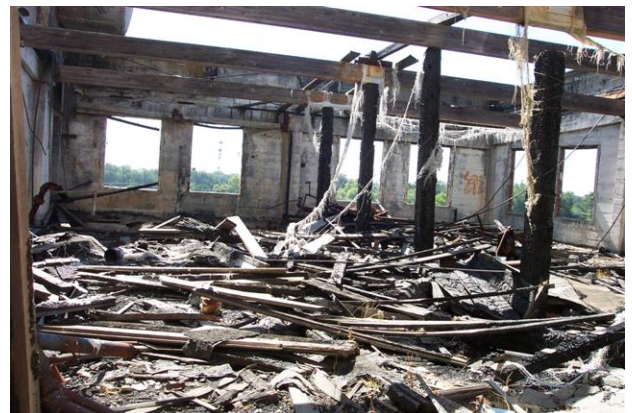
In 1995, a large fire struck the wood flooring of several buildings and destroyed them (see Figure 4 for typical floor damage in the Mill building). The city contemplated razing the complex in the late 1990's and until the current rehabilitation was planned, the complex had been derelict in 2000's.

**Figure 4. Interior View of Fire-Damaged Mill Building**

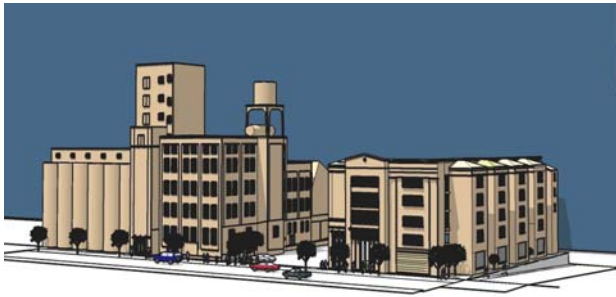
**Figure 5. Architectural Rendering**

In the 2000's, as part of the city's rehabilitation plan, an adaptive reuse and development plan for the site was initiated. The project scopes were to preserve the historic character of the complex and provide affordable housing for active seniors. The architectural rendering of the rehabilitated complex is shown in Figure 5 ([Applied Architecture, 2008](#)).

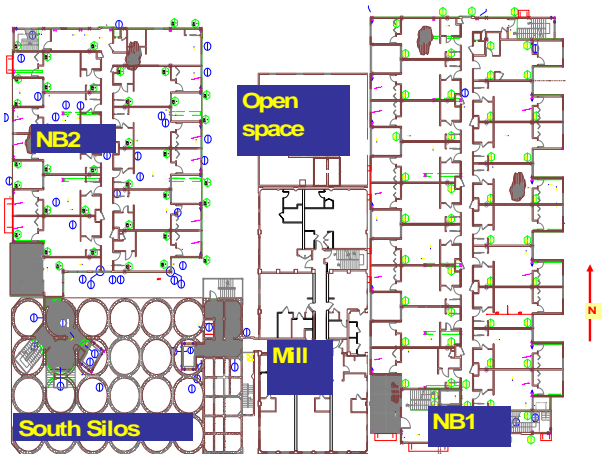
The project consisted of preservation of the South Silos and converting the head house unit above the silos to an activity center for seniors. The Mill building was retrofitted. The barley building, constructed of wood, was a safety hazard and was demolished and its site converted to an open space community area. All other structures were demolished and, in their place, two new buildings, hereafter referred to as NB1 and NB2, were constructed providing 146 mixed income units of housing including 100 units for seniors. The project includes tenant-serving retail and common area facilities. The new site plan is shown in Figure 6. The construction cost was approximately \$40 million. This is one of the largest rehabilitation and re-uses projects in the greater downtown Sacramento area.

**Figure 6. New Site Plan**

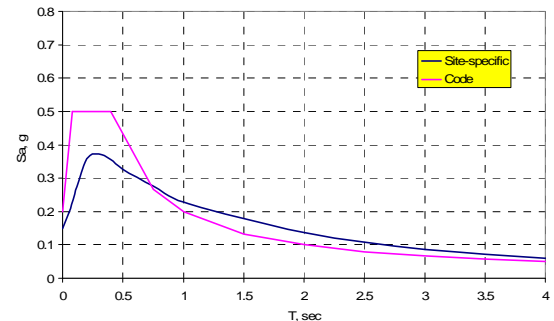
Conventional code procedures and performance-based design were used in design and evaluation of the buildings. Geotechnical investigations were conducted (JP Singh and Associates, 2006) and site-specific response spectrum (Figure 7), and acceleration records were prepared for this purpose. Both the site-specific response spectrum and design spectrum constructed following FEMA 356 (NEHRP, 2000) guidelines were used in evaluation. Note that in the short period, the design spectrum governs response, whereas, in longer periods,

the site-specific spectrum has higher spectral acceleration ordinates.

**Figure 7. Code and Site-Specific Response Spectra**

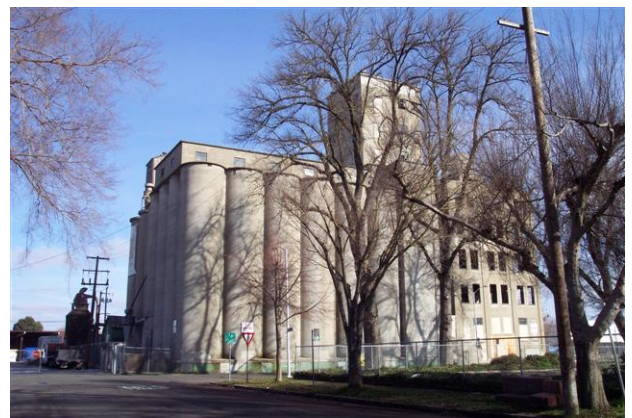
This unit consists of 24 interconnected annular silos, a rectangular silo, and a stairway. A comprehensive investigation was undertaken to assess the structural performance of the silos in the new configuration. Figure 8 presents a photograph of the structure, and Figure 9 depicts the plan layout of the silos with the removed areas identified.

**Figure 8. South Silo Structure**

The total height of the structure is approximately 127 ft above the basement slab. Reinforced concrete shearwalls provide the main support for both vertical and lateral loading. Each annular silo has a diameter of 15 ft and a wall thickness of 6 in. The rectangular silo measures 16 ft wide and 60 ft long, and has a perimeter 6 1/4-in. thick wall. The stairway segment measures 3 ft by 22 ft. The Structure is supported on a 13 1/2-in thick concrete slab, which in turn, is supported by a series of 12 in. thick concrete walls and a 9-in. thick perimeter wall. The height of the silos is nearly 73 ft, where they are capped by a 5 in. slab. At the top, a head-house is situated which will be used as a community center. Above this level, a portion of the rectangular silo structure extends for three additional floors.

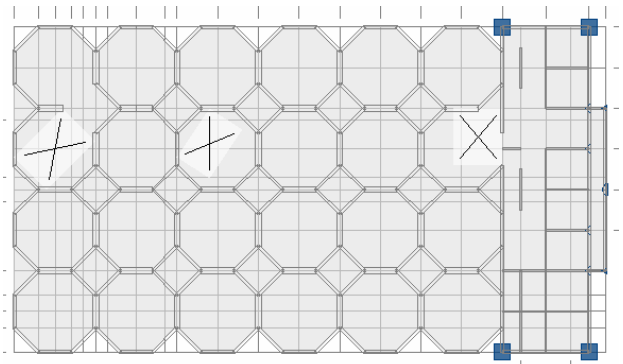
**Figure 9. South Silo Plan Layout**

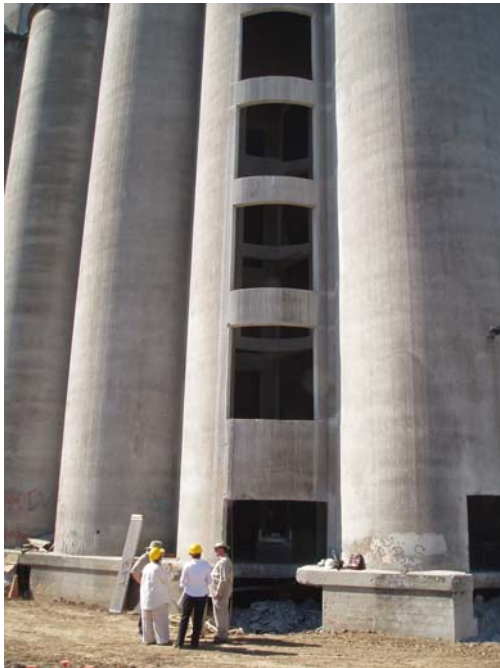
The silos are “connected” to (via a seismic gap), and provide access to the Mills building at five levels. Two stairways and an elevator shaft have been added to the existing structure. This necessitated removing sections of some of the silos. Figure 10 depicts some of the openings.

**Figure 10. Openings in the Silo**

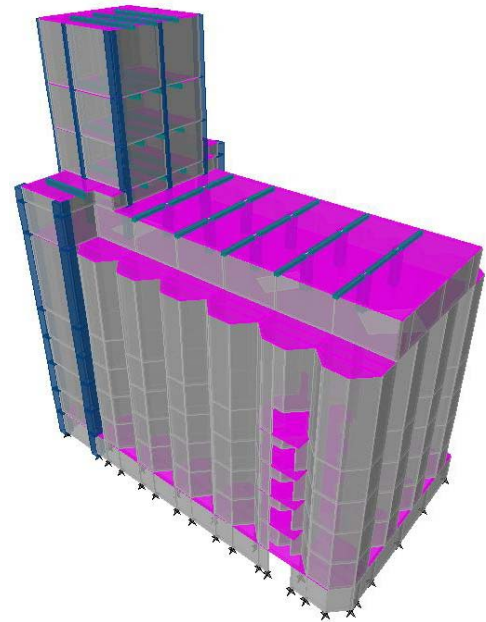
Figure 11 presents a schematic representation of the model. For all members, centerline dimensions per as-built drawings were used. Annular walls were modeled as an assemblage of eight concrete wall segments in an octagonal pattern. Analysis of a single silo modeled as an annular ring and an octagon showed that this approximation was accurate. Concrete walls, slabs, beams, and columns were sized using available data from plans, field measurements, and from the field evaluation report. Concrete material properties were specified using conservative test data. Except for the concrete strength of the annular silo walls, field data for concrete walls, slabs, and columns were within range of FEMA 356 (NEHRP, 2000) recommended lower-bound compressive strength values. Cracked properties were used. Live loads of 20 psf for roofs and 100 psf for corridors and assembly areas were considered. In addition to member self-weight, a load of 50 psf was placed on floor members to account for equipment and additional seismic mass. The total inertial mass of the structure was computed as approximately 14,000 kips. Per FEMA 356 recommendation, a 5% offset in center of mass was included in analysis to account for accidental torsion.

**Figure 11. Mathematical Model of South Silos**

Sufficient modes were used in analyses to account for close to 100% of the seismic mass in each orthogonal direction. Table 1 presents the first six modes of the structure. It is noted that response in the x-direction is uncoupled. The extension of the rectangular silo above the head-house on one side introduces some coupling in torsional and translational response in the y-direction. The structure is stiffer than individual silos due to the contribution of interconnected walls.

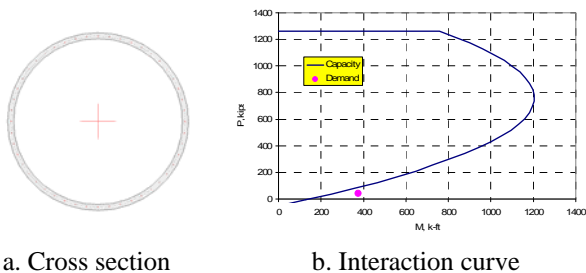
The design module of the program was used to check the concrete walls. The critical wall for the annular silos is the exterior wall segment for the corner silo. The computed maximum shear demand to capacity ratio (DCR) was 0.35. A separate mathematical model of a typical wall segment was prepared; see Figure 12. Nominal dimensions and measured material properties were specified for the wall segment. An axial load-bending moment interaction diagram for the wall segment was developed. The computed DCR was 1.6, less than FEMA 356 minimum  $m$ -factor of 2.0; as such, the flexural design is adequate. The floor slabs were checked for the gravity loading and were found to be adequate. Hence, the south silo capacity was adequate and no retrofitting was necessary.

**Figure 12. Strength Evaluation for an Individual Silo**

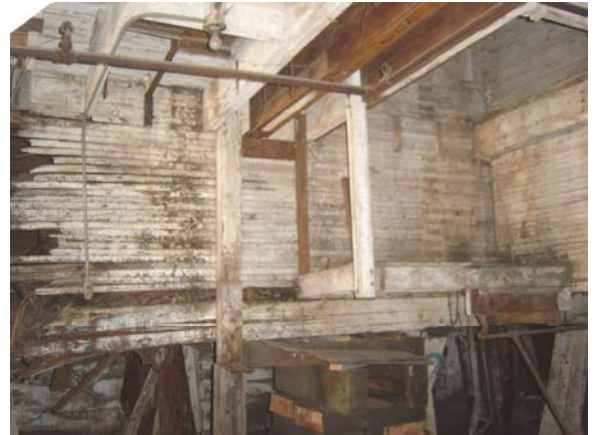
This is the oldest building in the complex, originally constructed in the 1880's. This wood building had severely deteriorated (Figure 13) and presented a life-safety hazard due to severe loss of capacity of its gravity-resisting members (Figure 14). It was not feasible to rehabilitate this building and, as such, it was demolished.

**Figure 13. Existing Condition of the Barley Building**

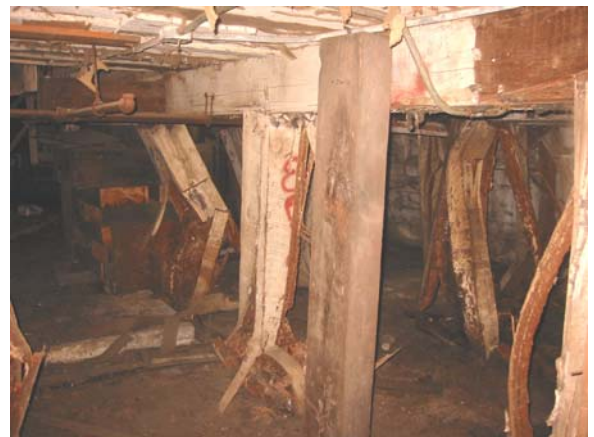
**Figure 14. Failure of Existing Columns**

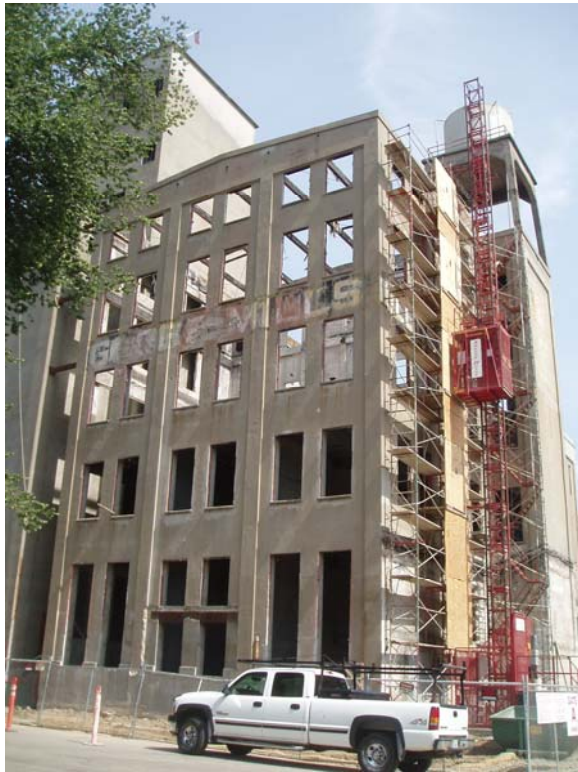
The 50 x 100 ft multi-story Mill building used cast-in-place reinforced perimeter walls. The wood floors of this unit were destroyed in past fires. This is the third generation of the building on the same foundations. The building had rotated on its foundation and had a permanent skew. The building skeleton prior to retrofit is shown in Figure 15.

**Figure 15. Mill Building Prior to Retrofit (Leaning Left)**

The new walls were supported on 36-in. thick concrete footings. The existing building footings were also thickened and the result was a solid concrete mat at the building ground level. Dowels were used to connect the existing and new foundations. This design mitigated concerns with the permanent tilt in the building that was previously mentioned.

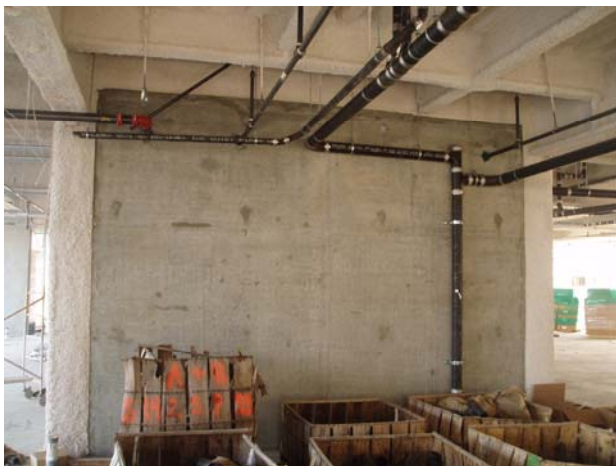
Seismic assessment showed that the perimeter walls were adequate in the short (EW) direction. However, the building had insufficient lateral load capacity in the long (NS direction). To address this deficiency, full height concrete walls were added in this direction. A typical wall segment is shown in Figure 16.

**Figure 16. Concrete Wall Retrofit**

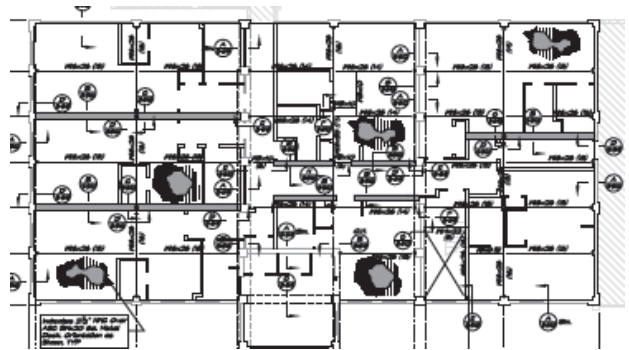
A typical floor plan for the building is shown in Figure 17. A system of steel gravity beams and columns was used to frame between the walls. 3W steel deck topped with 2.5 in. of normal weight concrete was used for floors.

**Figure 17. Plan Layout of Mill Building**

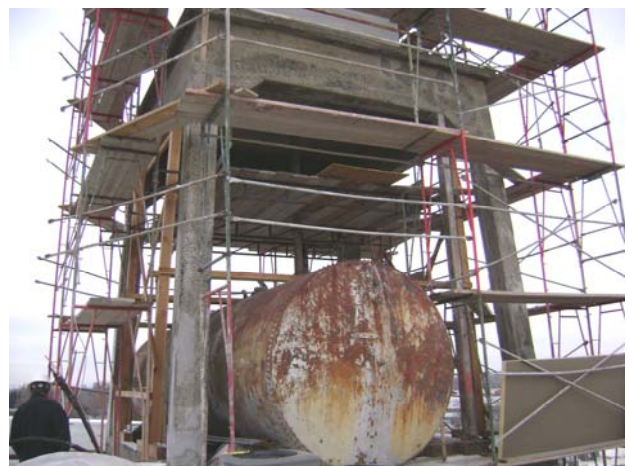
**Figure 18. Retrofit of Water Tower**

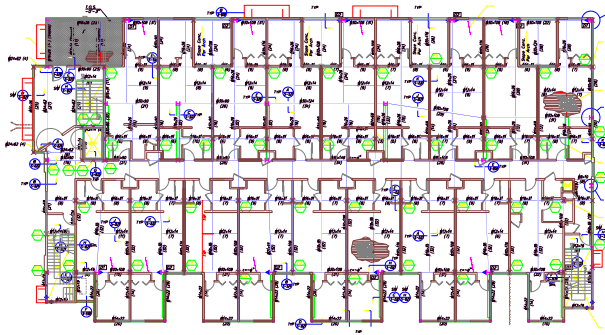
Figure 19. Plan View of NB1

These new five-story structures were designed and constructed to replace some of the existing units on the complex. NB1 measures 82 x 156 ft, and is shown in Figure 19. NB2 measures 80 x 90 ft and is shown in Figure 20.

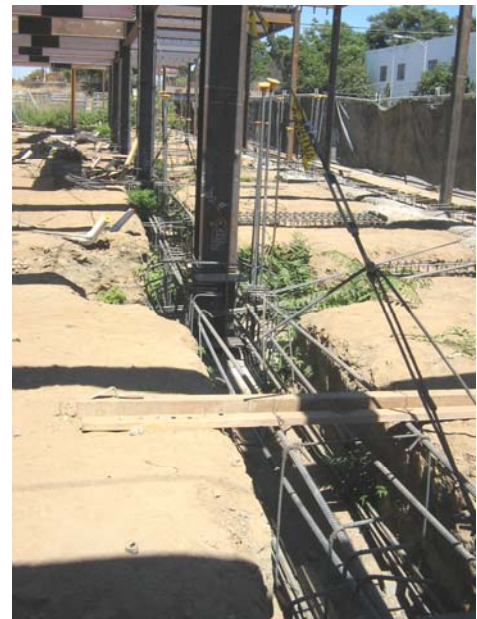
Figure 21. Foundation Construction for Podium

The three investigated alternatives all used a system of concrete/steel podium with steel ordinary moment resisting frames (RMRF) in one direction and concrete shear walls in the perpendicular direction. Reinforced concrete walls were 12 in. thick, and the second level floor consisted of a composite concrete slab of a 2.5 in topping over W3 steel decking. Concrete grade beams (see Figure 21) were used to provide fixity at the base of podium columns. Typical grade beams were 2 ft wide and 3 ft deep.

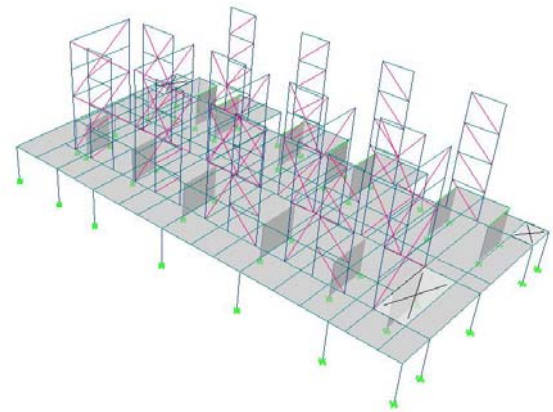
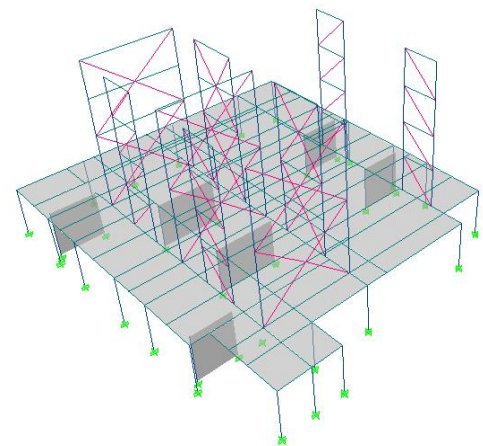
In option 2, heavy wide flange transfer girders were required. Detailed three-dimensional mathematical models of NB1 and NB2 were prepared using the computer program ETABS ([CSI, 2005](#)); see Figure 22. Only pertinent lateral load resisting

members were included in the model. For all members, centerline dimensions were used. Loading from upper story bearing walls was simulated as dead- and live- line loading at the second floor level. The seismic mass at each level was lumped at floor center-of-mass. Both translational and rotational mass were included in the model. Total mass of NB1 and NB2 was approximately 4,500 and 3,000 kips, respectively. Rigid diaphragms were placed at each level.

**Figure 22. Mathematical Models of NB1 and NB2**

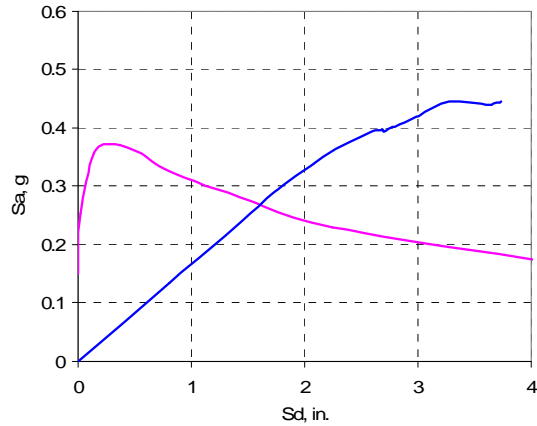
FEMA 356 (NEHRP, 2000) coefficient method and ATC 40 (ATC, 2000) performance point procedure were utilized. The performance point was selected to provide Life Safety (LS) for the site-specific design earthquake (DE). Figure 23 presents the spectral demand-spectral capacity curves for one of the analyses. The target displacement for this case was 2.4 in (with a single degree of freedom spectral displacement of 1.7 in, as shown in the figure). Note, the building response is linear up to the performance point. The yield displacement is estimated at 3 in. (spectral displacement of 2.5 in.). Similar analyses showed that there was little or no nonlinearity at the performance points for either NB1 or NB2. No yielding of beams was observed from analyses; in other words, the members supporting discontinuous columns remained elastic.

**Figure 23. Typical Pushover Data and Performance Point**

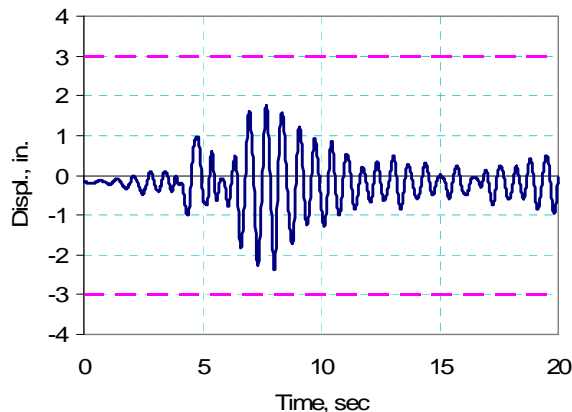
Finally, nonlinear dynamic procedure (NDP) was used to analyze NB1 and NB2 and to verify the computed displacements from conventional code analysis and NSP. Three pairs of spectrum-compatible histories oriented at 0- and 90-degrees (6 total cases) were used in analysis. Figure 24 presents the roof displacement response for buildings subjected to a typical acceleration history input. The linear limit is shown by the dashed line. Note that the response is below the yield value.

**Figure 24. Roof Displacement Response**

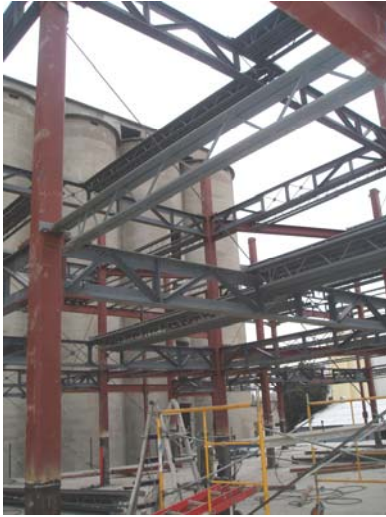
In this alternative, a system of truss moment frames (see Figure 25), steel joists, and Hambro framing (see Figure 26) for resisting gravity loading were used. The truss moment frames were typically 18 in deep.

**Figure 25. Typical Truss Moment Frames**

The truss moment frames consisted of small tubular columns and light truss frame elements. The columns were spaced at approximately 14-ft on center (Figure 27 depicts the size and spacing of columns).

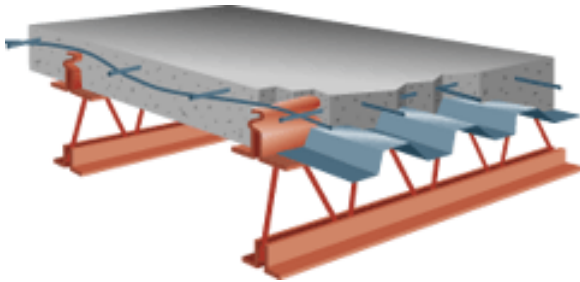
**Figure 26. Hambro Joist System**

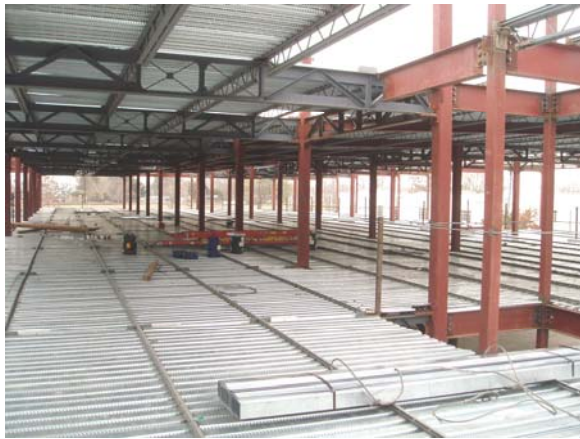
**Figure 27. Columns of Truss Moment Frames**

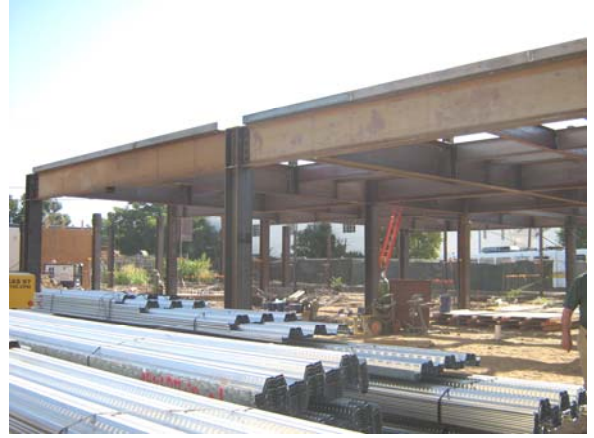
Such small column spacing greatly reduced the lateral forces for podium design. Thus, typical moment frame beams were

W30 and frame columns were W12. Figure 28 shows a photograph of the partially completed podium.

**Figure 28. Partially Completed Podium**

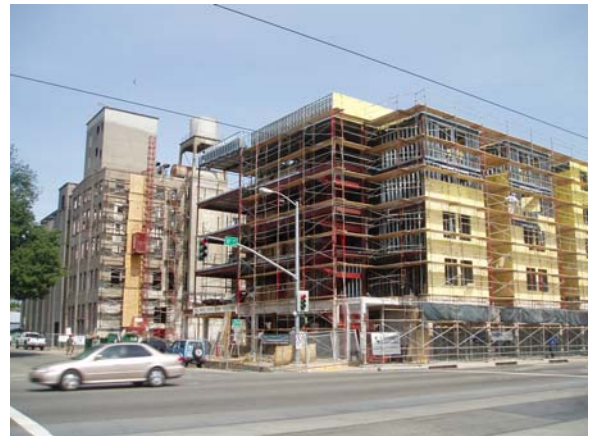
**Figure 29. NB1 Under Construction**

Photographs of NB1 and NB2 under construction are presented in Figure 29 and Figure 30, respectively.

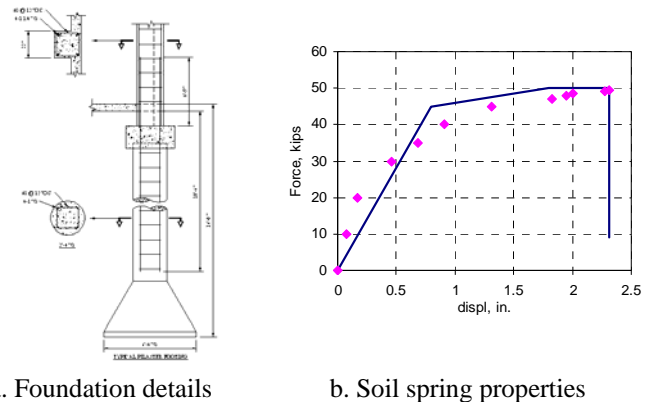
Figure 31. Foundation Detail for Pilasters

The original 25-ft tall, 17,000 ft<sup>2</sup>, structure was constructed in the 1940's with two stories. It measured 136 feet in the North South and 61 feet in the East West direction. The existing structure was composed of cast-in-place concrete slab supported by a system of interior columns and perimeter walls and pilasters. Columns were supported on 16 ft deep cylindrical shafts terminated in belled caissons; see Figure 31a (CUC, 2006).

A detailed geotechnical investigation of the site was conducted by Wallace-Kuhl, (2006) to prepare site-specific design spectrum and acceleration records and by JP Singh and Associates, (2007) to model the soil-structure interaction and calculate soil spring properties. The soil-structure interaction was based on the soil data obtained from site borings. The lack of confinement in the shaft and inadequate lap splices of longitudinal reinforcement from the pile to the columns were included. Pile lateral capacity of only around 45 kips were computed, see Figure 31b.

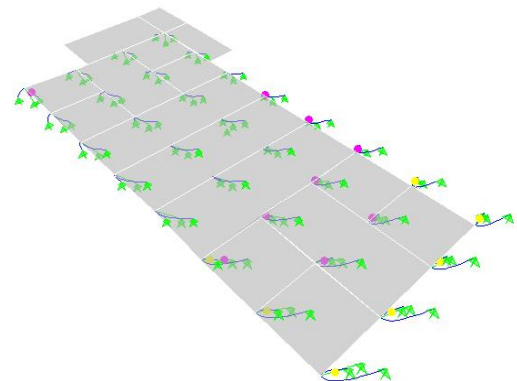
Figure 32. Plastic Hinge Pattern

Computer analysis program SAP (CSI, 2007) was used to model the structure. Nonlinear springs accounted for the soil-structure interaction. Nonlinearity was modeled as user-defined plastic hinges in pushover analysis or by using nonlinear elements for response history analysis. Figure 32 presents the deformed shape of the ground slab and piles from the pushover analysis. The building nonlinear behavior was concentrated at the soil springs and that the nonlinear demands on members exceeded the allowable values.

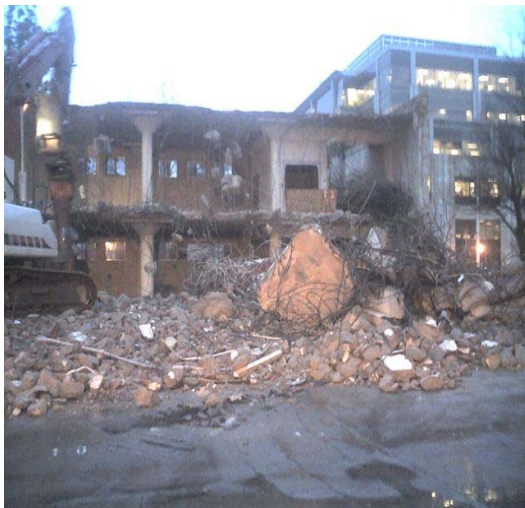
This decision and the foundation concerns, raised during analysis evaluations, were validated during demolition. As the contractor attempted to extract some of the shafts, they broke at the shaft-caisson joint. The demolition of the building is shown in Figure 33.

**Figure 33. Photograph of Building During Demolition**

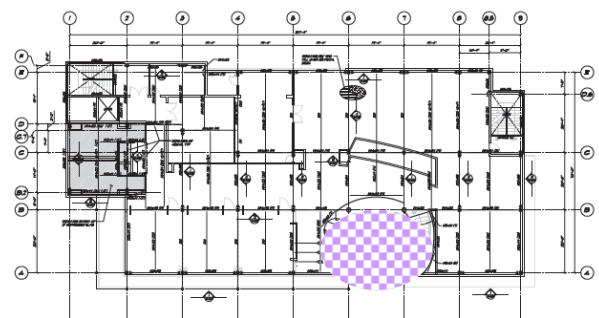
large atrium at the entry to the building. Figure 35 depicts the second floor plan. The atrium area is shaded.

**Figure 35. Floor Plan**

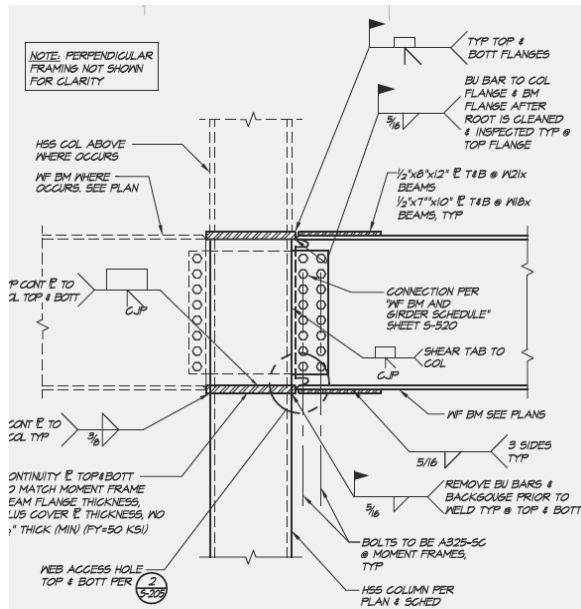
The Vertical loading components consist of self-weight, nonstructural components and live load. The planned occupancy consisted of exhibit space, teaching space, office space, and auditorium. For future flexibility for use of space, the structure was designed for live load of 100 psf. The lateral resisting system consists of ordinary steel moment resisting frames (OMRF). Since the roof structure has several different levels, wide flange columns were not an option since it would have resulted in moment frame connections to the weak axis of the columns. HSS tube columns were utilized in order to avoid weak axis columns connections at the moment frames; see Figure 36. Additionally, the architect could use the tube columns as architectural features throughout the structure. Moment connections at the floor and roof levels were created by cutting the tube column, adding continuity plates at the top and bottom flanges, and reinforcing the beam flanges to have the strength to resist the combined forces with over strength level seismic forces. The structure required a one-hour fire rating; concrete with metal deck was provided with adequate fire rating supported by composite steel beams and columns to resist gravity loading. All of the moment frame columns have been fixed at the base. The moment at the base of the columns is transferred to the foundation through reinforcing welded to continuity plates at the column, which develop into the grade beam.

**Figure 36. Tubular Column-wide Flange Beam Connection Detail**

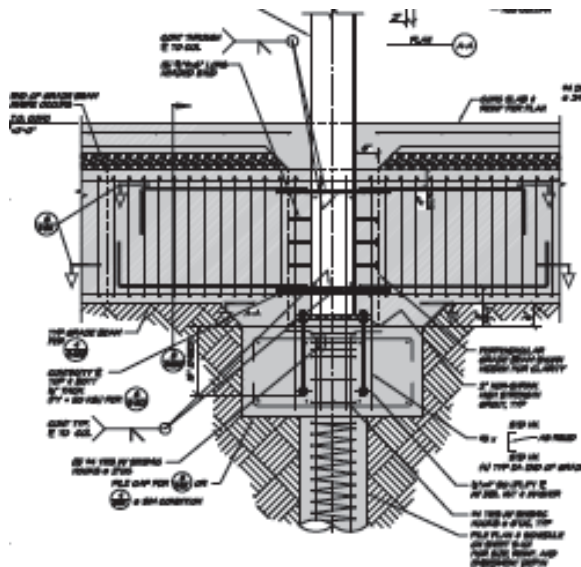
The columns are supported on end bearing auger cast piles with a tip elevation approximately 30 feet below finished grade. Figure 37 shows the steel columns supported on the augur pile. The grade beam is used to provide fixity at the base of columns.

**Figure 37. Foundation Detail**

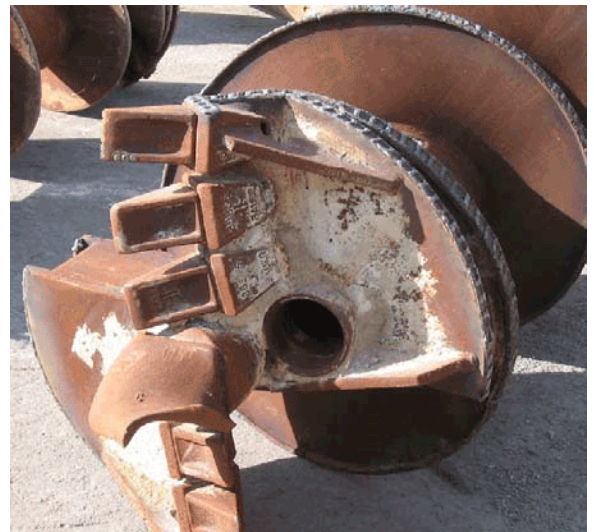
Augur piles are one type of drilled shaft and are installed by rotating a continuously flighted hollow stem auger (Figure 38) into the ground to the specified design depth. No steel casings are used. High-strength concrete or grout is then injected into the augur shaft (stem) under pressure as the augur is withdrawn.

**Figure 38. Hollow-Stem Augur (FHWA 2007)**

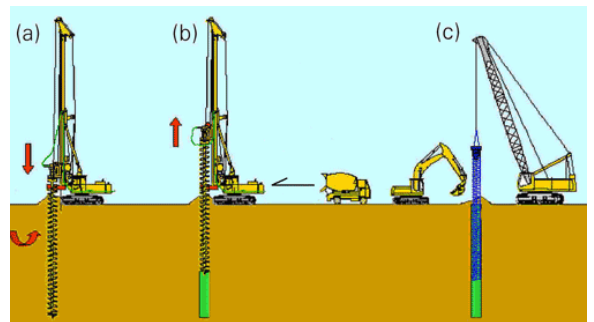
The high pressure is continuously maintained and monitored. This pressure acts upwardly on the soil-filled auger flights and laterally on the surrounding soil as the auger is withdrawn. The result is the formation of a concrete column in the drilled hole. Figure 39 presents the schematics of the pile placement (FHWA, 2007)

**Figure 39. Augur Cast Pile Installation**

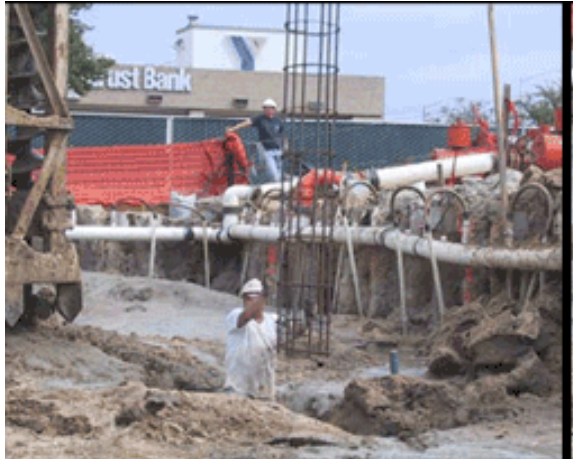
Reinforcing steel is placed in the center of the hollow stem and/or in the concrete column prior to hardening (FHWA, 2007), see Figure 40. The result is the augur cast pile.

**Figure 40. Placement of Reinforcement Cage**

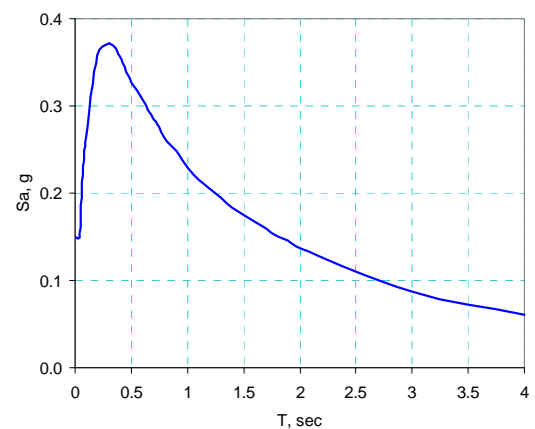
The code's linear static procedure (LSP) could be used for this building. However, due to presence of sloping roof, change in roof elevation, and large openings in the diaphragm for the atrium, linear dynamic procedure (LDP) was used instead. The unreduced site-specific design spectrum is shown in Figure 41. In analysis, the seismic demand was scaled to ensure that the strength calculations met the code's minimum specified values as percentage of values computed by linear static procedure. The code does not address drift calculations utilizing linear dynamic procedures. The drift calculated with linear dynamic procedure and that calculated with linear static procedures without the limit based on the period per code were within 5 percent of each other; therefore, linear static procedures were used in computing drifts.

**Figure 41. Design (DE) Response Spectrum**

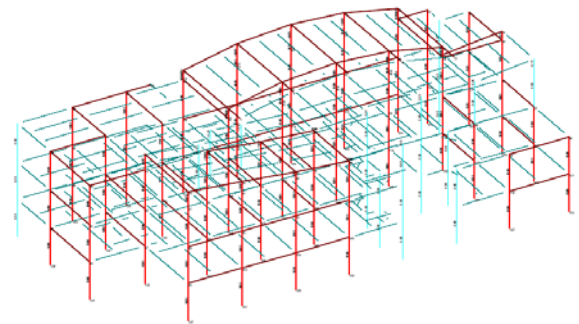
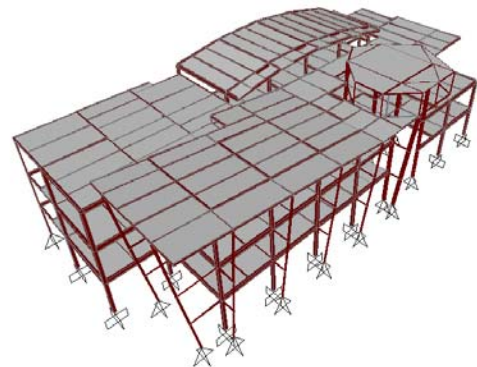
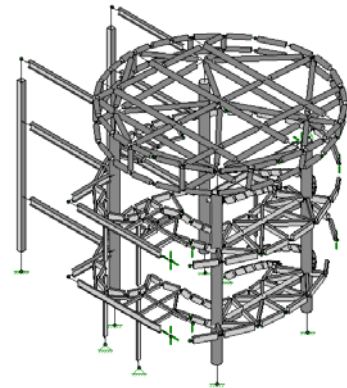
Detailed mathematical models of the building were prepared using commercially available programs RAM-Steel (Bently, 2007) for analysis and design of the main structure and RISA (2007) for the design and analysis of the atrium. SAP (CSI, 2007) was used for analysis and verification of RAMSTEEL and RISA results. Figure 42 depicts the mathematical models of the structure.

**Figure 42. Mathematical Models**
