## GLOBAL EXPERIENCE: SEISMIC RISK REDUCTION AND DISASTER RECONSTRUCTION PROGRAMS

H. Kit Miyamoto<sup>1</sup>, and Amir SJ Gilani<sup>1</sup>,

*1) President, Miyamoto International, Los Angeles, CA*

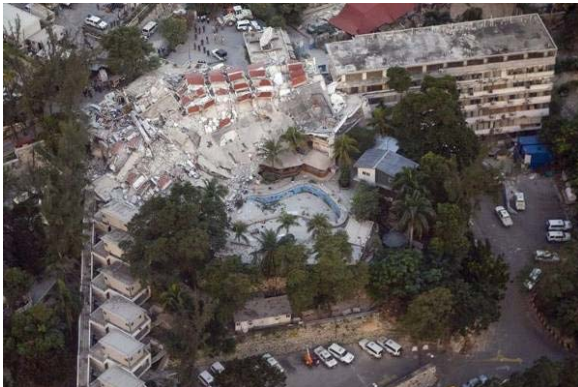
Thousands of buildings collapse, including the United Nations (U.N) headquarters Port-au-Prince; as shown in Figure 1.

Figure 1 Collapsed UN building (UNDP Global 2010)

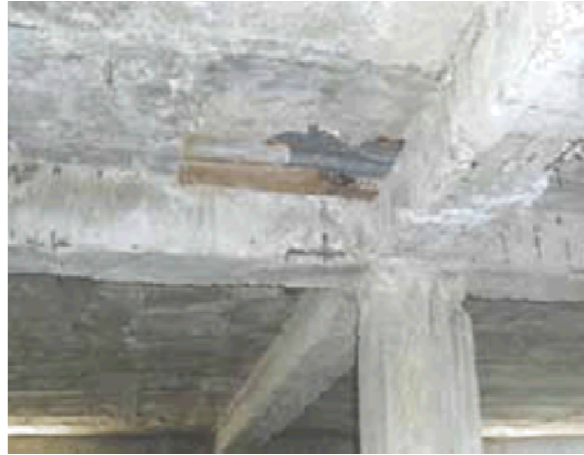
Similar to past and recent events in other developing countries such as Indonesia, Pakistan, and Turkey, the main causes of the devastation can be attributed to several factors. Among them: This earthquake caused devastation disproportional to its magnitude. If any form of standard of seismic design and construction had been used in Haiti, many lives and much of the economic loss could have been avoided. The main observed factors that exacerbated this tragedy were the following: a) Design and construction practices had not considered earthquake forces properly. In addition, many engineers and contractors had neither formal education nor experience in earthquake-resistant design methodologies. b) Absence of an accepted building or seismic engineering code, and proper quality control system in design, and construction. In addition, no formal building review process was in place. c) The rapid growth of low-income neighbourhoods due to migration into the city from outlying areas. In these neighbourhoods, unsafe housing had been built using substandard construction materials and practices. d) Lack of preparedness by the national government, local agencies, international organizations, emergency responders, and citizens for a major earthquake. Many of the structures in Haiti as well as other developing countries are constructed of either what is referred to as non-ductile concrete, unreinforced masonry (URM), or other stone-type block construction. These particular building types are seismically vulnerable and pose a life-safety hazard. An example of poor construction in Haiti is shown in Figure 2.

Figure 2 Example of poor construction in Haiti

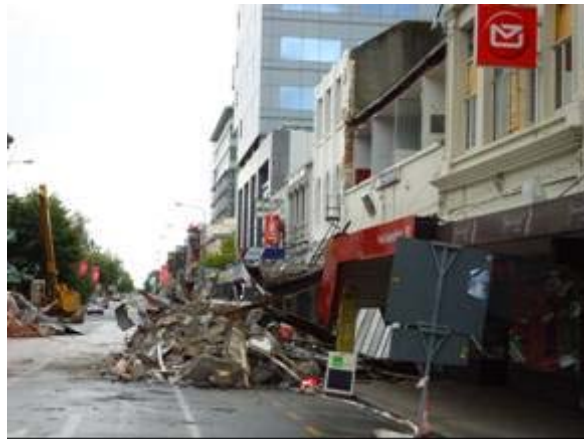
The magnitude-6.3 February 2011, New Zealand, earthquake caused more than 160 deaths and damage costing over US\$20 billion. Many buildings were damaged; over 30% of the brick and stone buildings in the central business district (CBD) either collapsed or sustained major damage (see Figure 3) resulting in total closure of the CBD for period of several months because many of the remaining buildings were considered unsafe (Miyamoto International 2011).

Figure 3 Collapsed masonry buildings in the CBD

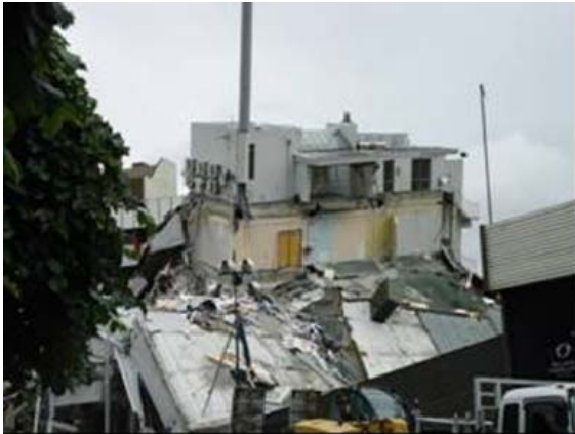
Figure 4. Collapsed nonductile concrete building in the CBD

widespread loss of water and electricity. The severity of this earthquake was unexpected in Christchurch and points to the same problem that exists in many other urban areas that are close to active faults. The level of damage to modern (post-1980) construction was alarming. Over 50% of the building stock—more than 1,300 buildings—are expected to be claimed as total losses. Many of these buildings were designed and constructed using modern seismic codes. Nonetheless, they sustained significant structural and nonstructural damage, and many have to be demolished. Similar observations were made following the 2010 Chile earthquake. In both countries, modern seismic codes are advanced and local engineers are quite capable, and there are tight construction standards. It is important to note that the building codes likely did what they were intended to do: that is, to provide life safety and prevent collapse. However, the codes do not have provisions for either the building condition after an earthquake or financial losses as a result of an earthquake.

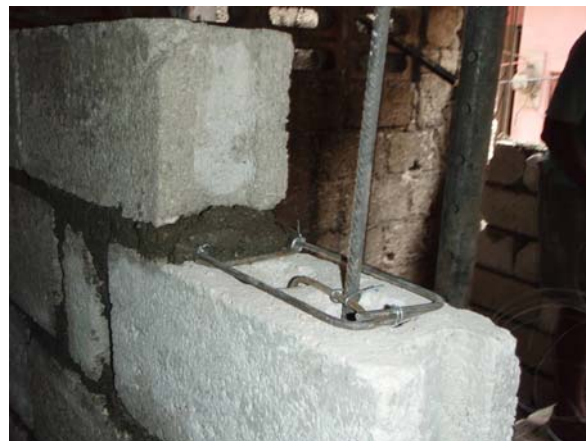
Figure 5. Example of acceptable reconstruction in Haiti

The seismic rehabilitation of thousands of buildings that is currently under way (see 0) will allow many more thousands to return home, and provide a safe and seismically resilient community for citizens. At the time of this paper, over 9,000 houses have been reconstructed under various programs; see 0.
