State of the Art Application of Seismic Isolation to Ancient Heritage Cathedrals in Haiti

2013 NZSEE
Conference

ABSTRACT: The 2010 Haiti Earthquake devastated the country and resulted in many casualties and enormous damage to infrastructure. Following the event, the authors visited the country, conducted a damage assessment program, and developed retrofit programs. While the bulk of retrofit has focused on traditional upgrade of residential units, seismic protection devices (isolators and dampers) were used to provide enhanced performance for important and historical buildings. In particular, a Cathedral damaged during the 2010 and earlier earthquakes, was retrofitted with seismic isolators. The design objectives for the structure was to minimize alterations to superstructure and thus to preserve the historical vintage, while providing enhanced seismic performance for large earthquakes. A key feature of this building is that the main lateral load resisting system was comprised of the URSM walls (stone and URSM without reinforcement). Detailed global mathematical models of the buildings were subjected to motions with site-specific spectrum-compatible motions. The seismic retrofit

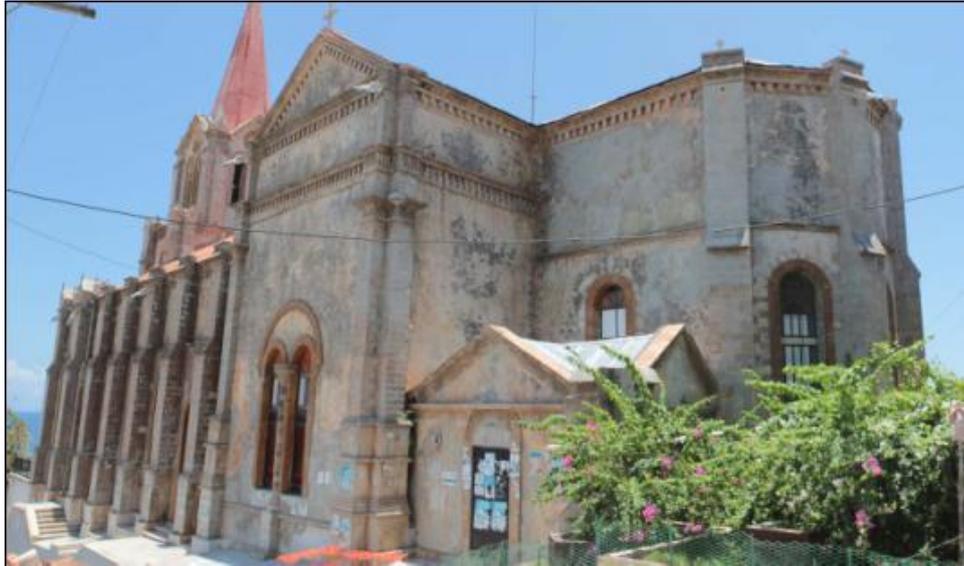
Figure 1. Photograph of the Cathedral, Looking east

Saint John Baptist Cathedral of Miragoane (hereafter referred to as the Cathedral) was originally constructed in the 1880's and is one of the oldest Cathedrals in Miragoane— a coastal town approximately 80 km west of Port-au-Prince, the capital of Haiti.

The building has a floor area of approximately 580 m² and is nearly rectangular. It is constructed using concrete floors with an unreinforced stone masonry (URSM) walls over stone masonry foundations. There is a ground floor, and a mezzanine with access to the upper tower that houses the bell. The roof structure is assembled with trusses that combine both wood and steel and is approximately 13.9 m tall at its peak. The roof is supported by the walls on the exterior and by uniformly placed columns along the interior. The front entrance of the cathedral has a bell tower that stands approximately 30.5 m high. The tower is constructed with steel frames above the walls. There is a concrete mezzanine that sits approximately 7 m above the finished floor of the Cathedral. The wall thicknesses along the perimeter vary from 500 mm to 750 mm and are the primary gravity- and lateral-load resisting members.

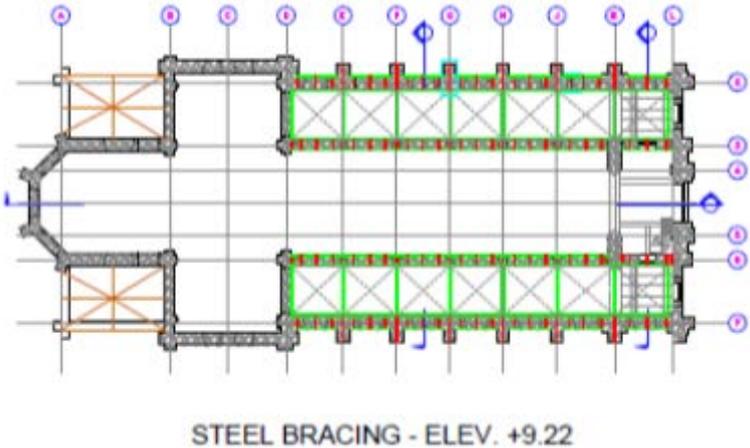
Figure 2. Typical detail of structural intervention

For the seismic isolation system to be effective, out-of-plane and non-ductile in-plane URSM wall failure type of failure need to be precluded, As such, it is important to connect structural elements and provide a robust path for the transfer of seismic forces. In the United States, this type of failure is mitigated and the seismic load path is developed by addition of either wood or concrete diaphragms to the existing buildings. Since such approach was not feasible in Haiti, the strengthening was provided by a series of steel rods and beams (channels and angles) serve to connect the wall elements and provide horizontal bracing (diaphragm) and vertical bracing. Such approach has been used extensively in Europe and especially in Italy and Greece (Pezzullo et al 1992) for retrofit of historic buildings. Figure 5 presents the plan and elevation view (longitudinal and transverse directions) of the Cathedral showing the added steel members.

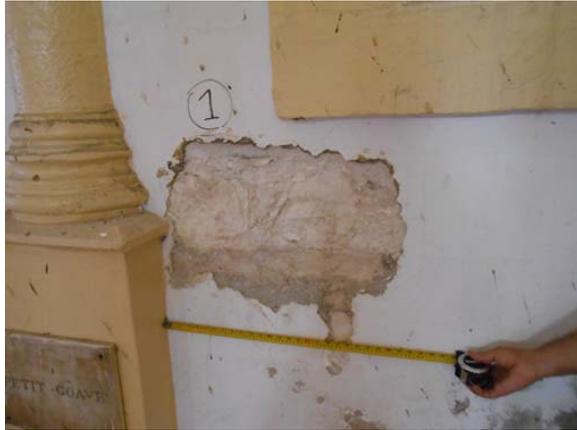
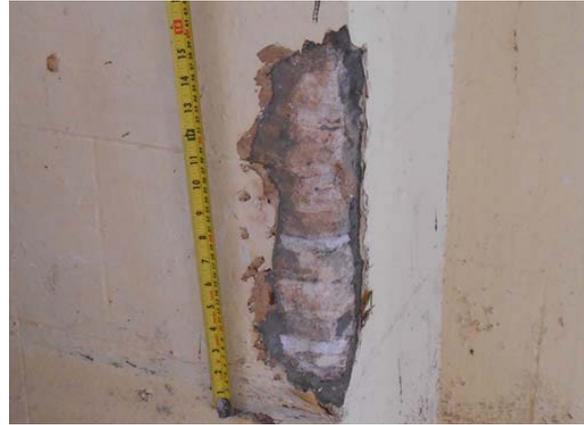
Irregular-shaped stones placed in the mortar

Rectangular-shaped stone and debris embedded in mortar

Figure 3. Typical composition of exposed unreinforced masonry stone walls

The Cathedral’s unreinforced stone masonry (URSM) walls are the load bearing elements resisting the applied vertical and lateral load applied to the building. Figure 6 depicts exposed sections of the walls with the wall plaster removed for investigation. The composition of the wall is that of unreinforced masonry with irregular-shaped stones or with rectangular-shaped stones and debris placed in mortar

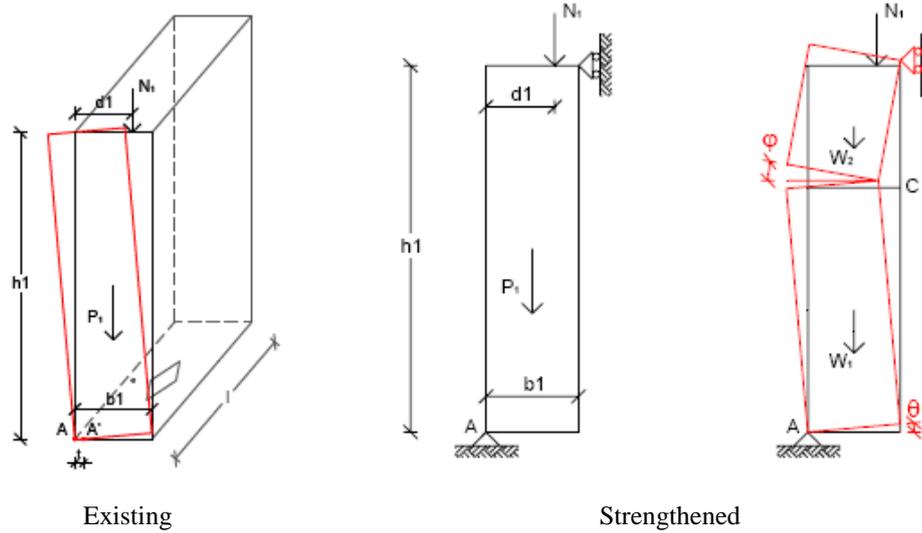
Figure 4. Out-of-plane failure modes for a typical wall segment

Figure 4 presents the kinematic failure modes for typical existing and retrofitted walls. For the existing wall, the failure mode is the rigid motion of the entire wall about its base. As part of retrofit, steel vertical members are added and these tie-downs serve two purpose: they alter the failure shape to a higher mode (thus increasing the acceleration required for failure), and b) they provide additional resistance to overturning and thus serve to increase the lateral load required to initiate out-of-plane failure of walls (Ismail and Ingham, 2012).

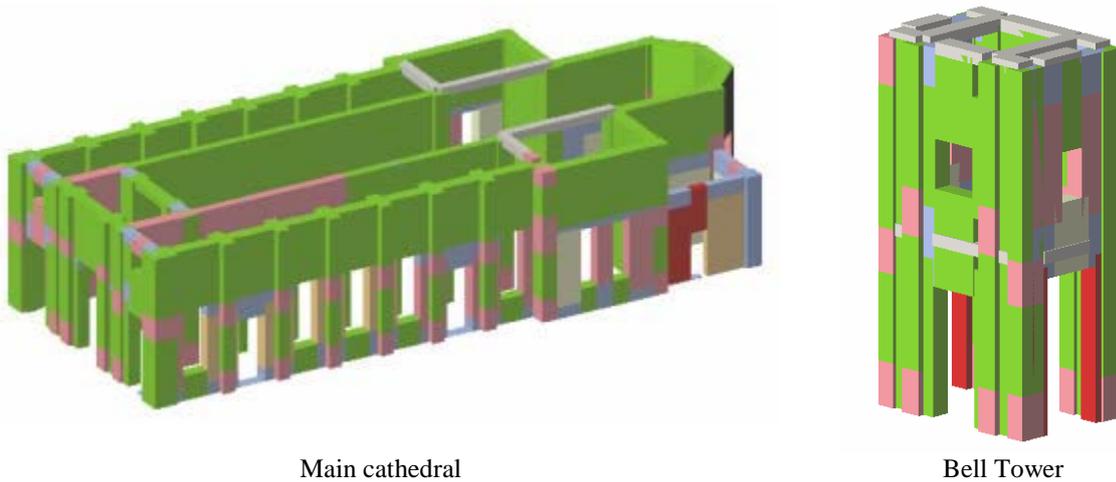
Main cathedral
Bell Tower
Figure 5. Main Cathedral, mathematical model, and failure mode

The capacity of the main cathedral and bell tower walls were determined using static pushover analysis and plastic hinges whose properties were obtained from interaction analysis. Program 3Muri (S.T.A. Data 2012) was utilized. Both flexural and shear failure modes were accounted for in the nonlinear analysis. The progression of the nonlinear response in the bell tower is listed in Table 5. Shown in Figure 8 are the state of Cathedral walls and tower bell structure at its limit state. In this figure: i) Green denote wall segments that remain elastic; ii) Pink corresponds to flexural yielding; iii) Red designates flexural failure; iv) Ivory indicates shear yielding, and v) Light blue represents traction failure

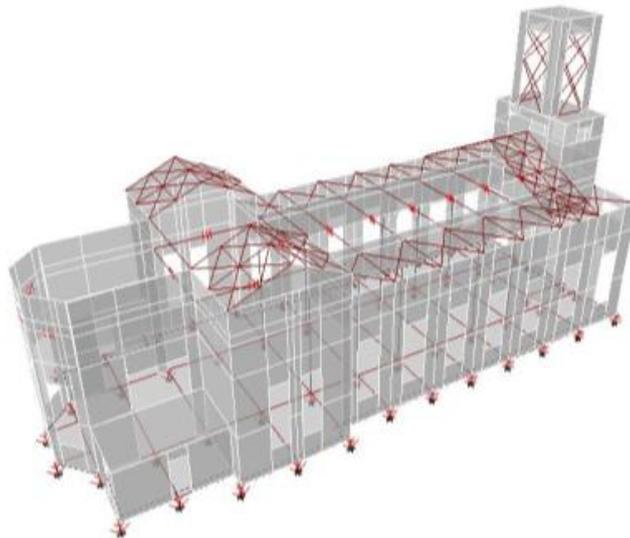
Figure 6. Analytical model of the building

A three-dimensional analytical model of the building was prepared using the program ETABS (CSI 2012); see Figure 8. The isolation system and new steel members are highlighted for clarity. The total inertial mass of the structure is estimated at 2,800 Mg. The individual isolators were model as bilinear link elements using the friction and curvature properties provided by the TP bearing manufacturer.

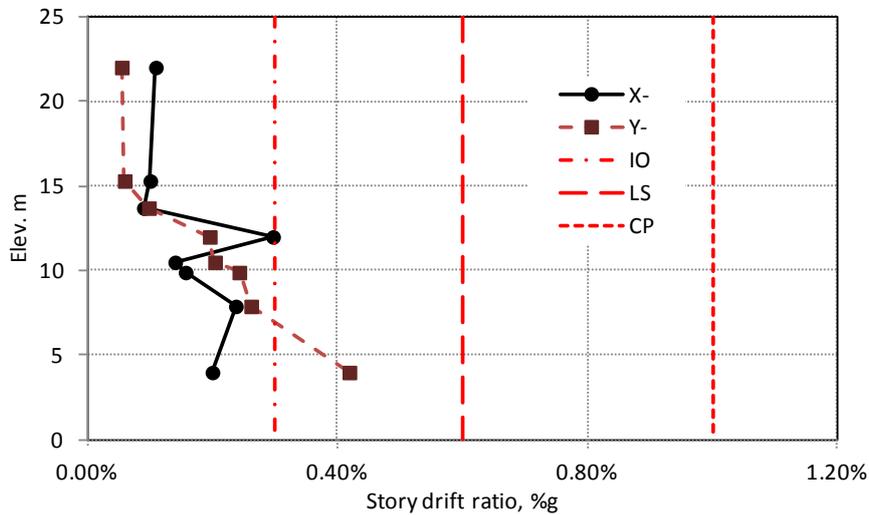
Figure 7. Computed story drift ratios (DE) and ASCE/SEI 41 performance limits

For unreinforced masonry non-infill walls, ASCE 41 (ASCE 2006) has the following limitations on drift ratios of 0.3%, 0.6%, and 1.0%, at IO, LS, and CP, respectively. For the retrofitted structure, at both DE and MCE levels, performance of between IO and LS are obtained; see Figure 8, and thus the enhanced performance criteria are satisfied for drift response.

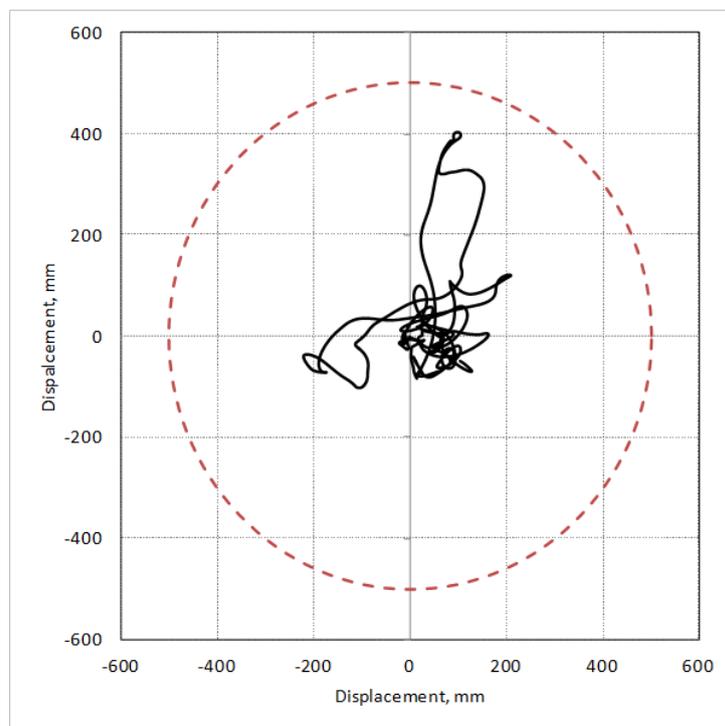
Figure 8. Bi-directional response of a typical isolator

Figure 11 presents the bi-direction MCE displacement response of a typical isolator. Also shown in the figure is the displacement limit (500 mm) as specified by the manufacturer. As seen, the isolator MCE displacements in any direction are less than its allowed maximum motion.
