THE 2007 WEST SUMATRA EARTHQUAKE: SEISMIC HAZARD MITIGATION IN DEVELOPING COUNTRIES

H. Kit Miyamoto and Amir S. Gilani
Miyamoto International Structural and Earthquake Engineers
West Sacramento, CA, U.S.

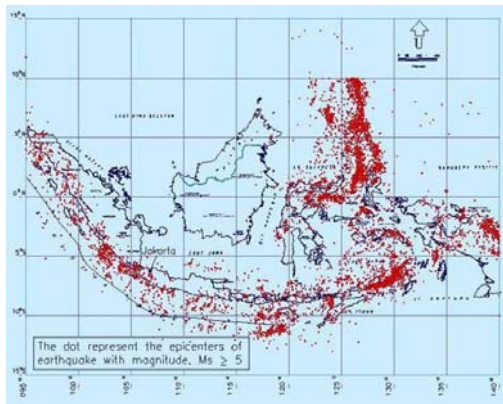
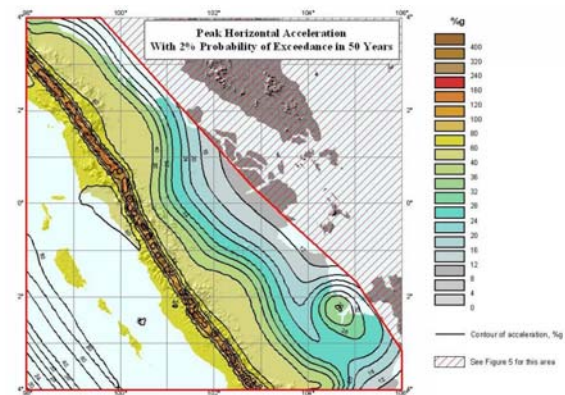
Figure 1. Seismicity of Indonesia (Courtesy of Institute of Technology, Bandung, Indonesia)

a. History of earthquakes in Indonesia

b. Earthquake hazard maps of Western Sumatra, 2500-year event

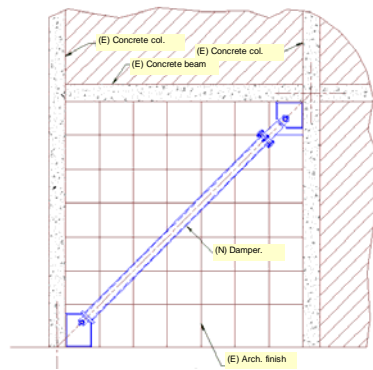
c. Soft story mitigation

For URM infills and concrete bond beams, it is recommended to strengthen the beam-to-column joints; see Figures 7a and 7b. This will avert the brittle shear failure at the joints and will allow the concrete elements to provide some confinement to infills. Most importantly, they will carry the gravity loading and mitigate the building collapse. To alleviate soft-story and torsional response of mosques and other commercial buildings, either braces or dampers can be added to the first floor of the building; See Figure 7c. For bridges that are supported at the abutments on inadequate bearing pads, seismic isolation pads provide an attractive replacement alternative; Figure 7d. This isolation system will serve to reduce the inertial forces transferred to the substructure. Additionally, a well-designed system with adequate transverse shear keys would prevent the type of failures observed during this earthquake.

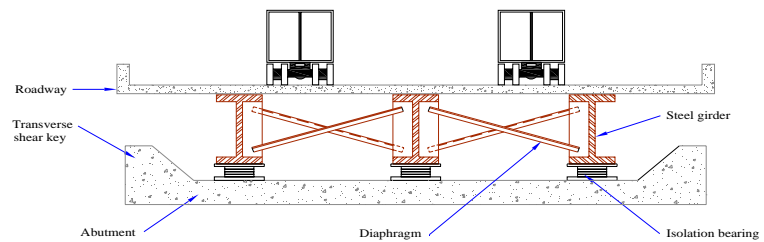
d. Steel bridge abutment
