# Damage Assessment and Seismic Retrofit of Buildings Following the 2015 Nepal and 2016 Ecuador Earthquakes

*H. Kit Miyamoto, PhD, SE and Amir SJ Gilani, PhD, SE  
Miyamoto International  
Los Angeles, CA*

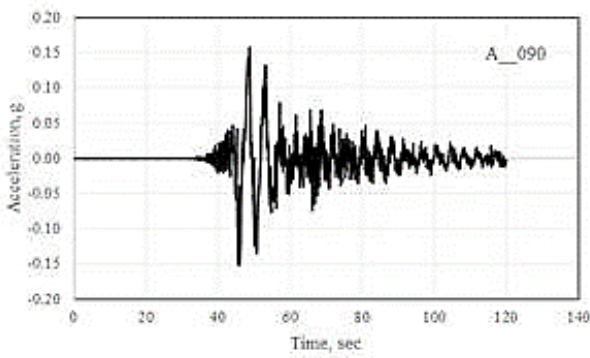
**Figure 1. Acceleration record**

**Strong motion data.** In Katmandu, which is built in an ancient lake bed far from the epicenter, strong motion data from the Earthquake; see Figure 1, was available and the peak ground acceleration was approximately 0.10-0.15g. However, site amplification resulted in large spectral acceleration at periods of 2 to 4 sec; see Figure 2. These peaks at larger periods in-turn excited the tall buildings with fundamental periods in this period range, resulting in significant damage to these modern concrete buildings. As seen in the figure, the spectral acceleration demand on buildings; in particular for structures with periods of larger than 1 sec, is significantly larger than the spectrum used to design these structures (NBC 1994 and IS 2002). Accordingly, buildings (in particular mid- and high-rise) designed per code would experience larger forces and displacements than were anticipated. As a result: i) for buildings with ductile detailing, the larger demand would result in plastic hinging and damage and ii) for buildings without ductility, severe damage and collapse could occur.

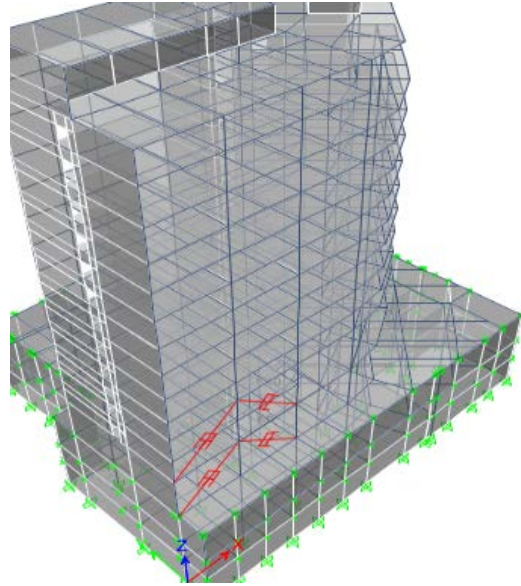
**Figure 9. Building model**

The new 70m tall hotel building has 15 stories and 3 basement levels, see Figure 9, reinforced concrete moment frame exterior shear walls comprises the lateral load resisting system. The structure was designed per IS 2002. Following the 2015 earthquake, it was decided to add the additional requirement of limiting the drift ratios to approximately 1.5 percent for a seismic event comparable to that earthquake. As shown in Figure 10, the building nearly met this criterion in the transverse direction. However, in the longitudinal direction, at the lower three levels, drift ratios exceeded this limit. To reduce the drift ratios, viscous dampers were added at these levels along the longitudinal direction. As shown in

the figure, in the new configuration, drift ratios were limited to approximately 1.5 percent.

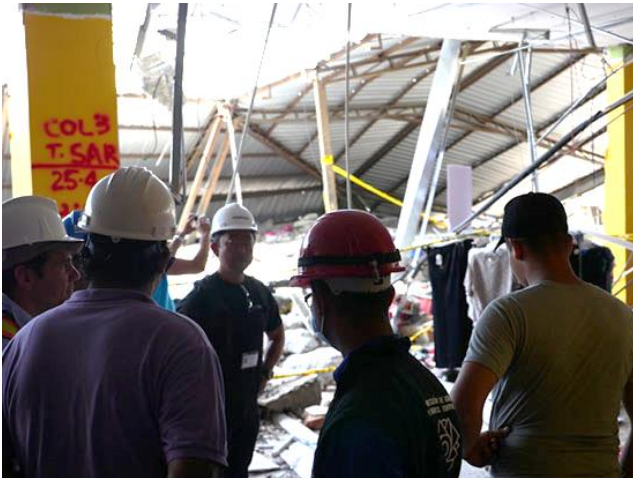
**Figure 14. Damage assessment training**

To provide training, local assessors were incorporated into assessment teams. The groups then conducted damage assessment surveys of some buildings to provide first-hand training so local engineers and volunteers could then continue the work for the rest of buildings, see Figure 14.

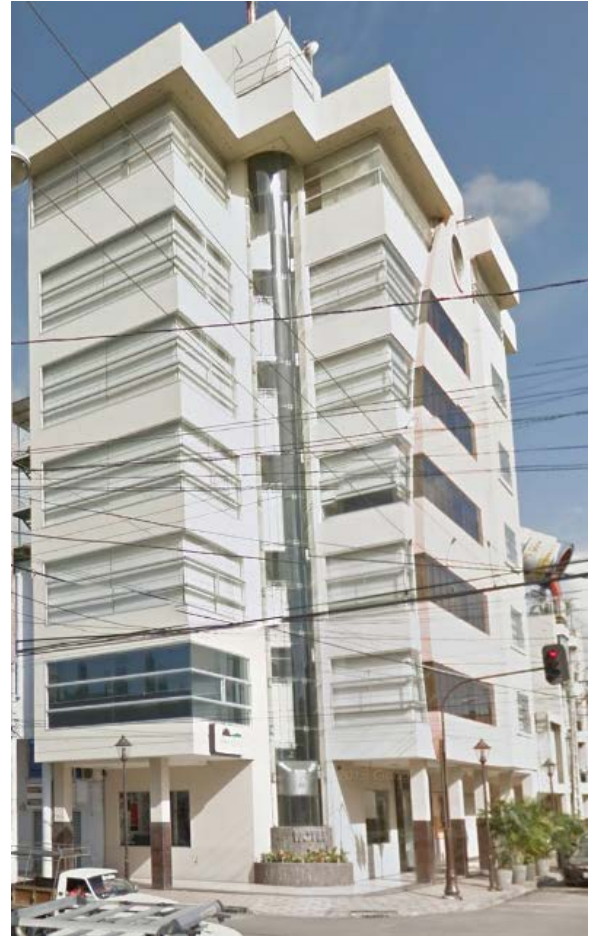
**Figure 18. Photograph of mid-rise building**

The 41m tall building has 7 stories and 2 penthouse levels, see Figure 19. Reinforced concrete moment frame comprises the lateral load resisting system. Typical beams measure 350 x 450 mm and square columns vary in size from 450 to 700 mm. The structure was designed per Ecuador building code. Following the 2016 earthquake, it was decided to add the additional requirement of limiting the drift ratios to approximately 1.5 to 2 percent for the MCE event. BRBs were added to the building model, see Figure 20. As shown in Figure 21, the drift ratios for moment frame alone exceeded this limit and were 2.8 percent at the middle of the

building. To reduce drift ratios, BRBs were added to the building and this reduced the maximum drift ratio to approximately 1.8 percent.
