# Earthquake Reconnaissance of the 2008 Sichuan Earthquake and Retrofit Options

***H. Kit Miyamoto, President & CEO  
Amir S.J. Gilani, Structural Specialist***

***Miyamoto International, Inc.  
Sacramento, CA***

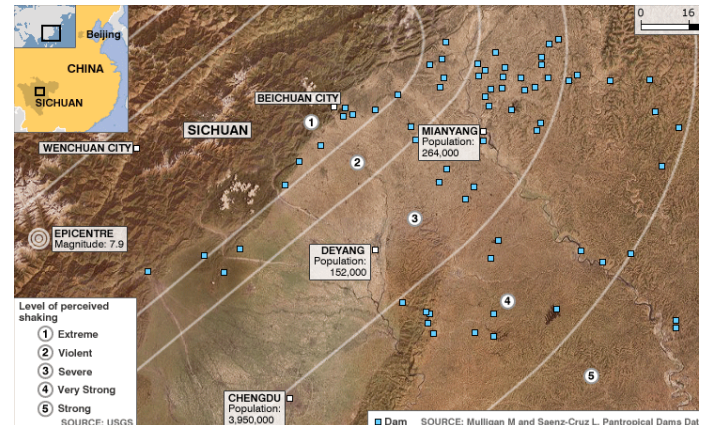
**Figure 41. Important Dams in Regions of Strong Shaking (BBC)**

This area of China, is the basin of many rivers flowing from the nearby mountains. There are thousands of dams in this region and many were subjected to severe ground shaking (Figure 41). Over 2400 large and small dams were damaged. The Three Gorges River Dam was not damaged. However, hundreds of important dams sustained either collapse or serious damage. Figure 42 shows the damaged Deyang City dam.

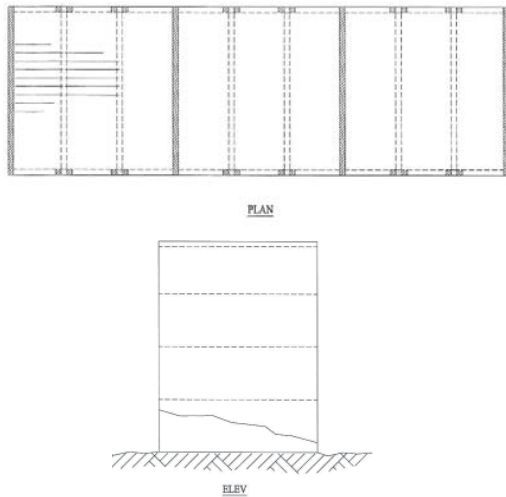
**Figure 45. Existing Condition URM Building**

Table 4 lists the seismic deficiencies, retrofit objectives, and robust means of achieving these goals for URM buildings with precast panel floors. As discussed in the earlier sections indicated, this type of construction is especially vulnerable to earthquake damage. The existing building condition is shown in Figure 45, whereas; Figure 46 depicts the rehabilitated condition.

Building Type	URM bearing wall
Deficiencies	Lack of lateral capacity and ductility
Retrofit goal	Retrofit design
Confine floor panels to work as a diaphragm	Check strength and ductility of the RC ring beams. Reinforce and confine them as needed. Add ring beams at each floor if they are not present.
Eliminate lateral loading demand on URM walls	Add full-height ductile, RC shear walls on the exterior of the building to carry the entire lateral load demand.
Enhance capacity of URM walls	Apply engineered cementations concrete (ECC) to the exterior of the walls. ECC will add strength and ductility to the walls and allows them to resist seismic forces without collapse.
Reduce seismic demand	Placing the structure atop of seismic isolator bearings to get a low frequency and highly damped building that would protect the non-ductile components.

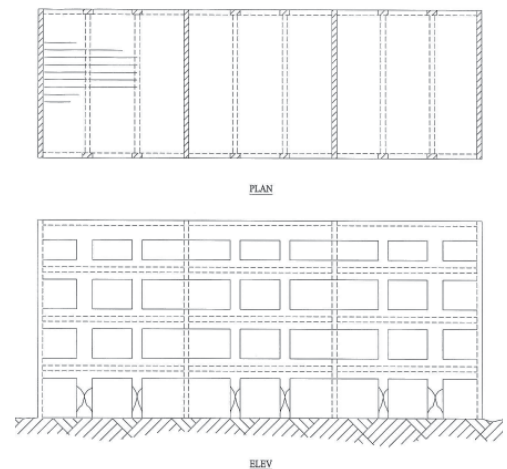
**Figure 47. Existing Condition RC Frame Building**

Table 5 lists the seismic deficiencies, retrofit objectives, and robust means of achieving these goals for buildings that use RC framing and precast panel floors. The existing building condition is shown in Figure 47, whereas, Figure 48 depicts the rehabilitated condition

Building Type	Nonductile RC moment frame with URM infill
Deficiencies	Inadequate joint capacity, lack of column confinement, captive columns
Retrofit goal	Retrofit design
Confine floor panels to work as a diaphragm	Check strength and ductility of the RC ring beams. Reinforce and confine them as needed. Add ring beams at each floor if they are not present.
Eliminate lateral loading demand on existing frame	Add full height ductile RC shear walls on the exterior of the building to carry the entire lateral load. Discount any contribution from existing frames.
Enhance capacity and ductility of existing frames	Cut the connection between the partial height infill URM walls and concrete columns to mitigate short column failure; Wrap columns using FRP to increase confinement and ductility; Add prestressing or confinement to joints to increase shear capacity; Add shotcrete to the existing members to increase capacity

Reduce seismic demand	Placing the structure atop of seismic isolator bearings to get a low frequency and highly damped building that would protect the non-ductile components.

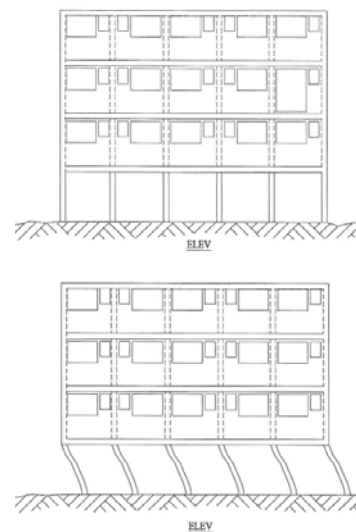
**Figure 49. Existing Condition RC Frame Building**

Table 6 lists the seismic deficiencies, retrofit objectives, and robust means of achieving these goals for buildings that exhibit soft story response at the ground floor. Many such buildings collapsed in the 2008 earthquake as the result of low lateral stiffness at the first floor. The existing soft story condition is shown in Figure 49, whereas, Figure 50 depicts the rehabilitated condition.

Building Type	Soft story at ground floor
Deficiencies	Termination of walls above the ground floor reduces lateral stiffness of that floor and results in sideways collapse of that floor
Retrofit goal	Retrofit design
Confine floor panels to work as a diaphragm	Check strength and ductility of the RC ring beams. Reinforce and confine them as needed. Add ring beams at each floor if they are not present.
Eliminate the soft story by adding walls	Add single-story ductile reinforced concrete shear walls on the exterior of the building to carry the entire lateral load.
Eliminate the soft story by adding bracing	Add single story steel braces on the exterior of the building to increase the lateral stiffness of the ground floor.
Reduce seismic demand on the first floor	Add viscous or Visco-elastic dampers to the ground floor to reduce seismic demand in the first floor and eliminate the soft story.
