# Massive Damage Assessment Program and Repair and Reconstruction Strategy in the Aftermath of the 2010 Haiti Earthquake

H. Kit Miyamoto,<sup>a)</sup> M. EERI, Amir S. J. Gilani,<sup>b)</sup> and Ken Wong<sup>c)</sup>

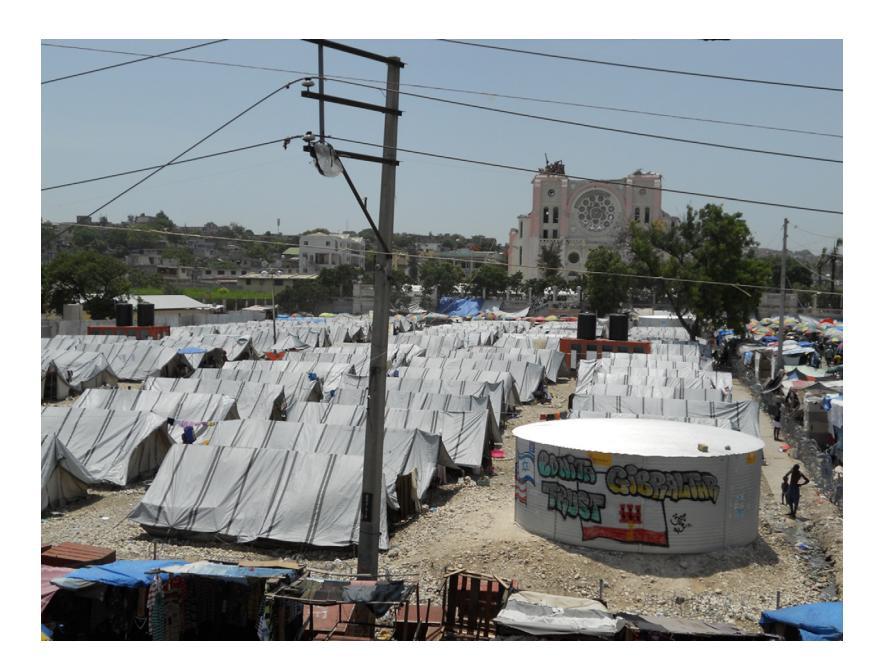
1.3 million people still lived in Internally Displaced Persons (IDP) camps. One year after the earthquake, 810,000 still lived in these camps, many of which offered only minimal services and little protection from natural hazards such as hurricanes, floods, and landslides (see Figure 4). The reduction in the number of people living in IDP camps was a direct consequence of the assessment program, which allowed people to return to the buildings deemed safe.

Figure 4. A Haitian IDP camp.

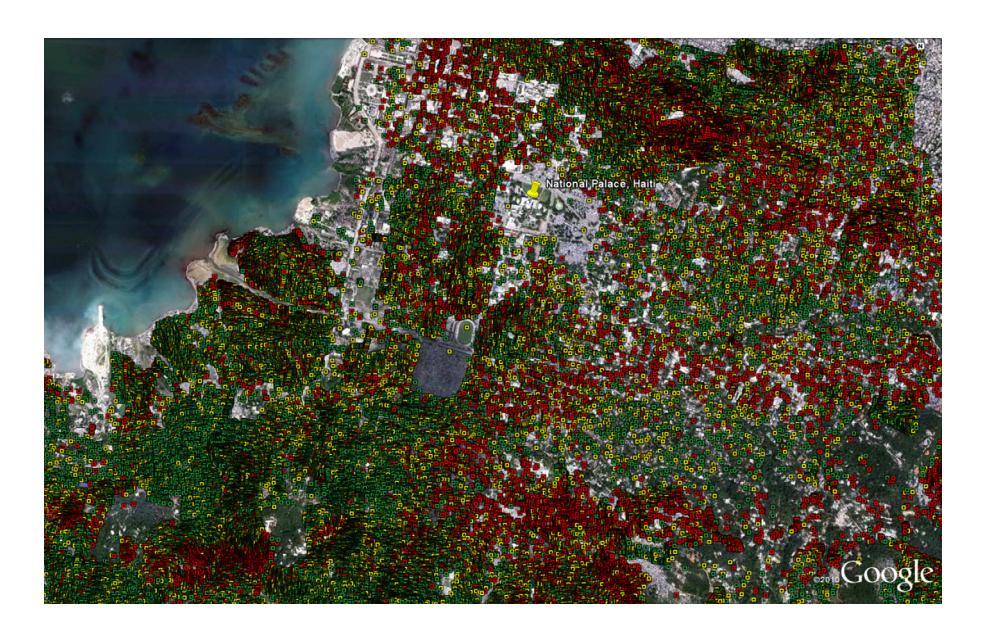
The majority of the damaged and collapsed buildings were in the low-lying districts west of the airport, which includes downtown Port-au-Prince, Nazon, Turgeau, Canape-Vert, Carrefour, and the lower portion of Delmas. By contrast, more southerly and easterly regions, in particular Juvenat and Pétion-Ville, suffered much lighter damage (see Figure 7). The difference in damage levels is mainly a result of soft-soil amplification (Seed and Idriss 1982), geographical effect, and construction quality. Softer soil is found in many of the high-damage areas.

**Figure 7.** Map of Port-au-Prince showing the location of green-, yellow-, and red-tagged build-ings as of March 2011.
