DAMAGE ASSESSMENT AND SEISMIC RETROFIT OF TRADITIONAL AND MODERN MIDRISE BUILDINGS IN THE AFTERMATH OF 2015 NEPAL EARTHQUAKE

H. Kit Miyamoto (1) and Amir SJ Gilani (2)

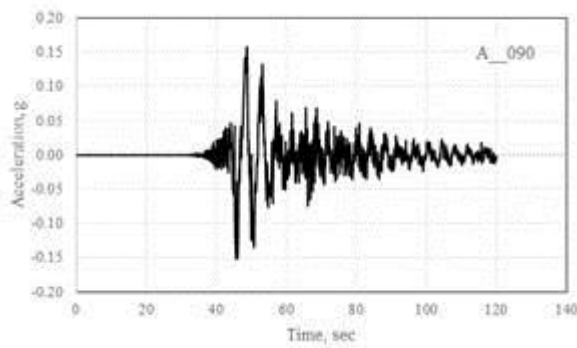
Fig. 1 Acceleration record, 90-degree component

In Katmandu, which is built in an ancient lakebed, far from the epicenter, strong motion data from the Earthquake; see Fig. 1, was available and the peak ground acceleration was approximately 0.10-0.15 g. However, site amplification resulted in large spectral acceleration at periods of 2 to 4 sec; see **Error! Reference source not found..** These peaks at larger periods, in-turn excited the tall buildings with fundamental periods in this period range, resulting in significant damage to these modern concrete buildings. After almost one year of political and environmental stalemate, reconstruction is just about starting.

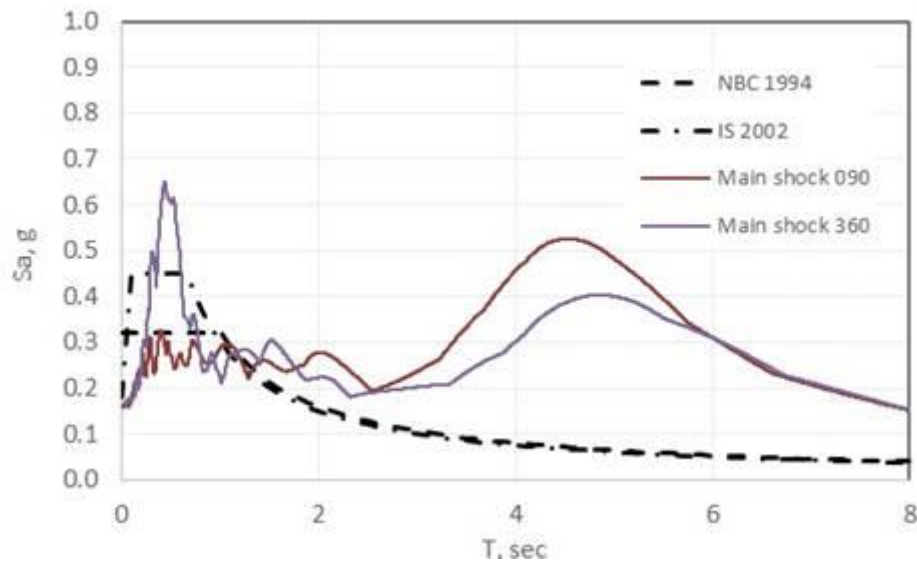
Fig. 6 Code design spectra and 2015 event spectrum

The plateau of the spectral shape is 0.08g and the period-inverse segment starts at periods of 0.1 to 0.4 sec for various site conditions. The Nepal code spectrum for Katmandu, for the case of non-ductile ordinary building situated on soil type III ($Z=1$, $I=1$, $K=1$) is shown in Fig. 6.

As seen in the figure, the spectral acceleration demand on buildings, in particular, for structures with periods of larger than 1 sec, is significantly larger than the spectrum used to design these structures. Accordingly, even buildings, in particular mid- and hi-rise buildings, designed per code would experience larger forces and displacements than were anticipated. The effect of such larger forces is:

- For buildings with ductile detailing, the larger demand would result in plastic hinging and damage for ductile members
- For buildings without ductility, severe damage, and collapse can be expected

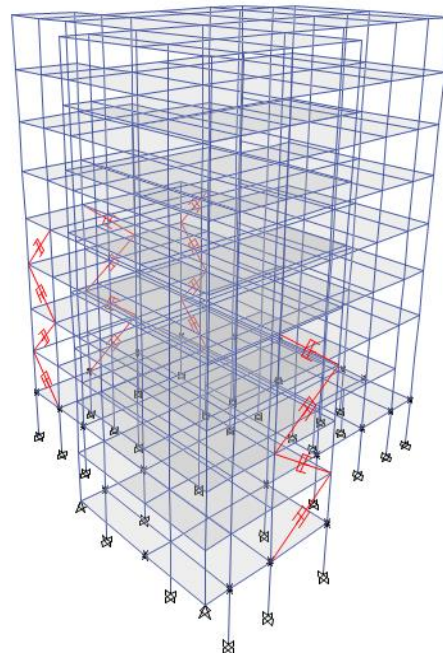
Fig. 14 Mathematical model of the tower

The application of seismic dampers to an existing building was demonstrated after damage assessment of a residential tower was completed. The 10-story 32-m tall tower is approximately square in plan measuring 18 m on side; see Fig. 13. This tower was constructed using reinforced concrete moment frame system with masonry infill. Typical columns were 600x600 mm to 800x800 mm square and rectangular beams measured 300x600 mm. The mathematical model of the building is presented in Fig. 14. In this model, the diagonal viscous dampers are also shown. The building seismic weight is approximately 47 MN.

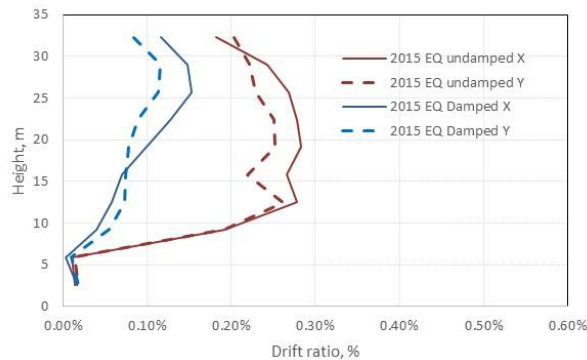
Fig. 15 2015-earthquake analysis

Fig. 15 and Fig. 16 present the computed drift ratios for the 2015 event and code-spectrum synthesized record analysis. It is noted that the addition of viscous dampers have significantly reduced the drift ratios and demand on the drift-sensitive reinforced concrete movement frame beams and columns.

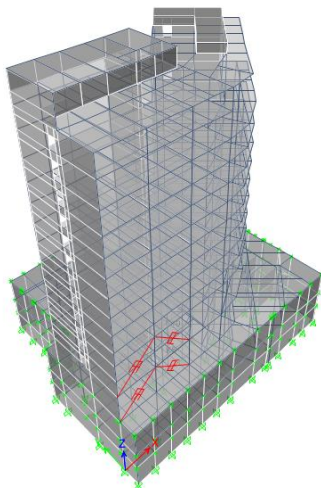
Fig. 17 -2015-earthquake analysis

The new 70-m tall hotel building has 15 stories and 3 basement levels; see Fig. 14. The dual system of reinforced concrete moment frame exterior shear walls comprises the lateral load resisting system. The structure was designed per IS 2002 [5]. Following the 2015 Earthquake, it was decided to add the additional requirement of limiting the drift ratios to approximately 1.5% for a seismic event comparable to that earthquake. As shown in Fig. 18, the building nearly met this criterion in the transverse direction. However, in the longitudinal direction, at the lower three levels, drift ratios exceeded this limit. To reduce the drift ratios, viscous dampers were added at these levels along the longitudinal direction. As shown in the figure, in the new configuration, drift ratios were limited to approximately 1.5%.
