SURVEY OF DAMAGED SCHOOL AND HOSPITAL BUILDINGS IN THE 2008 WENCHUAN EARTHQUAKES, RETROFIT OPTIONS, AND APPLICATION TO TURKEY

H.K. Miyamoto^{1,2}, and A.S. Gilani¹ and Akira Wada²

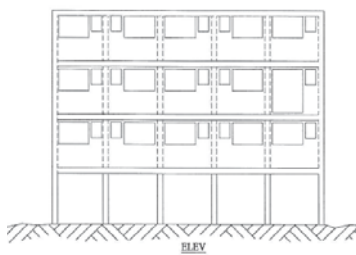
a. Existing

Nonductile RC moment frame with URM infill

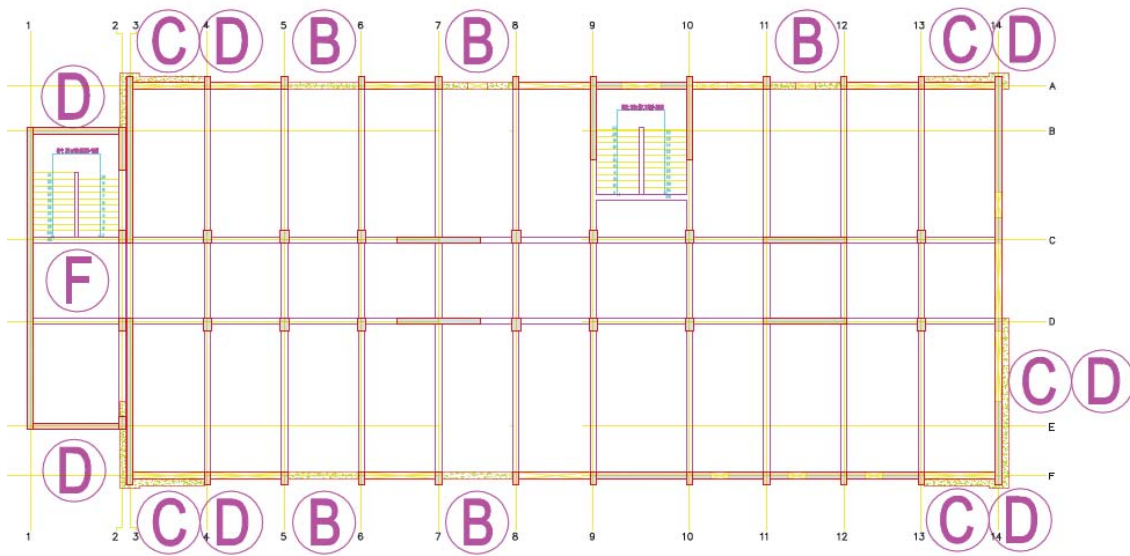
Figure 15. Example of retrofit with new CIP-RC walls

Many Istanbul school buildings are seismically strengthened by new CIP-RC shear walls. These walls are designed to carry the entire seismic loading and use ductile detailing and regular configuration. This cost-effective and relatively simple technique would have saved many schools and hospitals during the Sichuan Earthquake. An example of such retrofit is shown in Figure 15
