US EXPERIENCE – SEISMIC REHABILITATION OF HISTORIC STRUCTURE WITH DAMPERS

The 145,000-sf (13,470 m²) building, built in 1910, is a torsionally nonsymmetrical structure comprised of a six-story portion adjacent to a two-story portion. The building is located in Northern California. There was significant concern that the building will not be able to withstand the level of earthquake shaking expected at the site because of two reasons: a weak and soft lateral force resisting system at the first floor level, and the inadequate confinement of reinforcement in the first story columns. To assess the performance of the structure, a detailed mathematical model of the building was prepared based on FEMA 253 guidelines. The analyses indicated that the building is not seismically adequate to withstand anticipated lateral (inertial) forces generated by earthquake excitations at the site. The structure will suffer substantial damage and possible collapse in the event of a major earthquake. The focus of the seismic rehabilitation was to address the major deficiency of the structure, namely the soft-story response of the building. Nonlinear fluid viscous dampers were placed at the first story lev

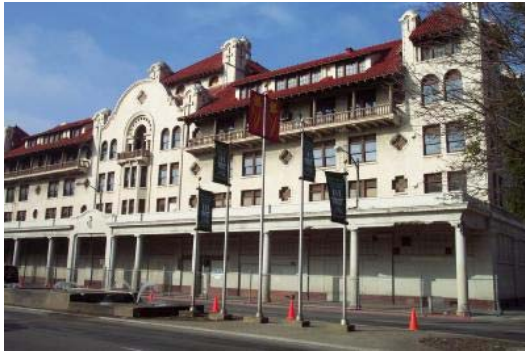
Figure 1: South elevation

The Hotel Stockton, built in 1910 as a 252-guest room hotel, is a historic landmark building in Stockton, California. The building, also referred to as *The Stockton*, measures approximately 300 ft (91.4 m) in the E-W direction and 100 ft (30.5 m) in the N-S direction. In elevation, it is comprised of a six-story portion on the east side and a two-story portion on the west side, and has a full basement. The first story is 18 ft (5.5 m) high and the remaining floors have a story height of 10'-3" (3.1 m). Figure 1 below shows a south elevation of the eastern portion of the building. In the E-W direction, the building consists of 15 bays at approximately 20-ft (6.1-m) spacing. In the N-S direction, there are five bays at approximately 20 ft (6.1 m) per bay, see Figure 2.

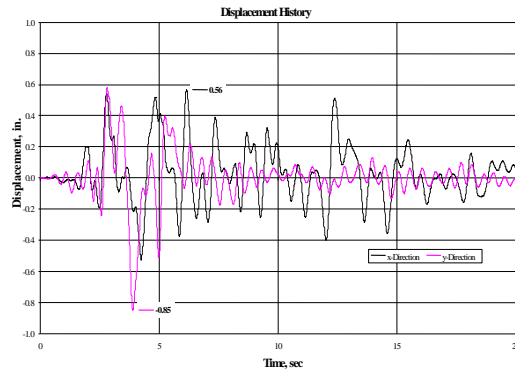
Figure 14: Displacement history of damped structure

To evaluate the seismic response of the upgraded structure, the displacement response of the second floor was examined and a stress check of all first story columns was performed. Figure 14 shows the second floor displacement responses for the lower-right (S.E.) corner. It is noted that the maximum computed displacements are approximately 0.56 in. (14 mm) and 0.85 in. (22 mm) in the longitudinal transverse directions, respectively, which are well below their target values. This corresponds to story drift ratios of approximately 0.003 and 0.004, respectively. A comparison of the displacement response for the original structure and this figure shows that the maximum response was reduced by more than a factor of five by the addition of FVD and FVED elements. Finally, the computed axial force in columns was examined. No net axial tension was found in the.

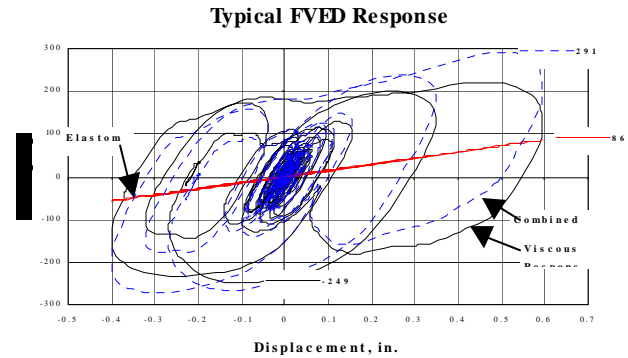
Figure 15: Typical FVED response

Finally, the computed axial force in the columns was examined. No net axial tension was found in the existing columns. The maximum force in the FVD was less than 200 kips (890 kN). As such, the 200-kip (890 kN) dampers used are adequate for these 16 damper bays. Figure 15 depicts the response of a typical FVED. It is noted that the maximum damper and spring forces are approximately 250 kips (1112 kN) and 90 kips (400 kN), respectively. Spectra acceleration of this structure was 0.19 g.
