# SEISMIC ISOLATION OF 200 YEAR OLD HERITAGE CATHEDRALS IN HAITI

# H.K. Miyamoto<sup>1</sup>, A.S.J. Gilani<sup>2</sup>, D. Sonda<sup>3</sup>, and A. Wada<sup>4</sup>

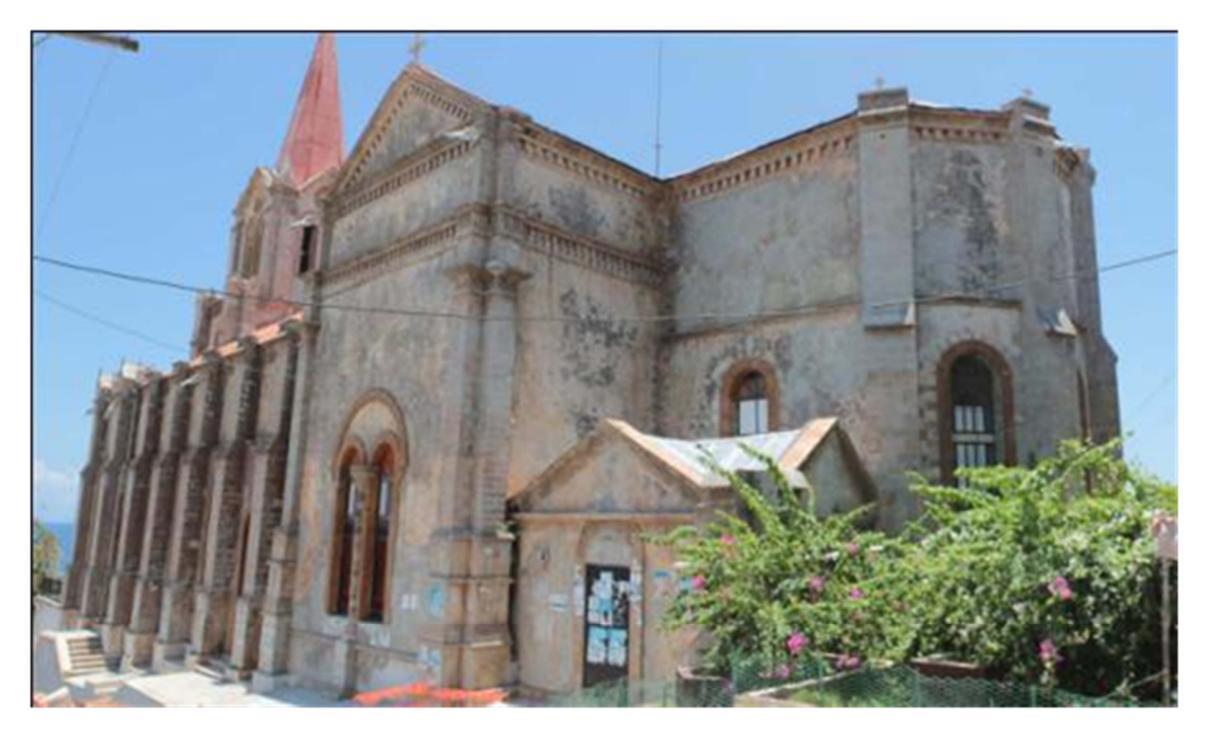
Figure 1. Photograph of the Cathedral, looking east

Saint John Baptist Cathedral of Miragoane (hereafter referred to as the Cathedral) was originally constructed in 1880 and is one of the oldest Cathedrals in Miragoane— a coastal town approximately 80 km west of Port-au-Prince, the capital of Haiti. Figure 1 shows a photograph of the building looking east. The building has an area of approximately 580 m2 and is nearly rectangular shape. The building is constructed using concrete floors with an unreinforced masonry and stone walls over stone masonry foundations. There is a ground floor, and a mezzanine with access to the upper tower that houses the bell. The roof structure is assembled with trusses that combine both wood and steel and is approximately 13.9 m tall at its peak. The roof is supported by the walls on the exterior and by uniformly placed columns along the interior. The front entrance of the cathedral has a bell tower that stands approximately 30.5 m high. The tower is constructed with steel frames above the walls. There is a concrete mezzanine that sits about 7m above the finished floor of the cathedral. The walls along the perimeter vary from 500 mm to 750 mm in thickness and are the primary gravity and lateral load resisting members. Figure 2 presents elevation and plan views of the building.

The Cathedral suffered minor damage, primarily minor cracking during the 2010 Haiti Earthquake. The damage to the building was minor because it was not located near the epicenter of the 2010 earthquake

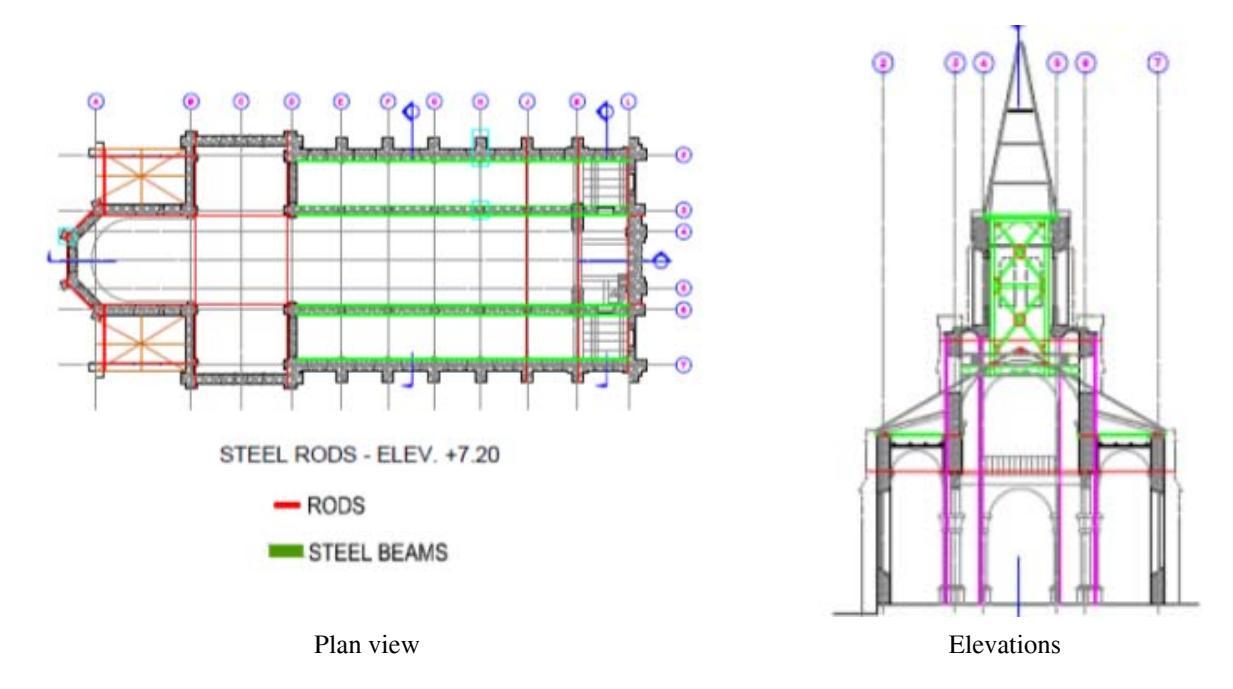
Figure 3. Typical structural intervention details

mechanisms and connect the internal columns to the external walls. Such approach has been used extensively in Europe and especially in Italy and Greece [10] for retrofit of historic buildings. Figure 3 presents the plan and elevation view of the Cathedral showing the added steel members. As shown in the figures steel members are added: a) Horizontal tie-down steel rods are added to the building to connect the perimeter walls in both directions, b) System of steel truss works is added to provide diaphragm action in plane and vertical bracing, c) Bracing is added to reinforce the tower and to connect this segment to the rest of the Cathedral, d) Vertical tie-down rods are added to reinforce the walls at tower base and to improve its flexural capacity, and e) Steel longitudinal reinforcement is added to the tower walls

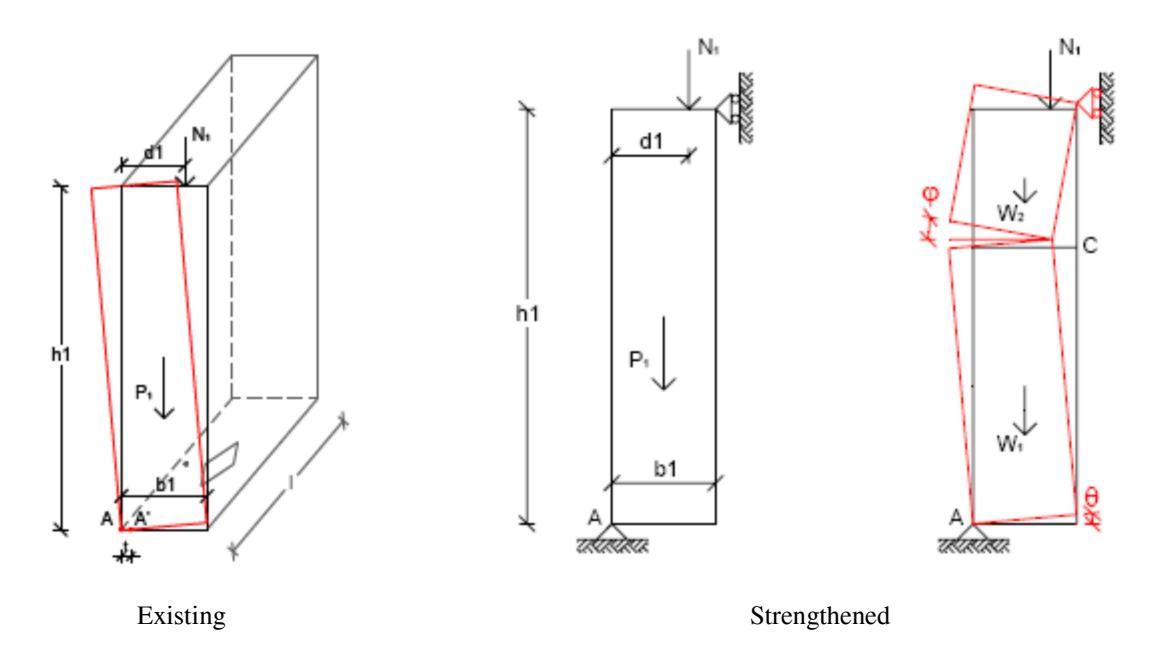
Figure 4. Out-of-plane failure modes for a typical wall segment

The wall failure in the original configuration will be comprised of the rigid motion (rocking) of the wall about its base; see Figure 4. This kinematic condition is possible since the top of the wall is not attached to a diaphragm. The lateral load (acceleration) required to initiate failure is resisted by the vertical load acting on the wall. Once the steel members are added, the diaphragm action excludes this mode of failure. Instead, the failure mechanism will include formation of a hinge along the height of the wall (see Figure 4). A larger lateral force (acceleration) will be required to initiate this higher mode failure. In addition, the tie-down rods provide additional resistance to overturning and thus serve to increase the lateral load required to initiate out-of-plane failure of walls [8] The key parameter for development of the out-of-plane strength is the lateral acceleration at the base of the wall and perpendicular to its plane that initiates failure. This is because, the seismic load is considered as static force (wall mass times spectral acceleration at the base of the wall), and acceleration is assumed to be constant along the height of the wall  $(a_0)$ . The computed capacities are further adjusted by two factors: a) Knowledge factor  $\kappa$  to account for uncertainties in material properties, construction details, and geometric characteristics, and b) Behavior factor q to account that the limited ductility of the walls and constraint by adjacent elements to provide restraint to the out-of-plane rotation of the wall segment under consideration. At the time of analysis, no field test data was available, a  $\kappa$ factor of 0.75 (1/1.35) was used as prescribed in the Italian seismic code [9]. Similarly, the Italian code recommends using a value of 2.0 for q when a simplified linear procedure is utilized.

Equilibrium kinematic analyses of various walls of the Cathedral were conducted. The analyses accounted for the dimensions (height and thickness) of the wall, the vertical force acting on it, and the vertical tie-down restraining forces. Table 2 summarizes the findings. The highlighted values are the modified strength values.

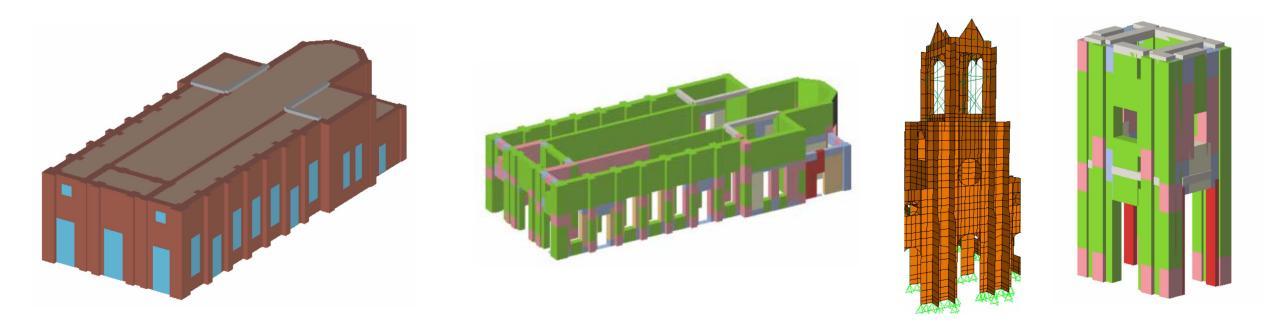
Figure 5. Mathematical model, and failure mode for main cathedral and bell tower

Shown in Figure 5 is the state of the main cathedral and bell tower at the limit state. In this figure:: a) Green denote wall segments that remain elastic, b) Pink corresponds to flexural yielding, c) Red designates flexural failure, d) Ivory indicates shear yielding, and e) Light blue represents traction failure Note that no shear failure was developed and limit state is reached when walls reach their ductile flexural capacity. The progression of the nonlinear response in the bell tower is listed in Table 3.

The capacity of the walls was determined using static pushover analysis using plastic hinges whose properties were obtained from interaction analysis and program 3Muri [12]. The observation of damages on existing structures has led to the definition of masonry as a macroelement that captures the shear behavior in its central part and the buckling behavior in the outlying areas. The kinematic model used is described by eight degrees of freedom: the six components of displacement of the end nodes and the two components of the macro-element. The overturning mechanism of the panel, caused by the absence of a significant tensile strength of the material, is represented assuming elastic contact in interfaces, while the mechanism of shear failure is schematized considering a state of uniform tension in the central module. Maximum deformations (drift) acceptable for the panels are settled to define the collapse mechanism, due to the mechanisms of shear and bending.

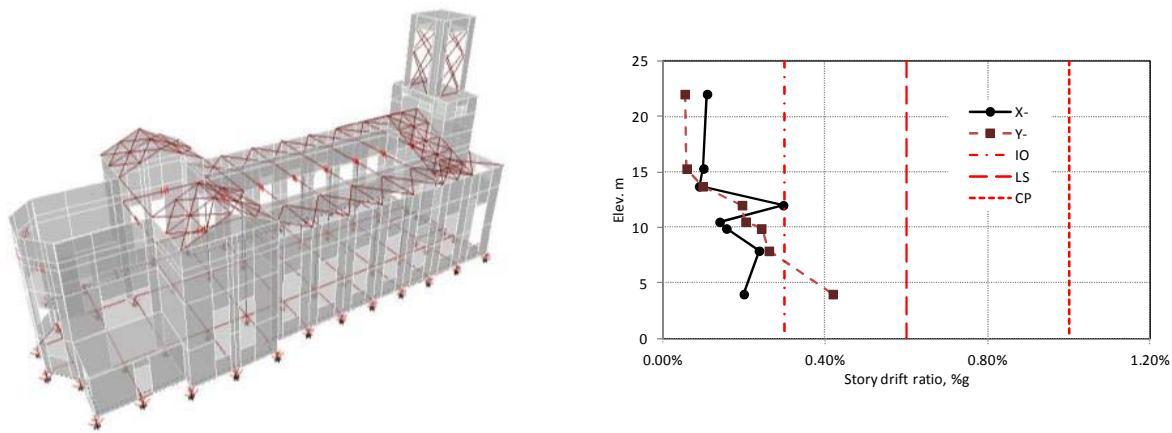
Figure 6. Analytical model of the building

A three-dimensional analytical model of the building was prepared using the program ETABS [2] see Figure 6. The inertial mass of the structure is estimated at 2,800 Mg. The individual isolators were model as bilinear link elements using the friction and curvature properties provided by the TP bearing manufacturer. All calculations were performed using nominal values (no upper- and lower-bound analyses were conducted.)

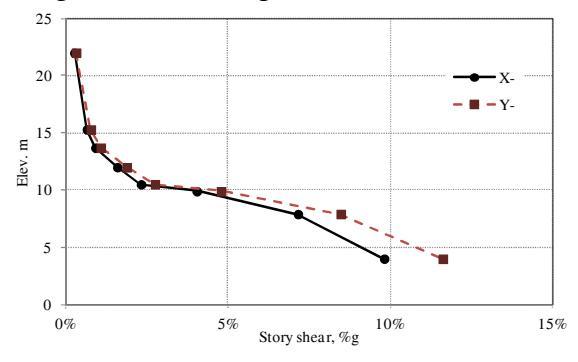
Figure 8. Distribution of story shear along building height

Figure 8 presents the distribution of shear force (normalized with respect to the building seismic mass) along the height of the structure. The effective base shear for this building is approximately 12%g at the DE intensity. The addition of the isolation system has served to significantly reduce the demand on the structure. This can be further seen in Figure 9 showing that maximum total acceleration of 0.5g is reduced to 0.18g as it travels (and thus filtered) through the isolation plane.

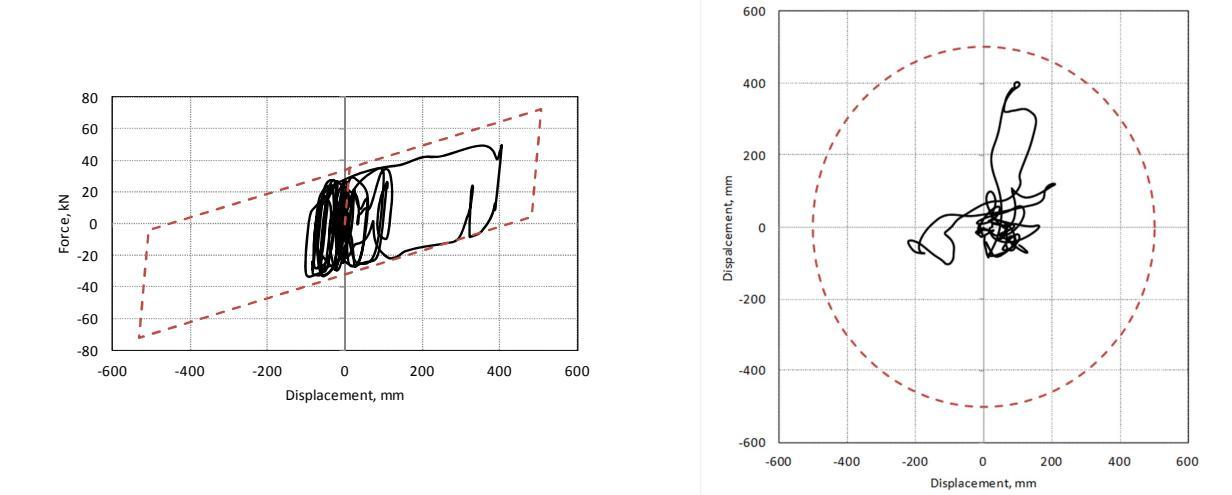
Figure 10. Typical isolator response

Figure 10 presents the force-deformation response of a typical isolator from MCE analysis. Also shown in the figure is the nominal bi-linear backbone curve of the isolator obtained from the manufacturer data. Figure 11 presents the bi-direction MCE displacement response of a typical isolator. Also shown in the figure is the displacement limit (500 mm) as specified by the manufacturer. As seen, the isolator MCE displacements in any direction are less than its allowed maximum motion.
