Cost-effective Seismic Isolation Retrofit of Heritage Cathedrals in Haiti

H. Kit Miyamoto¹ and Amir SJ Gilani²

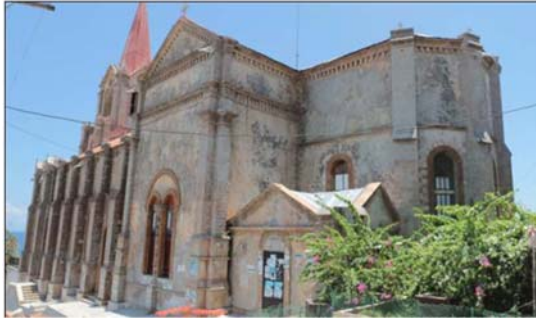
Figure 1. Miragoane Cathedral

Building description. Saint John Baptist Cathedral of was originally constructed in 1880 and is one of the oldest Cathedrals in Miragoane— a coastal town approximately 80 km west of Port-au-Prince, the capital of Haiti. Figure 1 shows a photograph of the building looking east. Saint Jacques et Saint Philippe Cathedral of Jacmel; see Figure 2 was originally constructed in 1859 and is one of the oldest Cathedrals in Jacmel— a coastal town approximately 80 km southwest of Port-au-Prince, the capital of Haiti.

The buildings were constructed using concrete floors with an unreinforced masonry and stone walls over stone masonry foundations. The roof structures were assembled with trusses that combine both wood and steel. The roofs are supported by the walls on the exterior and by uniformly placed columns along the interior. The front entrances of the cathedral have bell towers high. The tower is constructed with steel frames above the walls.

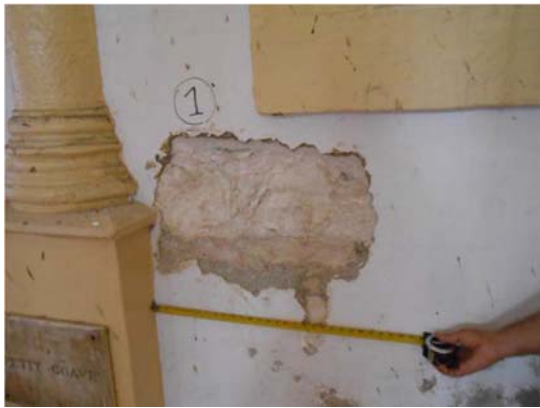
The Cathedrals' unreinforced stone masonry (URSM) walls are the load bearing elements resisting the applied vertical and lateral load applied to the building. Figure 5 depicts exposed sections of the walls with the wall plaster removed for investigation for the two structures. The composition of the wall is that of unreinforced masonry with irregular-shaped stones or with rectangular-shaped stones and debris placed in the mortar

Irregular-shaped stones placed in the mortar

Figure 5. Typical composition of exposed unreinforced masonry stone walls

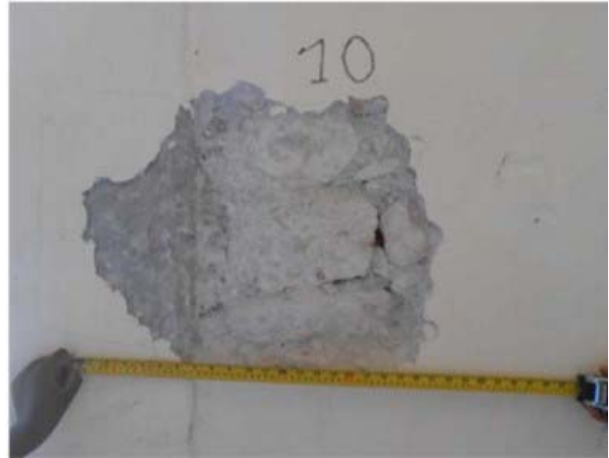
Rectangular-shaped stone and debris in mortar

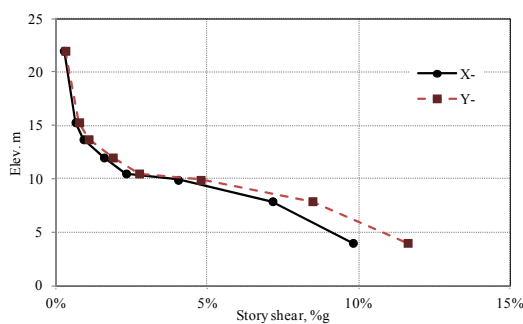
Story shear. Figure 10 and Figure 11 present the distribution of shear force (normalized with respect to the building seismic mass) along the height of the structures. The effective base shear for the two buildings are approximately 12% and 7% g, respectively at the DE intensity. The addition of the isolation system has served to significantly reduce the demand on the structure.

Figure 10. Story shear, Miragoane

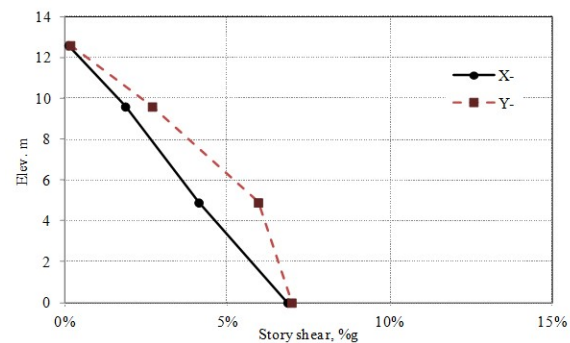
Figure 11. Story shear, Jacmel
